**EVALUATION OF THE
1,730,000 GALLON STANDPIPE
NEW CARLISLE, OHIO
FOR
CITY OF NEW CARLISLE
NEW CARLISLE, OHIO**

July 14, 2017

17.096.H1664.001

The subject of this report is the field evaluation of the 1,730,000 gallon standpipe in New Carlisle, Ohio. The tank was owned by the City of New Carlisle, Ohio. The field evaluation was performed on July 14, 2017 by Gregory P. Cannon, NACE Certified Coating Inspector Level 3, Certificate No. 10339, Jamie Stewart, NACE Coating Inspector Level 1 Certified, Certificate No. 64809, and Jared Colahan, NACE Certified Inspector Level 3, Certificate No. 47251 of Tank Industry Consultants. The Owner's representative on the site at the time of the field evaluation was Jason Rose. The column and rafter supported roof tank was of welded steel construction. According to information on the tank nameplate, the tank was built in 1975 by Chicago Bridge and Iron Company under contract number 74-20814, and had a capacity of 1,730,000 gallons. The tank nameplate also stated that the tank diameter was 60 ft, and the nominal shell height was 82 ft.

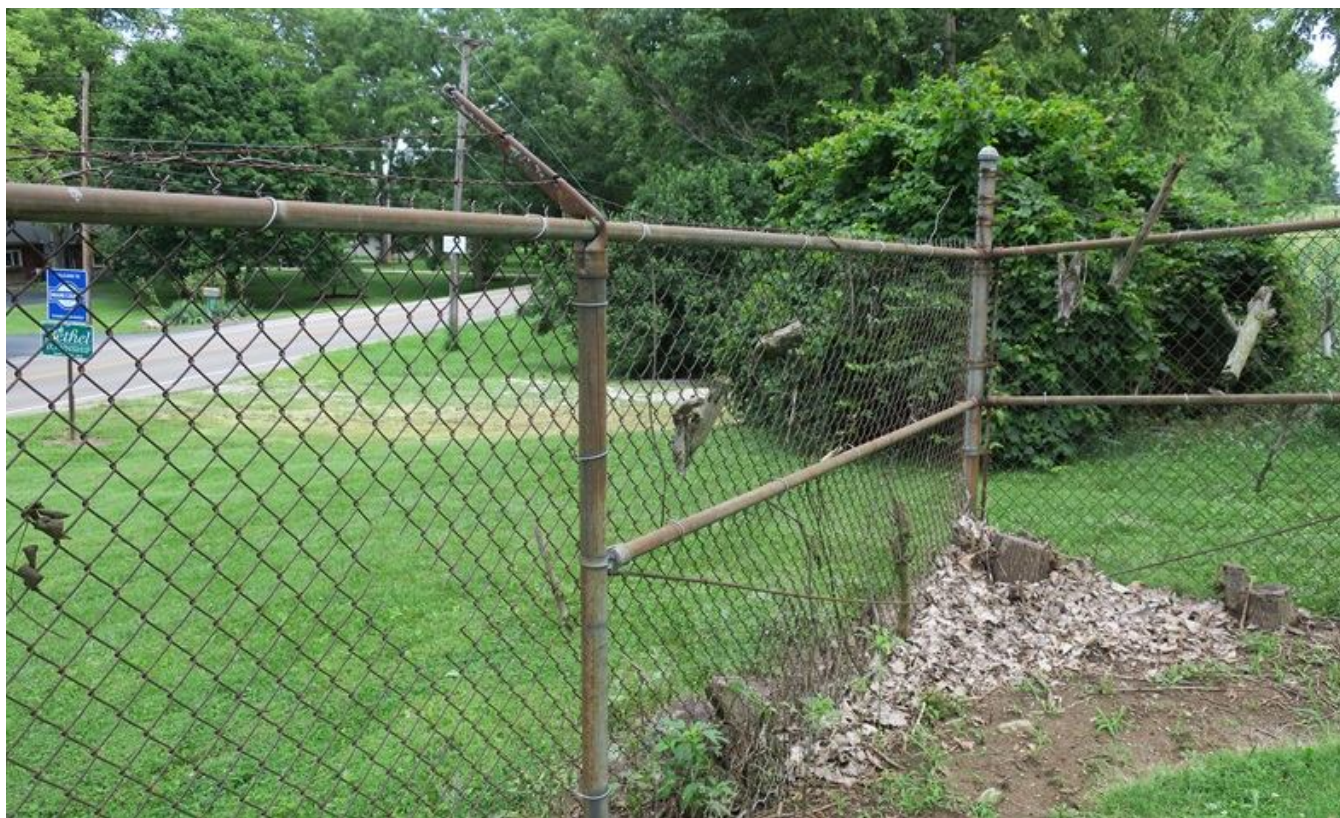
7. Surrounding site. Note damaged fence.

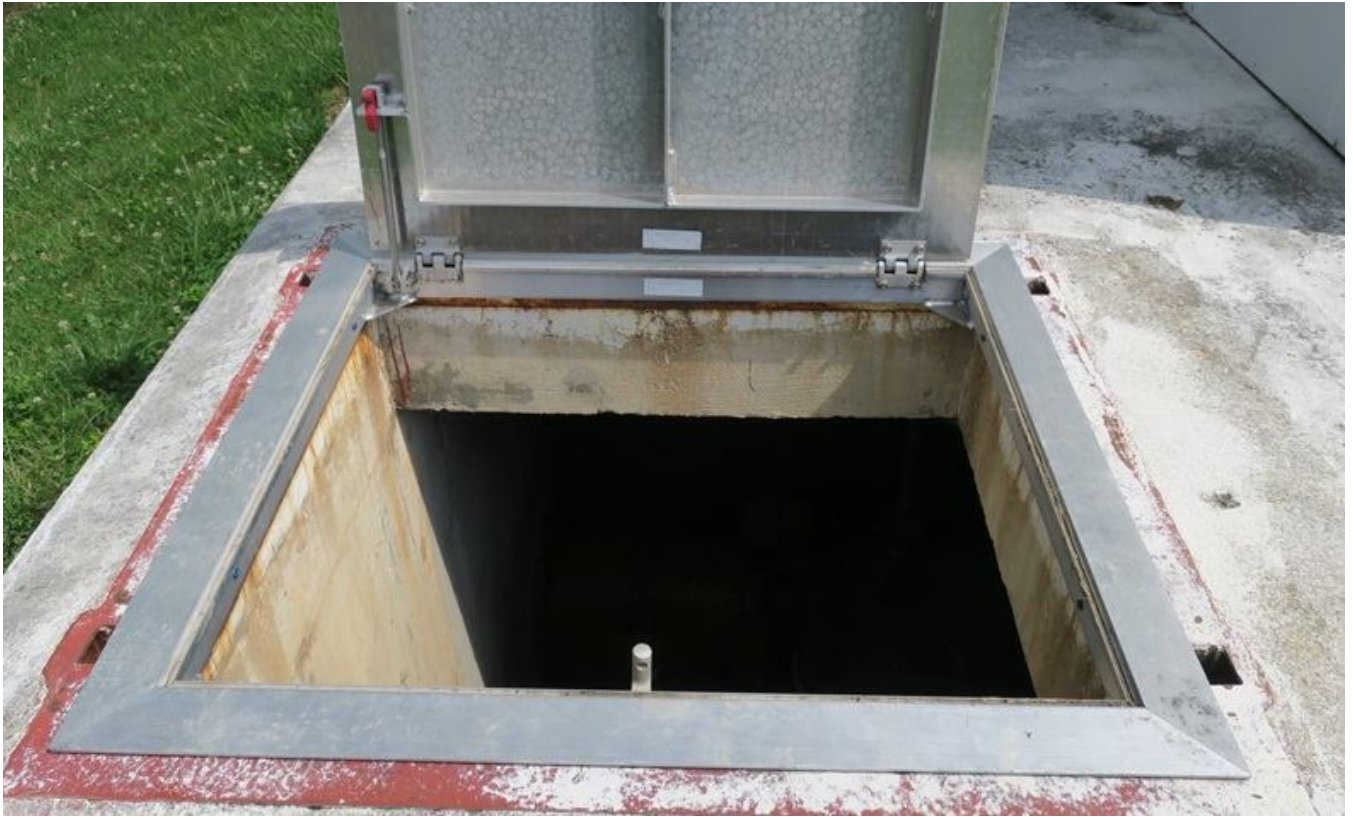
5. **Valve Vault:** There were a safety and OSHA deficiencies noted: (1) the 6 in. toe room did not meet the required 7 in. minimum, (2) the 28 in. minimum head clearance did not meet the minimum required 30 in., (3) the electrical equipment did not appear to include ground fault interrupt circuits, and (4) water was located on floor and vault contained electrical equipment. There was a valve vault located on the west side of the tank site. Access into the valve vault was locked prior to or after this field evaluation. The piping in the valve vault was in poor condition with widespread corrosion. The vault was equipped with a heater vent, and inoperable light fixtures. An electrical meter was immediately adjacent to valve exterior. Water was observed in the bottom of the vault. (See photos 12-15)

13. Valve vault access.

6. **Valve Vault:** The piping and valves located in the valve vault should be cleaned and painted in accordance with the interior coating recommendations at the time of the tank cleaning and coating. The exterior concrete surfaces should be cleaned to the equivalent of a brush-off blast cleaning and painted with a concrete sealer. The valve vault access should continue to be locked at all times in order to limit liability to the Owner and to protect water system security. Freeze protection should be provided for on all control piping and static water lines. The existing ladder should be modified to allow adequate head clearance and toe room. The electrical equipment should be modified to include ground fault interrupt circuits. Inoperable lights should be fixed or repaired and a small pump should be used to eliminate standing water.

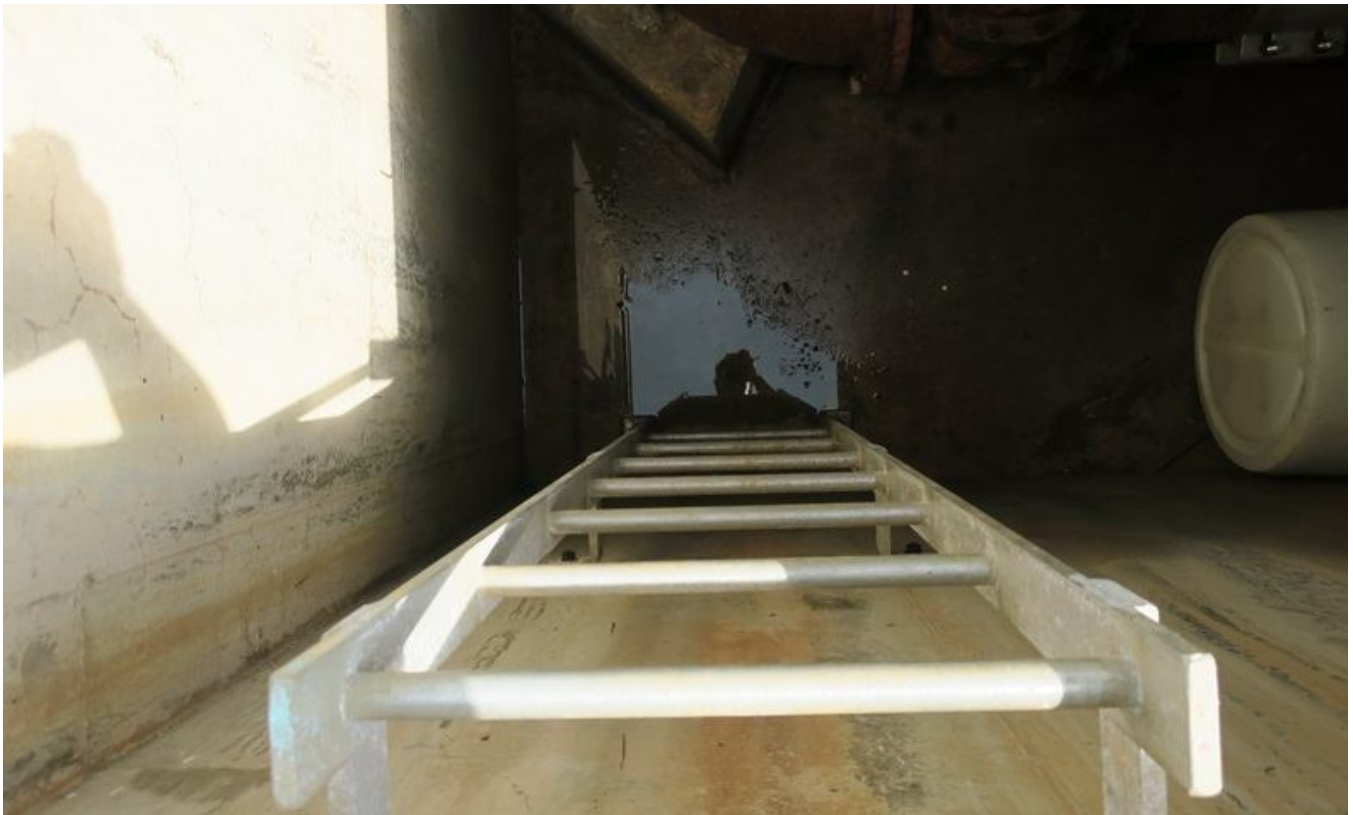
14. Valve vault ladder. Note standing water.

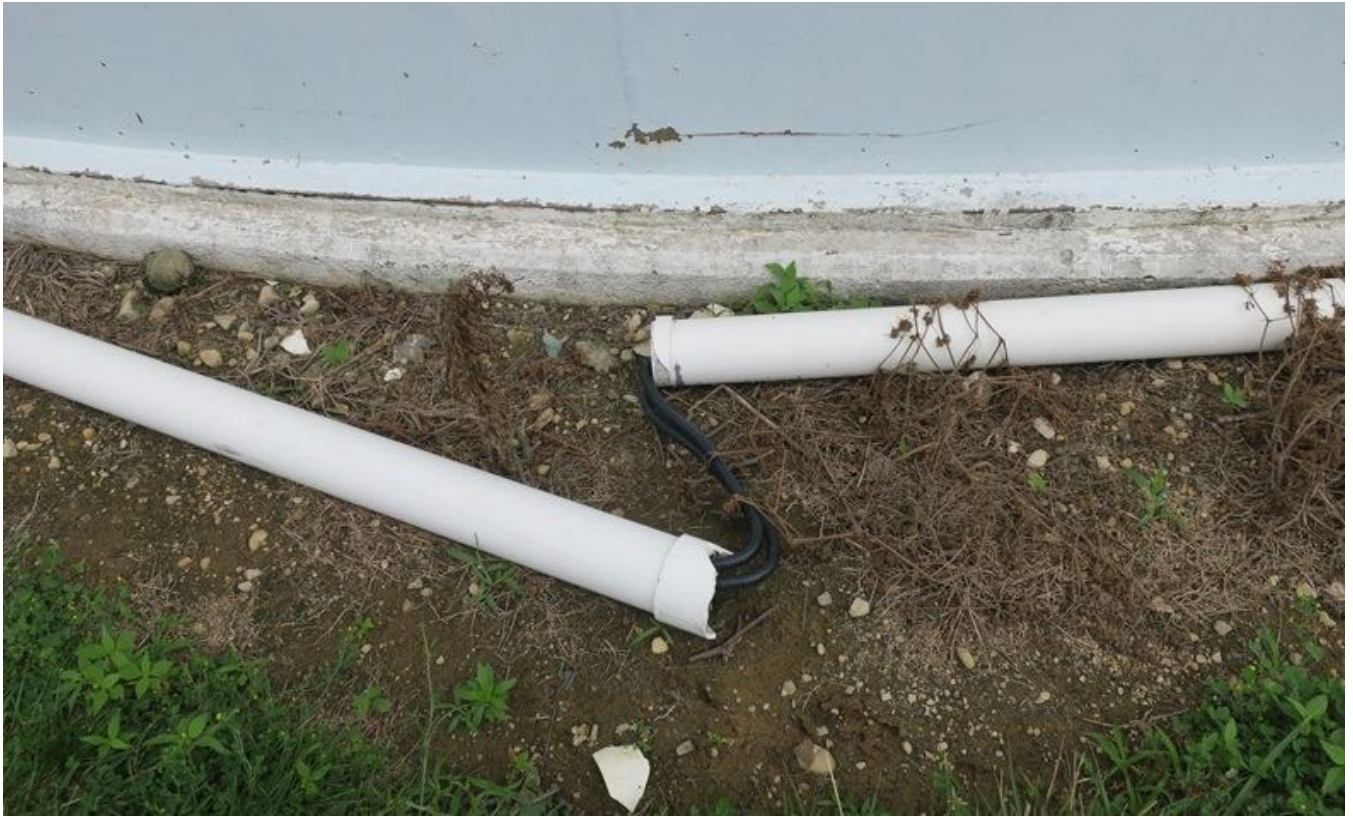
2. **Site Conditions:** **There was a safety deficiency: electrical cables were exposed at a broken conduit adjacent to the tank.** The tank site was covered with grass and was not graded to provide adequate drainage away from the foundation. The tank site was fenced. The chain link fence was topped with barbed wire and was equipped with a locked gate on the west side of the site. The fence appeared to be in fair overall condition with the exception of a damaged section of barbed wire on the northwest corner of the site. An informational sign was posted in site fence. Shed, electronic meter, and an antenna tower were located on site. (See photos 1-11)

17. Broken electrical conduit exposing cables.

12. **Electrical Apparatus:** All unused antennas, fixtures, electrical metering equipment, cathodic protection apparatus, and control cabinets should be removed from the tank and tank site. The broken conduit at grade needs to be repaired. All required equipment should be repaired and maintained in accordance with the National Electric Code (NEC).

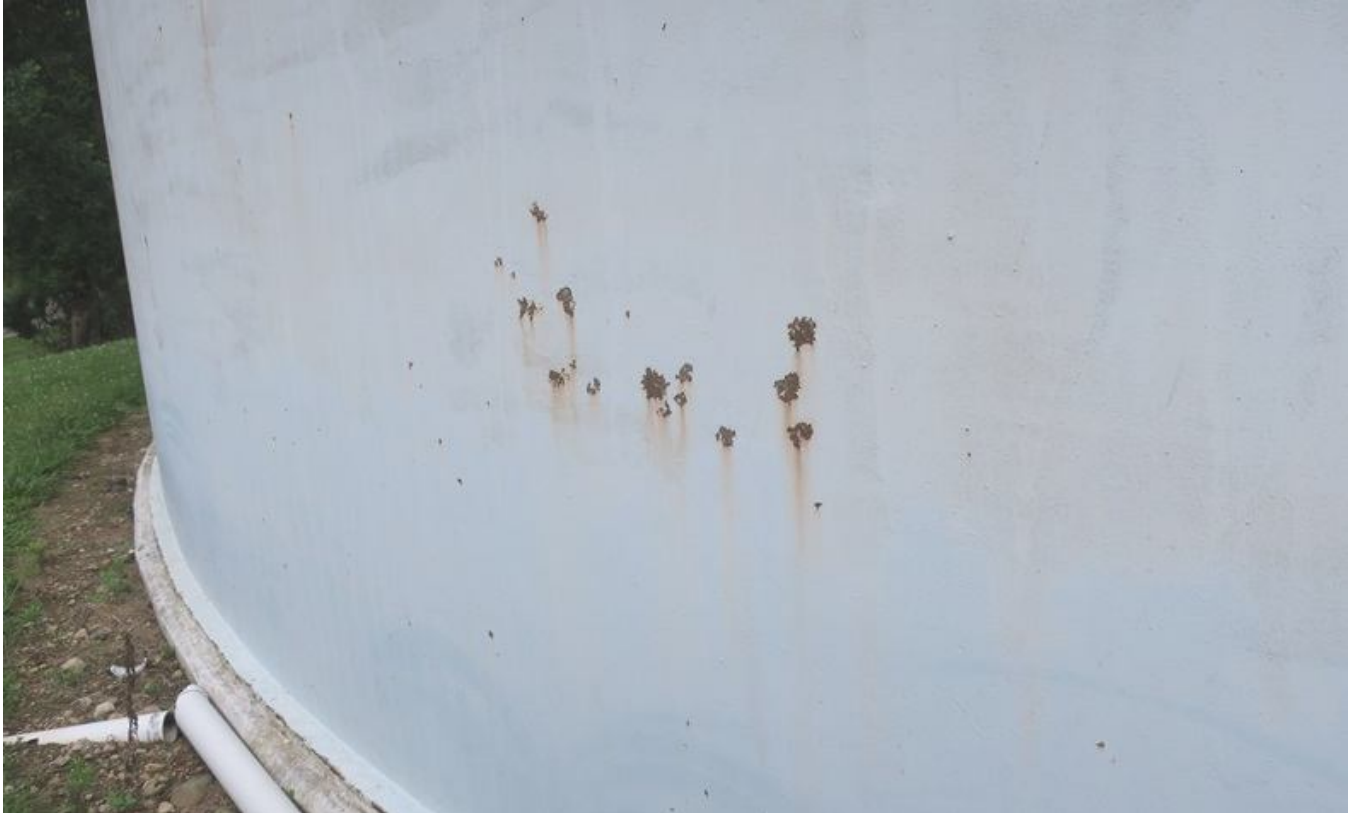
18. Shell exterior with spot corrosion.

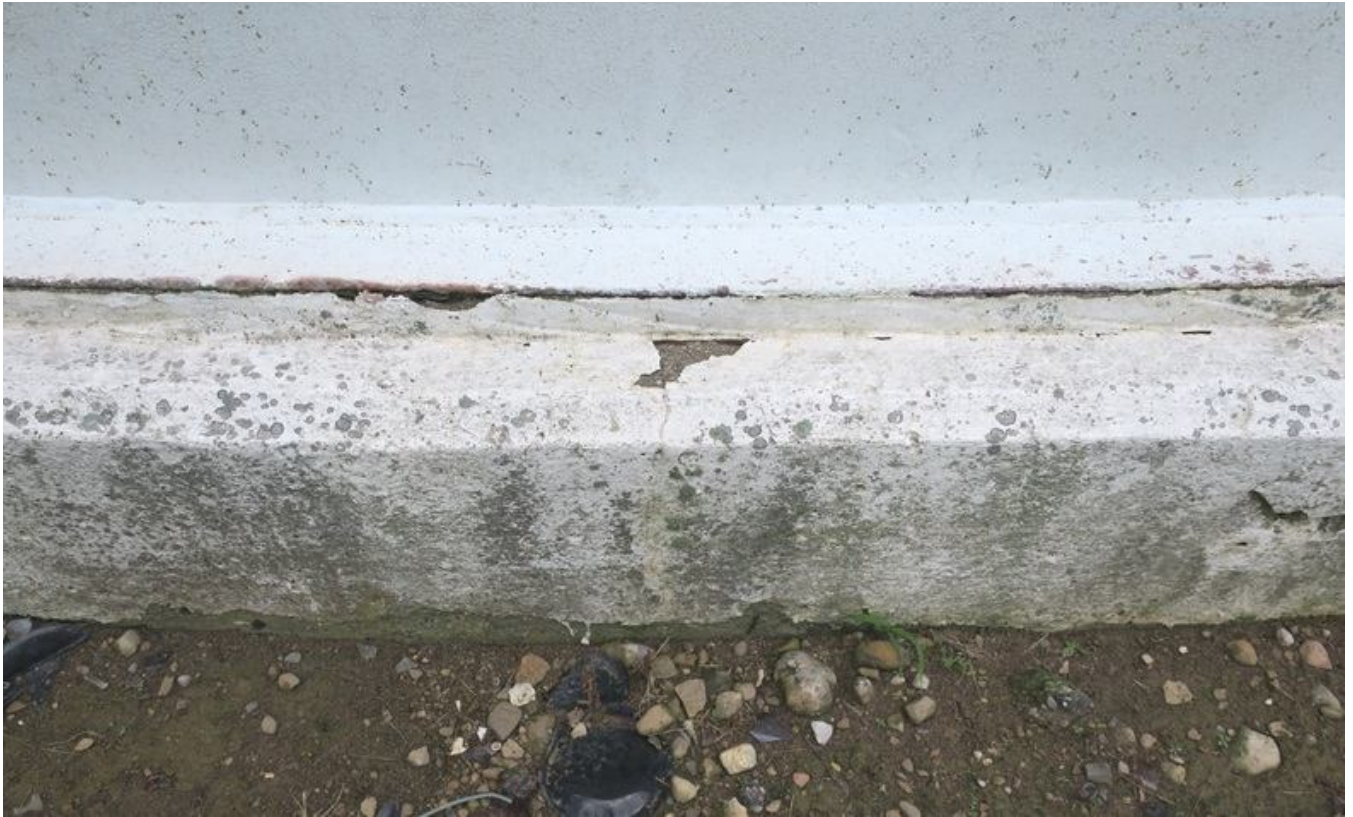
3. **Foundation:** The tank foundation appeared to be a concrete ringwall. Except for minor cracking and some spalled areas, the exposed surface of the foundation appeared to be in nearly its

19. Tank foundation. Note coating cracking and chipping.

4. **Foundation:** When the tank exterior is repainted, any unsound concrete should be chipped to sound material and the concrete should be brush-off blasted. Any deteriorated areas or voids found should have a bonding agent and a vinyl emollient modified concrete patching mortar applied to build up the surface to its original contour. The concrete should then be painted with a concrete sealer.

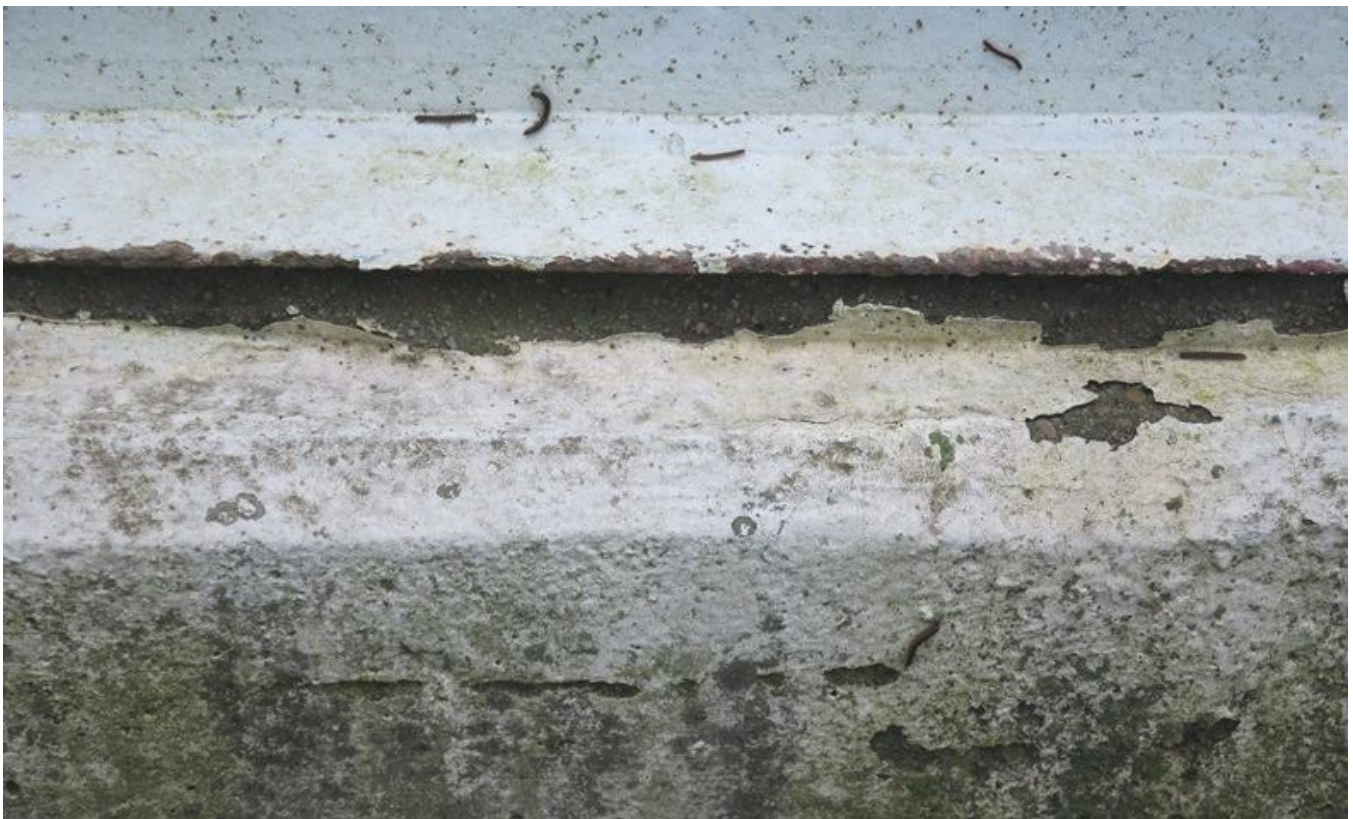
20. Tank foundation. Note coating cracking and chipping.

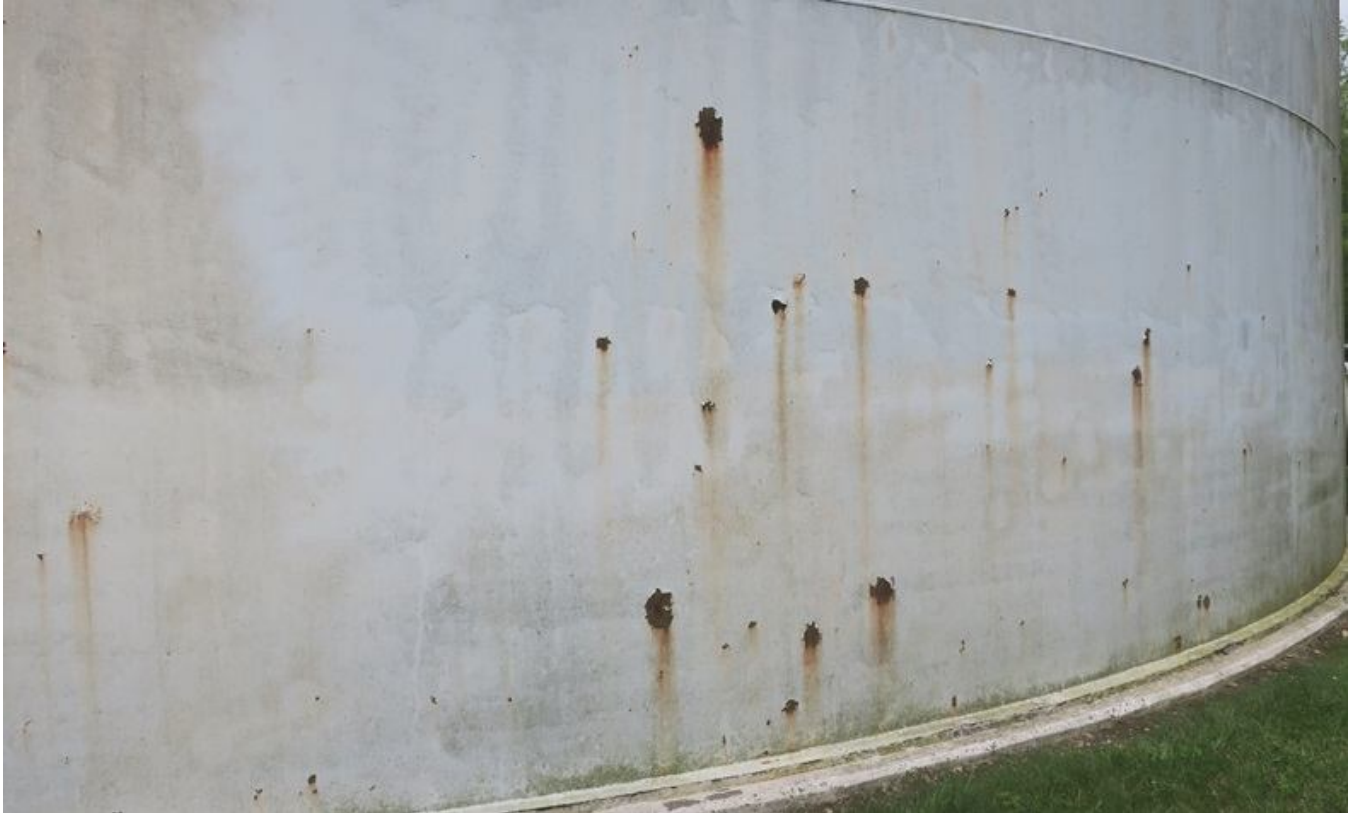
22. Shell exterior with spot corrosion.

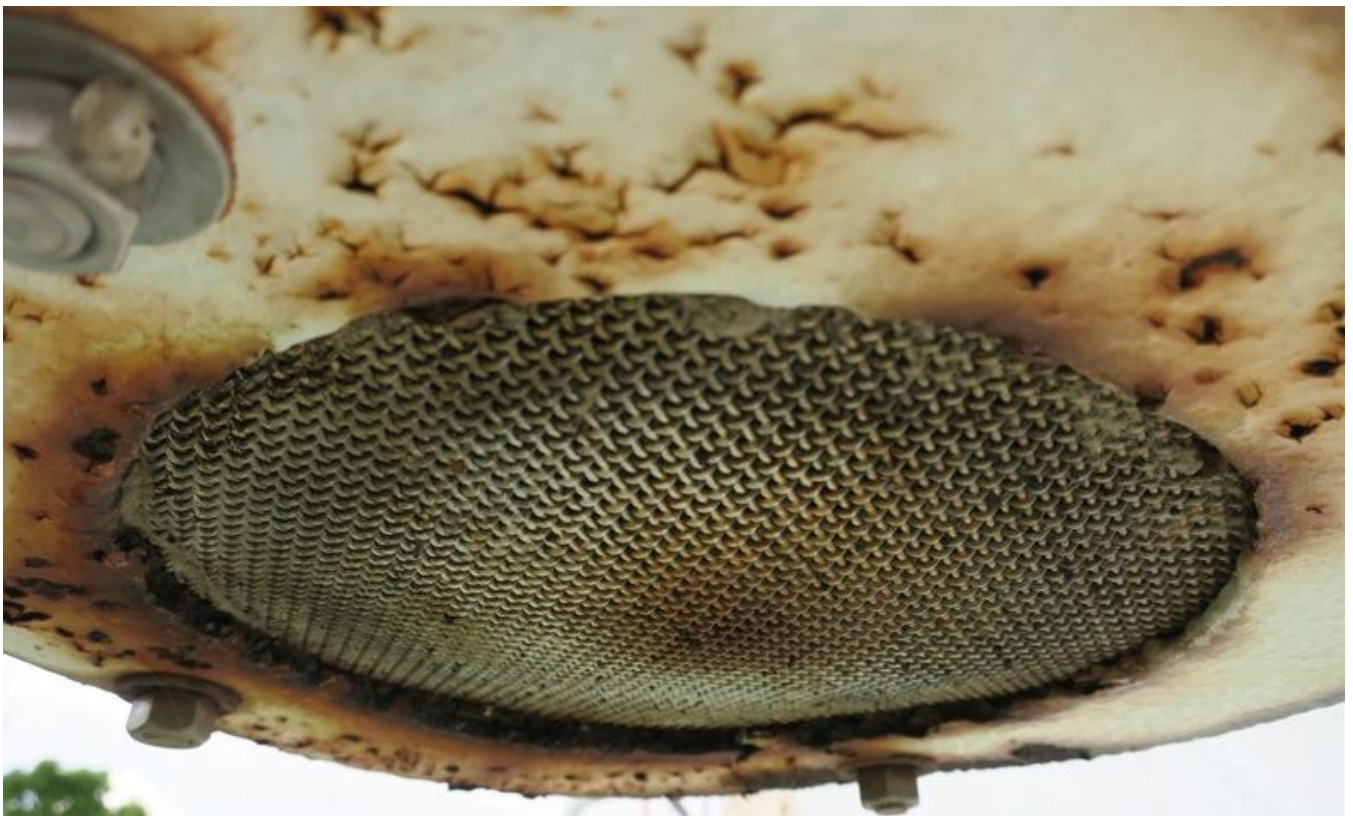
discharge end was not adequately screened to prevent the ingress of insects into the tank. The pipe was equipped with welded steel brackets which appeared to be in their original structural condition at the time of this field evaluation. No significant coating failure was observed on the overflow pipe although there was corrosion on the flange surrounding the screening. (See photos 25-27)

26. Overflow pipe drain. Note corrosion.

14. **Overflow Pipe:** The overflow pipe discharge 8 x 8 screen mesh should be replaced with a 24 mesh to prevent the ingress of birds, small animals, and insects into the tank. The air break should be adequately sized to allow the proper functioning of the new flap gate.

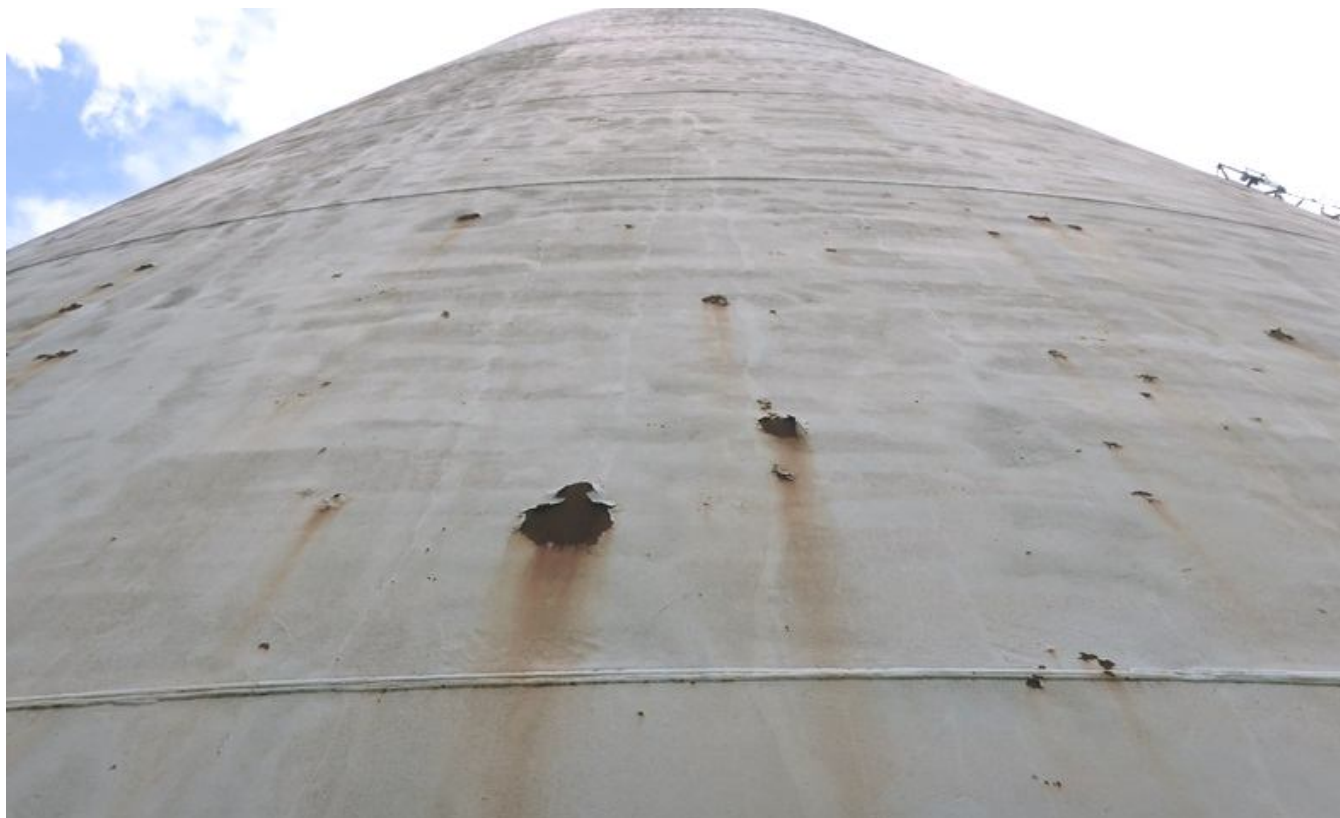
3. **Shell Condition:** The contour of the tank shell was good with no significant discontinuities observed at the time of this field evaluation. The coating appeared to be in fair to poor with several spots of peeled coating and corrosion observed. The shell coating had cracked, weathered and chalked. The coating exhibited good adhesion to the underlying coating. A tank nameplate was located on the southeast side of shell ring #1 above the shell manhole. Debris, mildew, and fish eyes were noted in coating. A cathodic protection cabinet was located on the lower south side of the shell. The cabinet housed a manually controlled potential rectifier. Signs were located on the north and south sides of the shell. The signs read, "NEW CARLISLE," and were dark blue. However, the sign coating was in poor condition as it had weathered and chalked significantly. (See photos 29-33)

29. Shell exterior with spot corrosion.

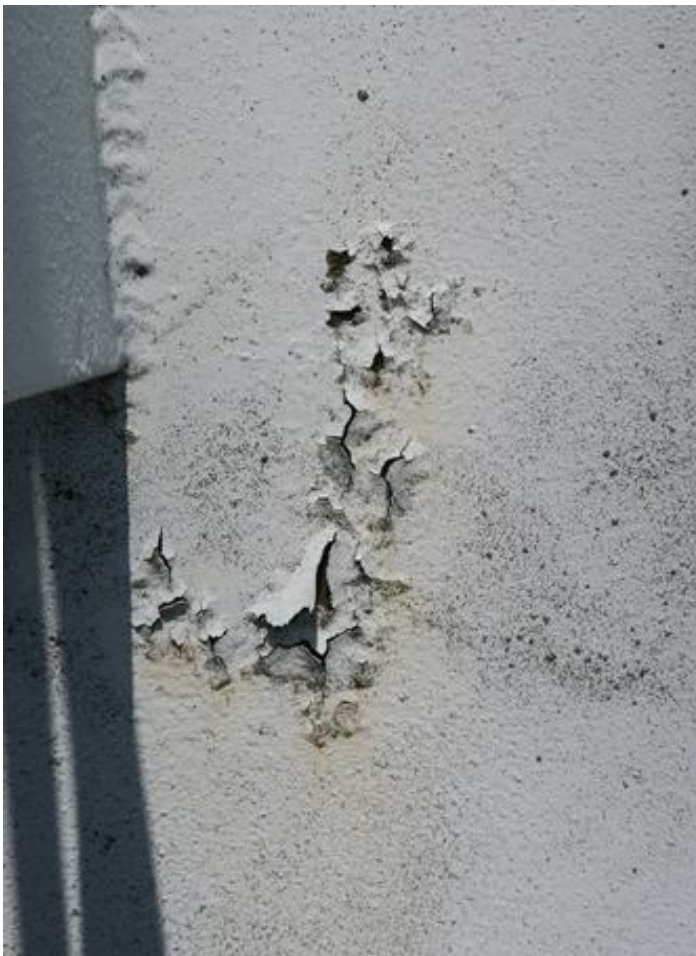
32. Paint failure along shell exterior.

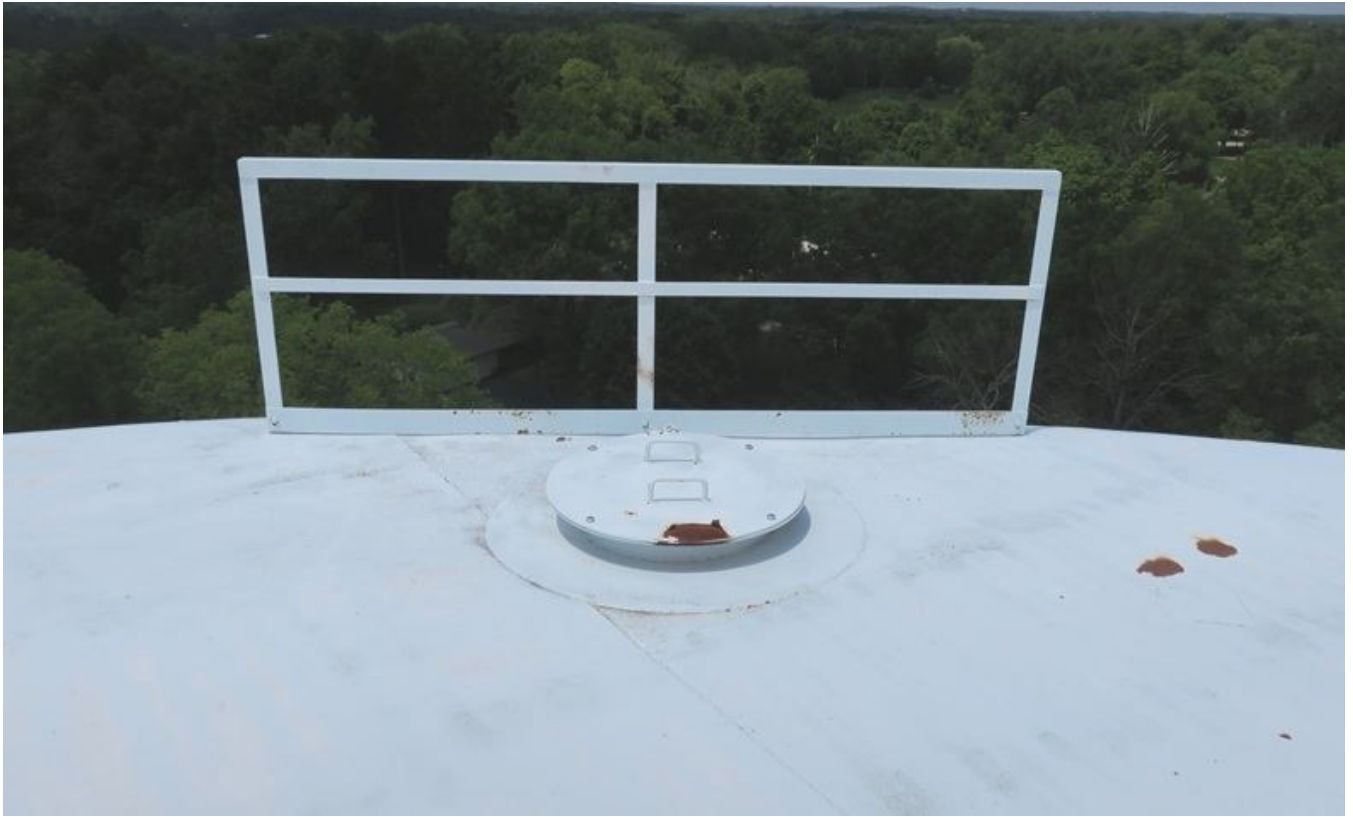
10. **Roof Manholes:** There was a sanitary, AWWA, and operational deficiency noted: the manhole covers were not locked. The roof was equipped with two manholes. One of the manholes was equipped with a hinged cover. The other manhole was flanged and equipped with a bolted cover. The bolted cover was equipped with a retaining chain which was welded to both the cover and to the roof. The roof manholes were not locked prior to or after this evaluation. The roof manholes were welded on the exterior only. Corrosion was observed on both manholes. (See photos 39-40, 46)

39. Roof manhole and safety railing.

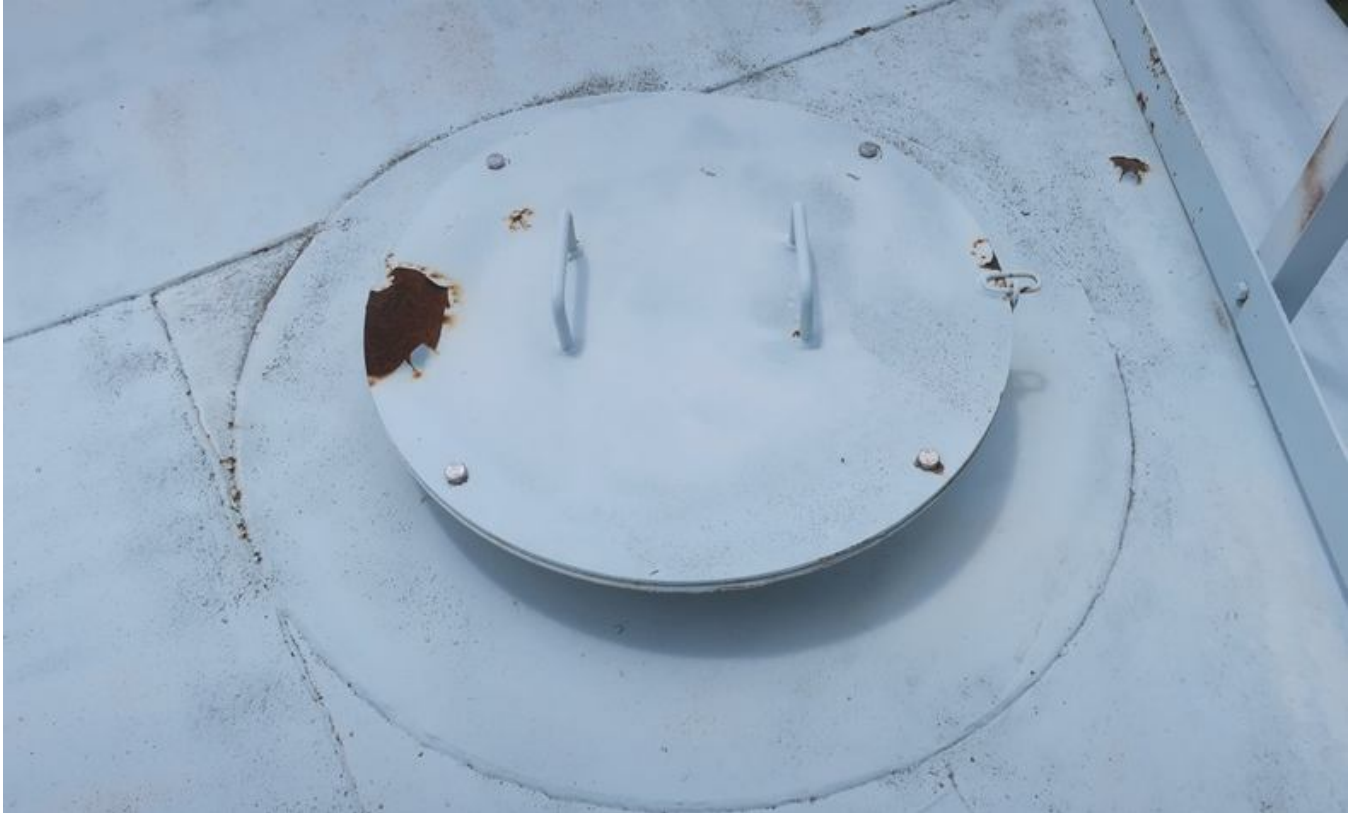
40. Corrosion on roof manhole cover.

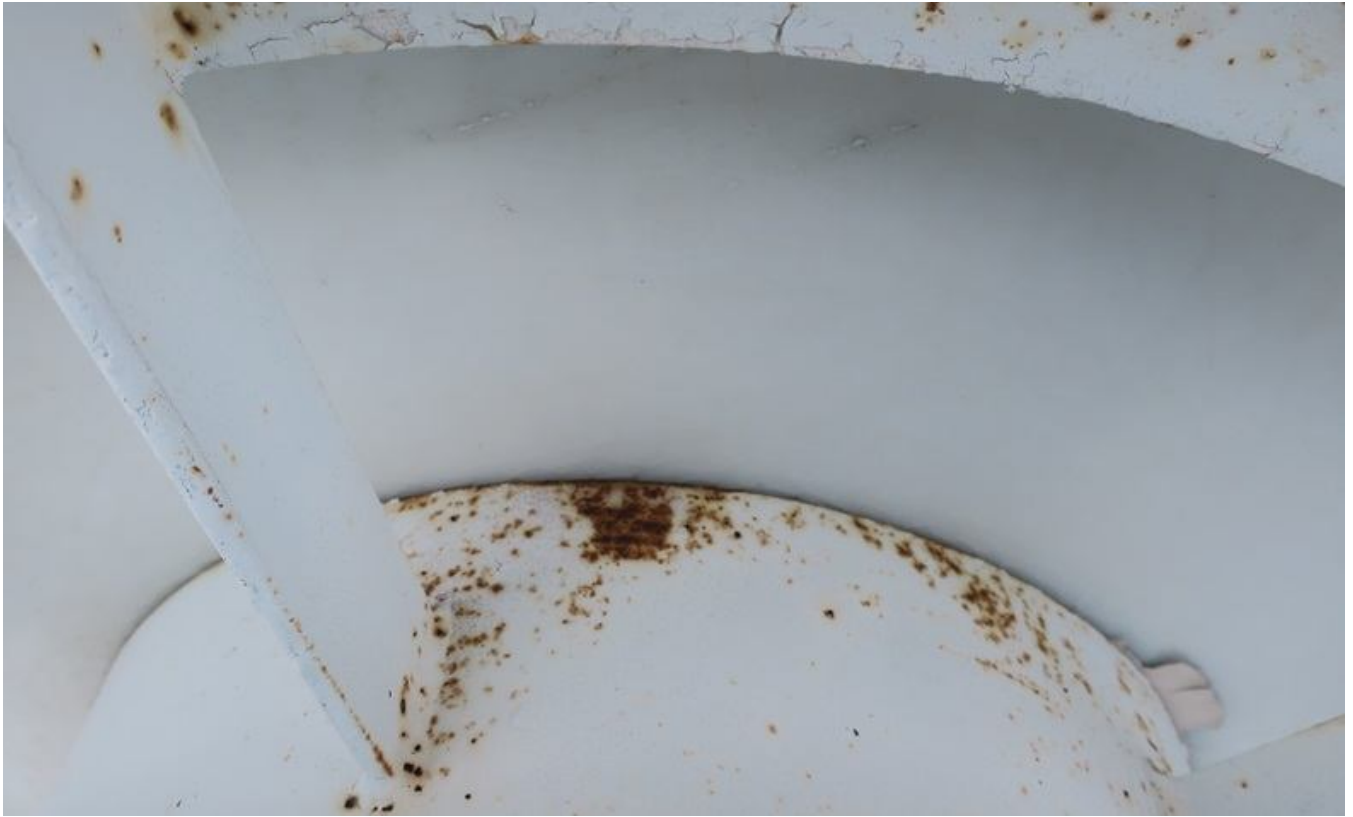
43. Roof vent. Note spot corrosion.

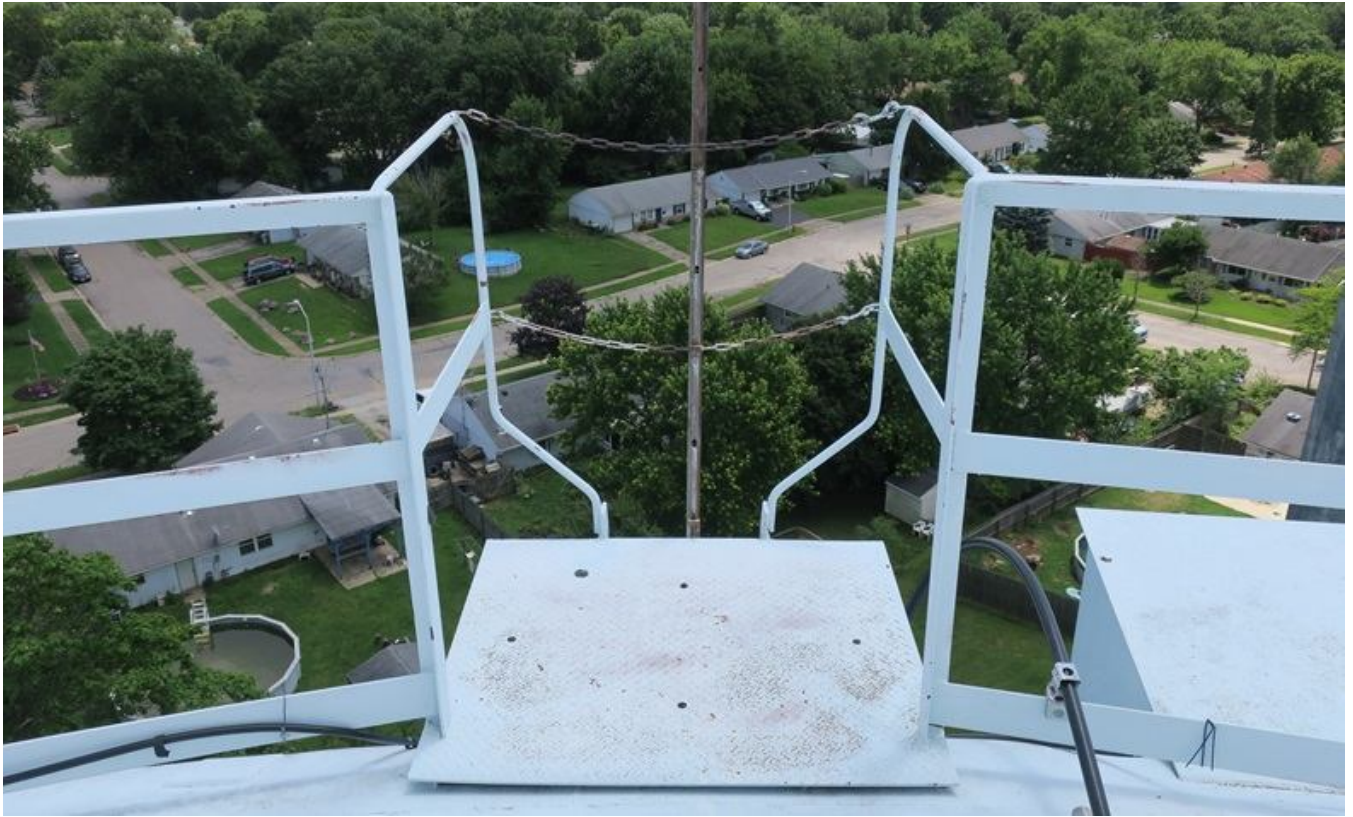
8. **Roof Safety Railing:** There was a safety-related and OSHA deficiencies noted: (1) the safety railing opening was not equipped with a self-closing gate, and (2) gap between the toe bar and roof greater than maximum allowed 1/4 in. The roof was equipped with two sets of safety railing at the roof access and adjacent to the roof manholes. The safety railing was constructed from welded angle and flat bar members. The coating on the railing was in good condition. An antenna was attached to the railing. (See photos 38-39, 47)

47. Roof access and safety railing. Note closure chains.

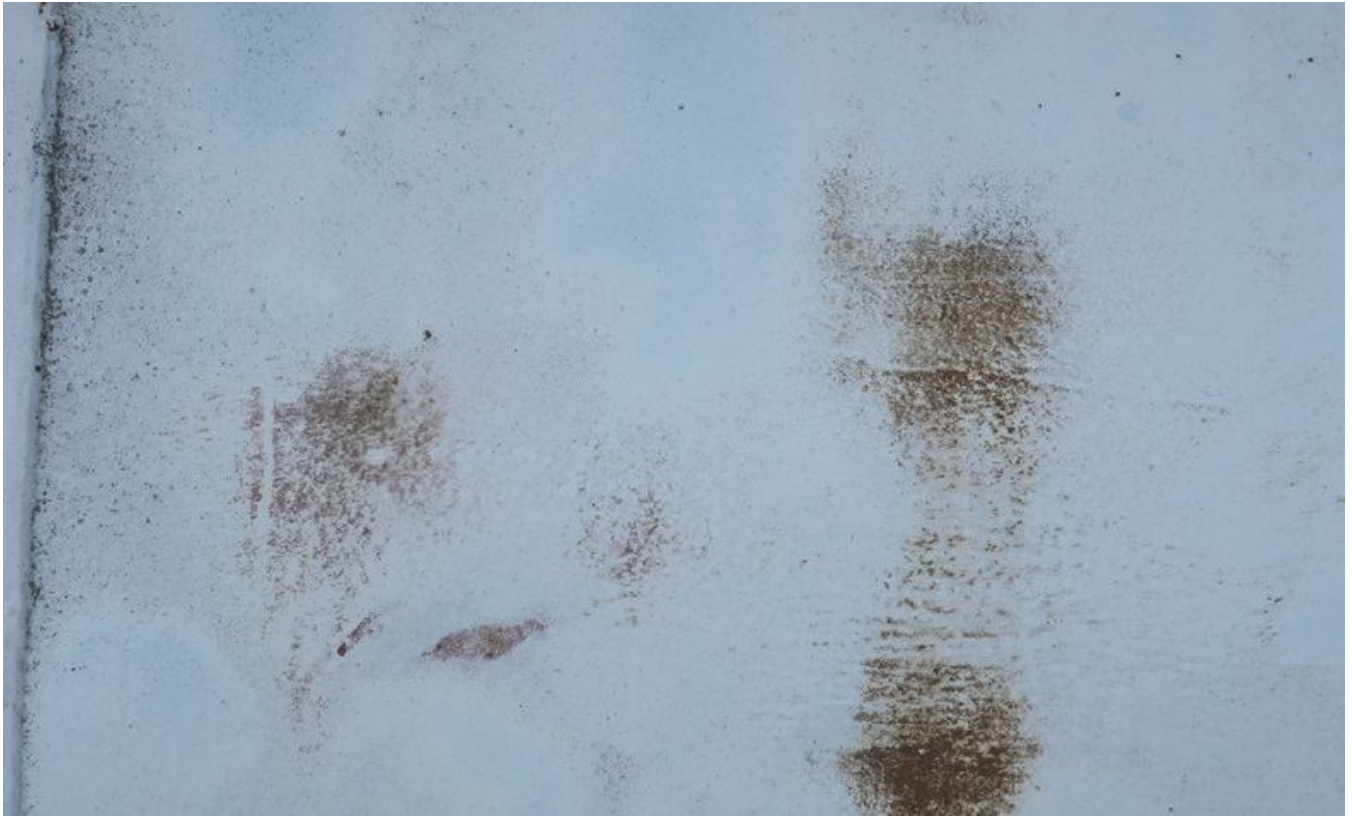
9. **Roof Condition:** The contour of the roof was adequate at the time of this evaluation. The coating on the roof had good adhesion to the primer. There were several areas of peeled coating and corrosion coating observed at the time of this field evaluation. The roof coating had experienced heavy chalking, heavy weathering, fading, popping, cracking, and fish eyes. Coaxial cable extended across roof to the vent antenna. Eighteen capped couplings and a welded steel rectangular patch plate were located in the roof. (See photos 38-53)

51. Roof corrosion.

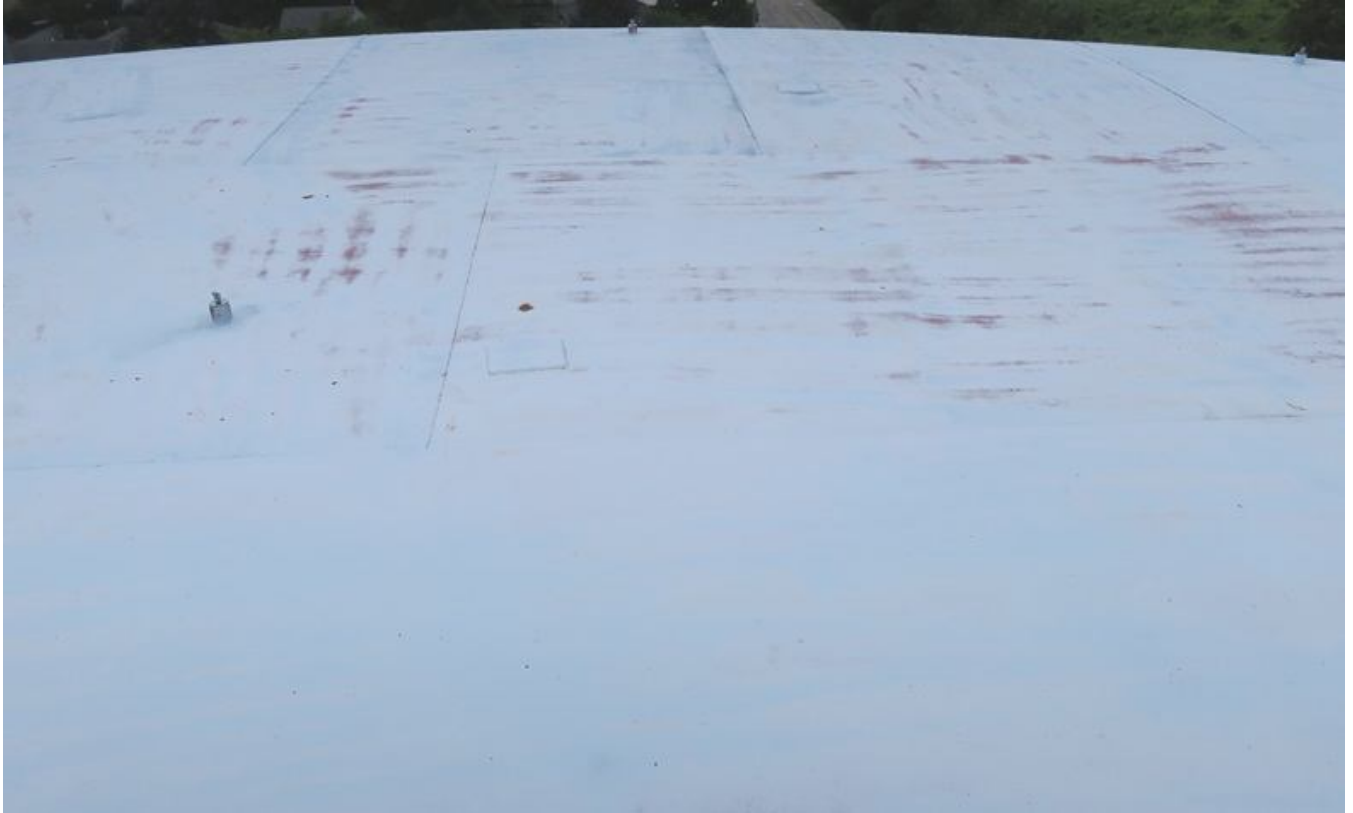
52. Weathered roof coating.

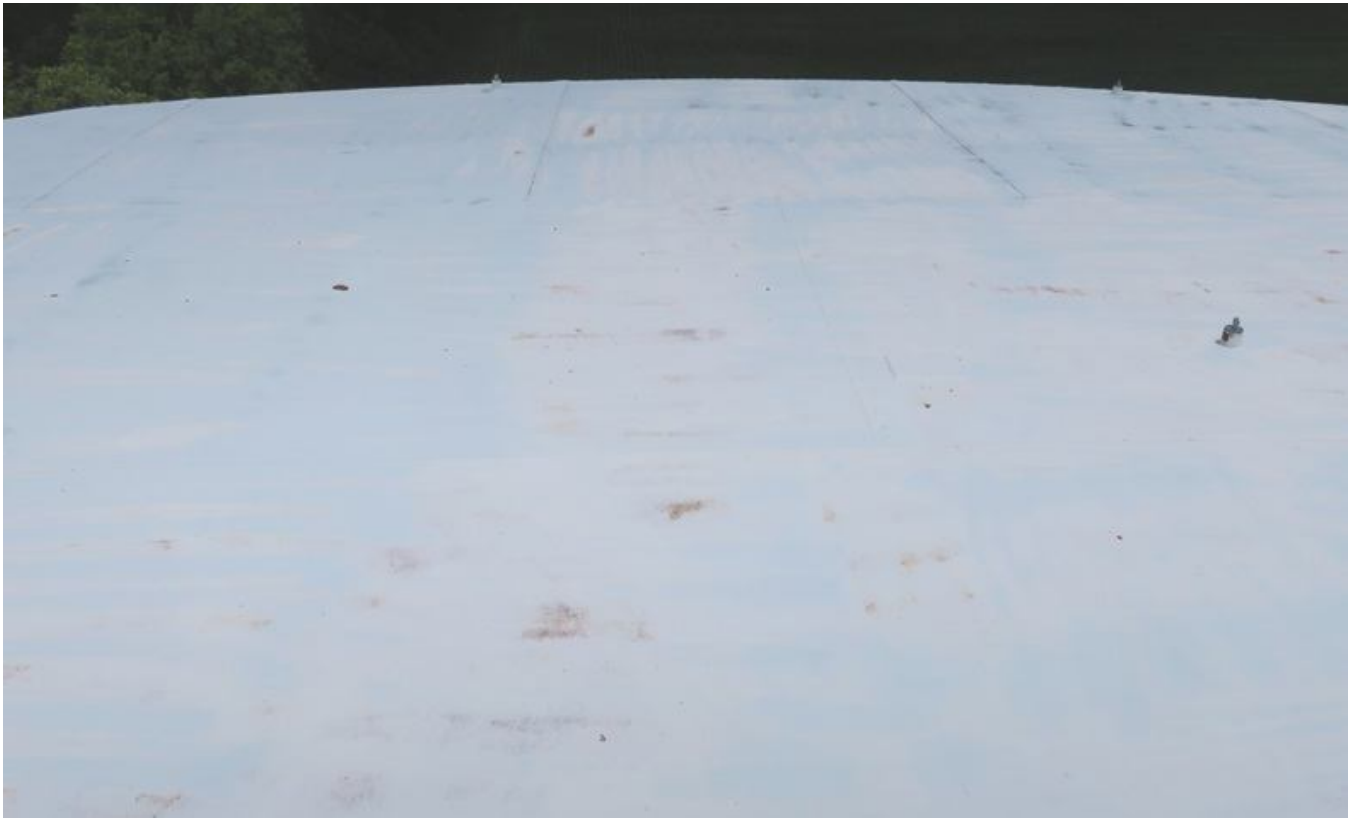
53. Roof corrosion and weathered coating.

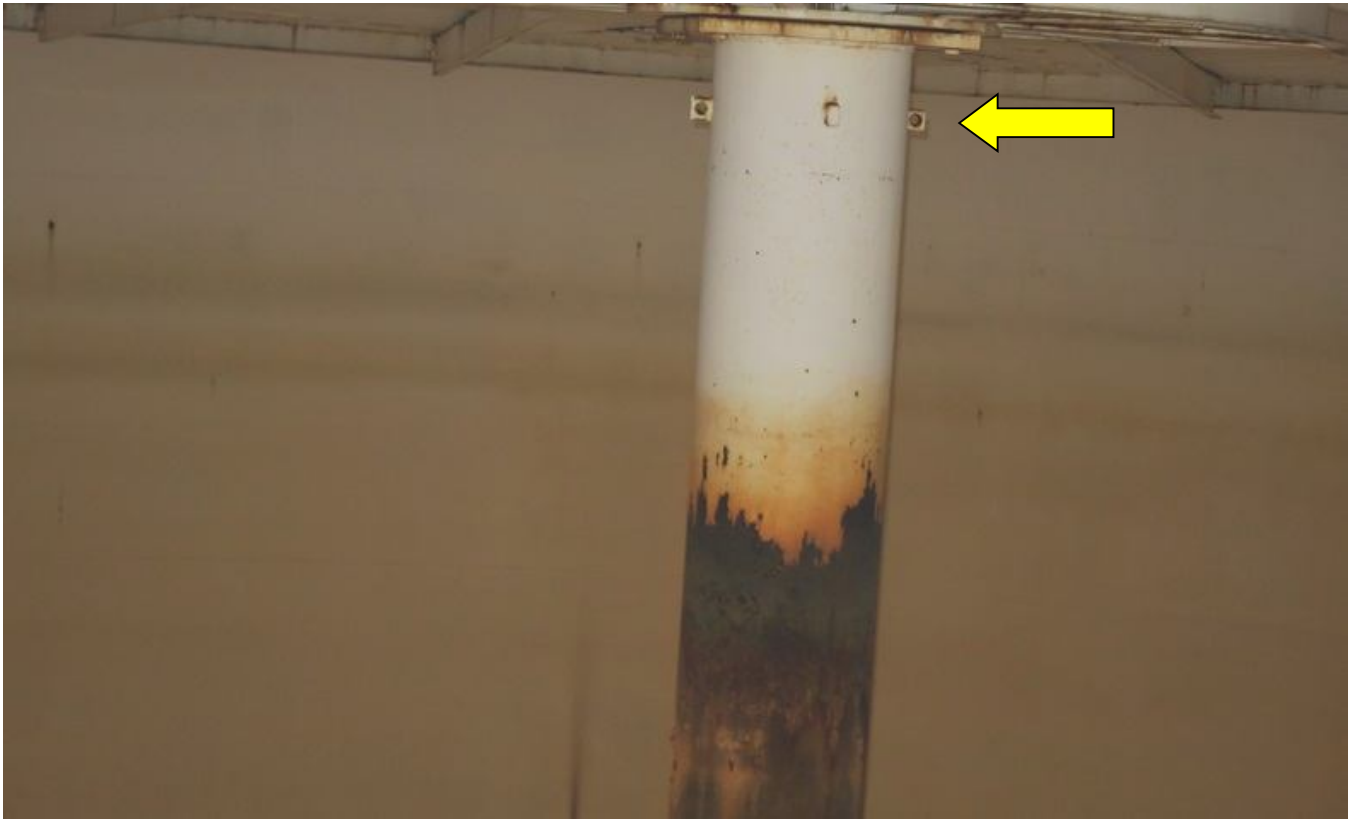
57. Support column, and rafters. Note corrosion on column and lungs on column.
