**EVALUATION OF THE
1,730,000 GALLON STANDPIPE
NEW CARLISLE, OHIO
FOR
CITY OF NEW CARLISLE
NEW CARLISLE, OHIO**

July 14, 2017

17.096.H1664.001

The subject of this report is the field evaluation of the 1,730,000 gallon standpipe in New Carlisle, Ohio. The tank was owned by the City of New Carlisle, Ohio. The field evaluation was performed on July 14, 2017 by Gregory P. Cannon, NACE Certified Coating Inspector Level 3, Certificate No. 10339, Jamie Stewart, NACE Coating Inspector Level 1 Certified, Certificate No. 64809, and Jared Colahan, NACE Certified Inspector Level 3, Certificate No. 47251 of Tank Industry Consultants. The Owner's representative on the site at the time of the field evaluation was Jason Rose. The column and rafter supported roof tank was of welded steel construction. According to information on the tank nameplate, the tank was built in 1975 by Chicago Bridge and Iron Company under contract number 74-20814, and had a capacity of 1,730,000 gallons. The tank nameplate also stated that the tank diameter was 60 ft, and the nominal shell height was 82 ft.

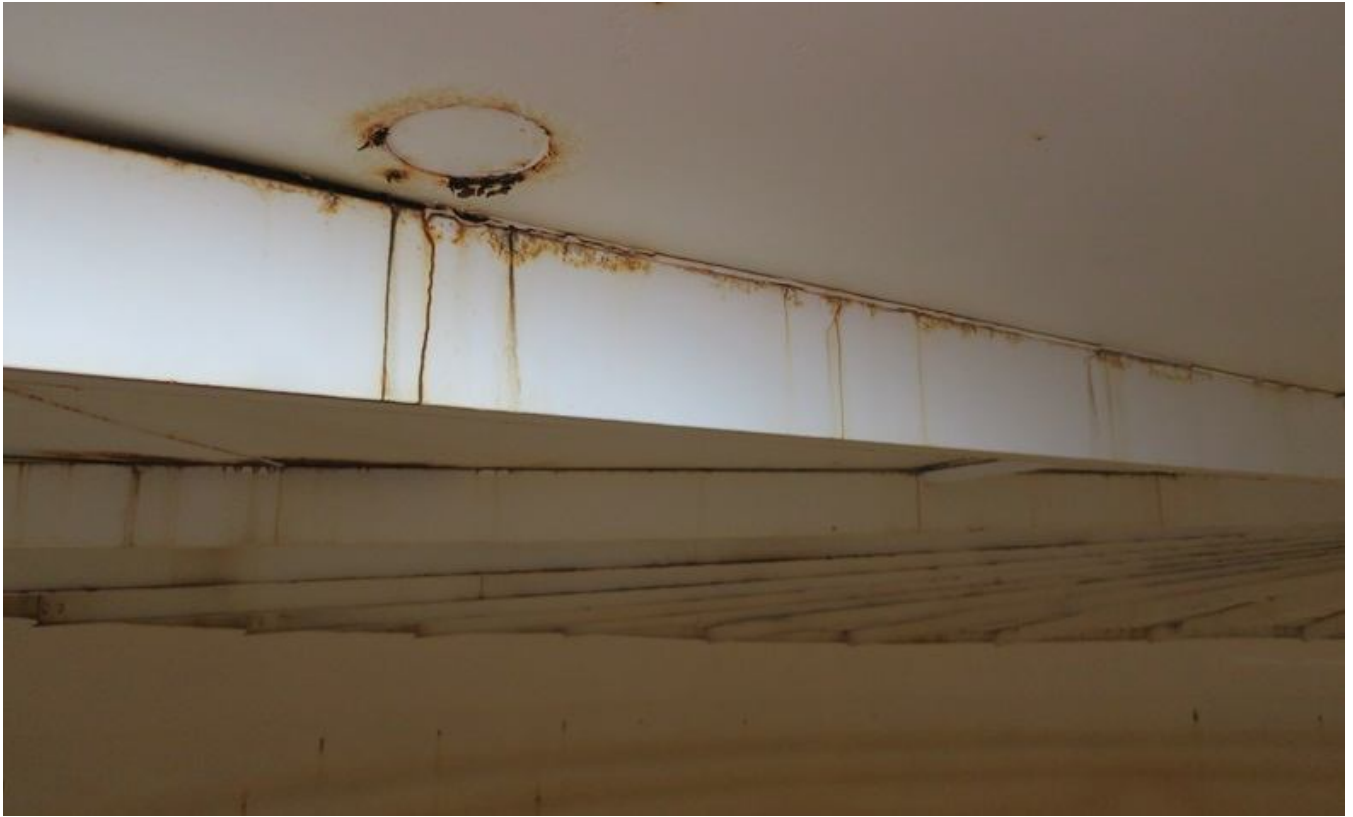
61. Support rafters. Note corrosion along rafters and circular welded patch plate.

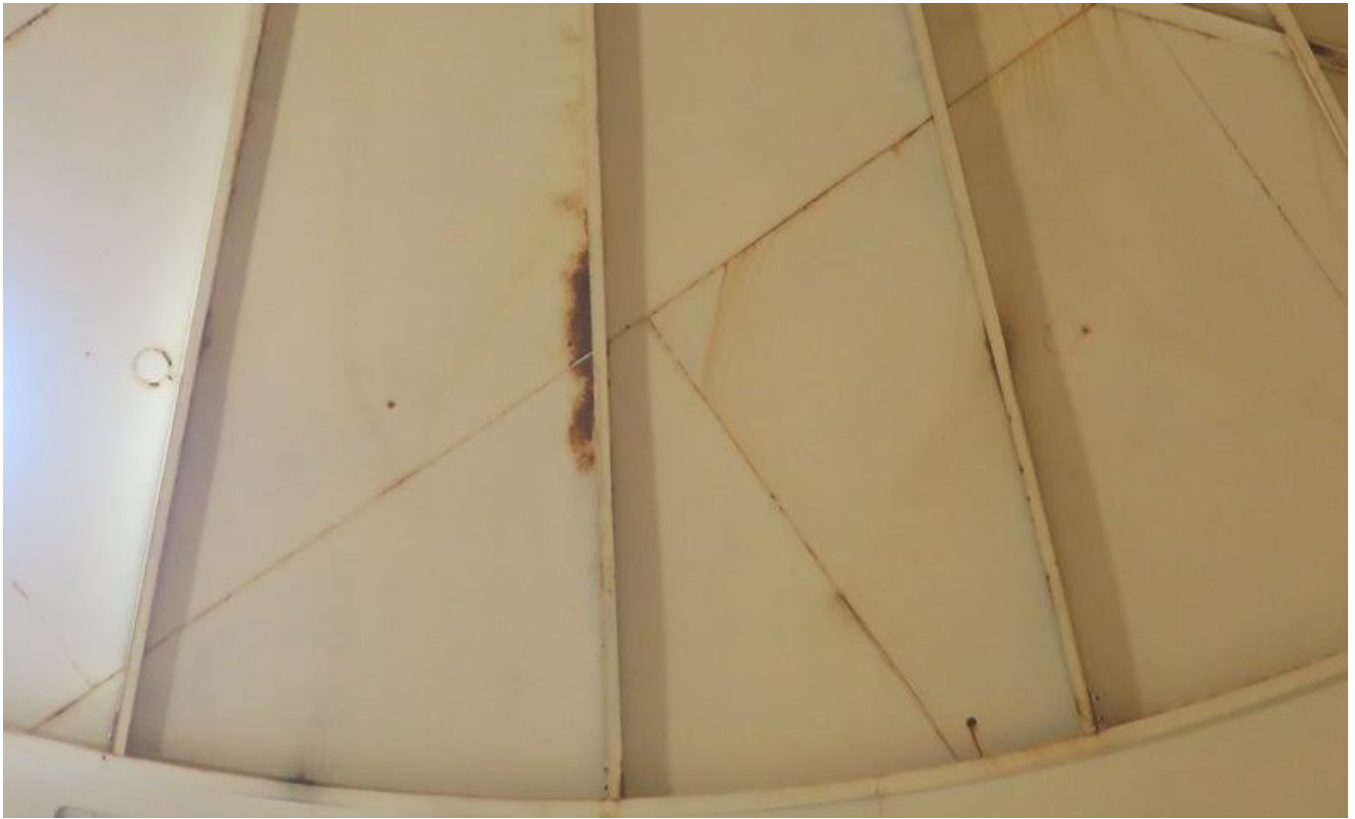
63. Corrosion on roof interior.

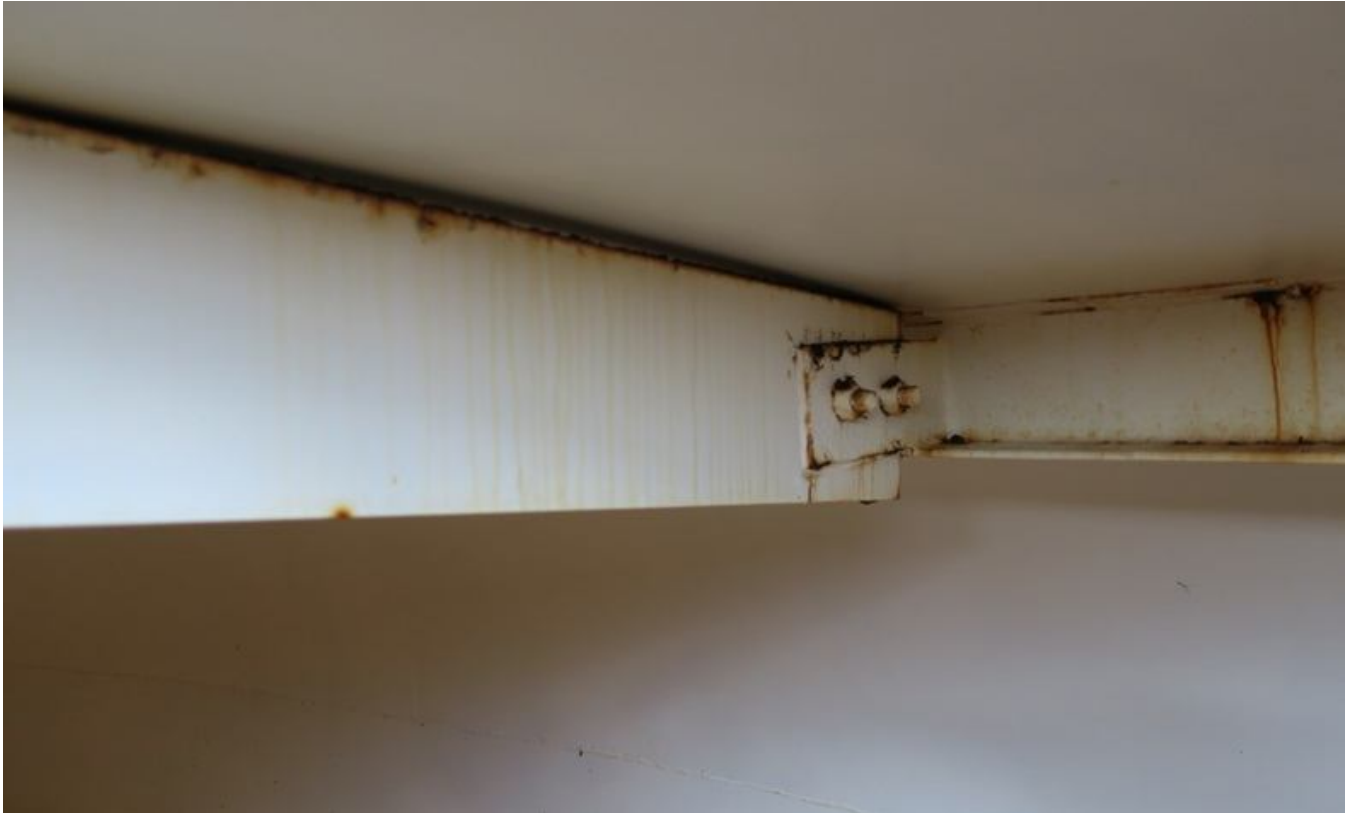
64. Rafter with bolted connections. Note corrosion.

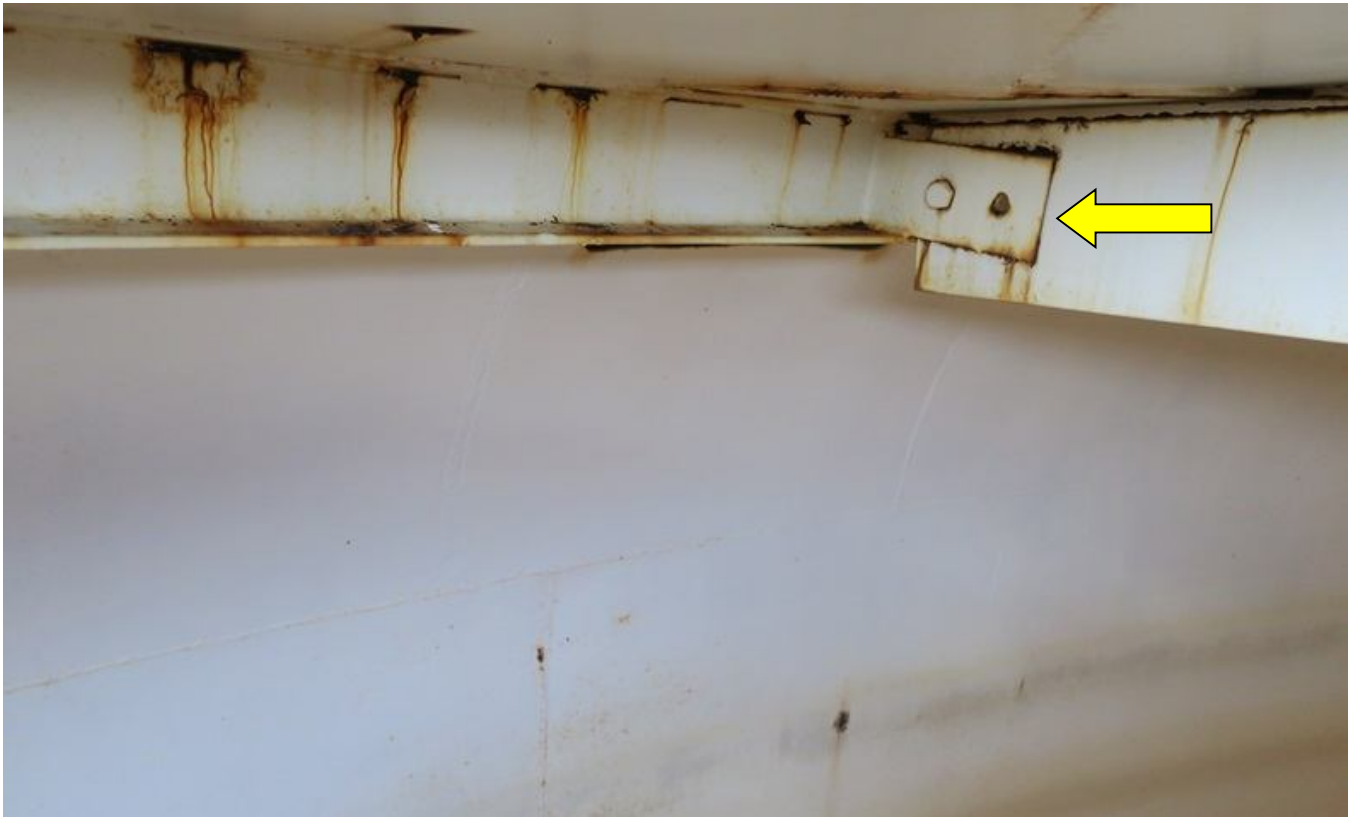
2. **Roof Condition: There was a structural deficiency noted: bolts missing from rafter-to-shell connections.** The coating on the roof plates appeared to be in fair overall condition. Rust staining was noted along the top of the roof rafters, along the roof plate lap seams, and along the rafter edges. The interior roof support structure consisted of a center column, purlins, and a set of roof rafters. The inner ends of the roof rafters rested on a center hub which was located at the top of the center column. The outer ends of rafters were bolted to steel clips which were welded to the shell. A single bolt was missing from at least two of the attachment clip connections. Rust staining and corrosion were observed at this connection. Corrosion and rust straining were observed on the rafters and on the center column. Lugs were located near top of the column. Circular and rectangular patch plates were observed near the top of the shell and on the roof. Rust staining located around a welded steel circular patch plate in roof. **It is the opinion of Tank Industry Consultants that the center column lugs should not be used for rigging purposes.** (See photos 54-67)

65. Rafter with bolted connections. Note corrosion and missing bolt.

7. **Roof Support Structure:** After abrasive blast cleaning, the roof support structure should be carefully evaluated as metal loss repairs may be necessary at areas where the metal loss was not previously visible. All rafters ends should be accessed and 2 bolts installed where currently only 1 bolt is present.

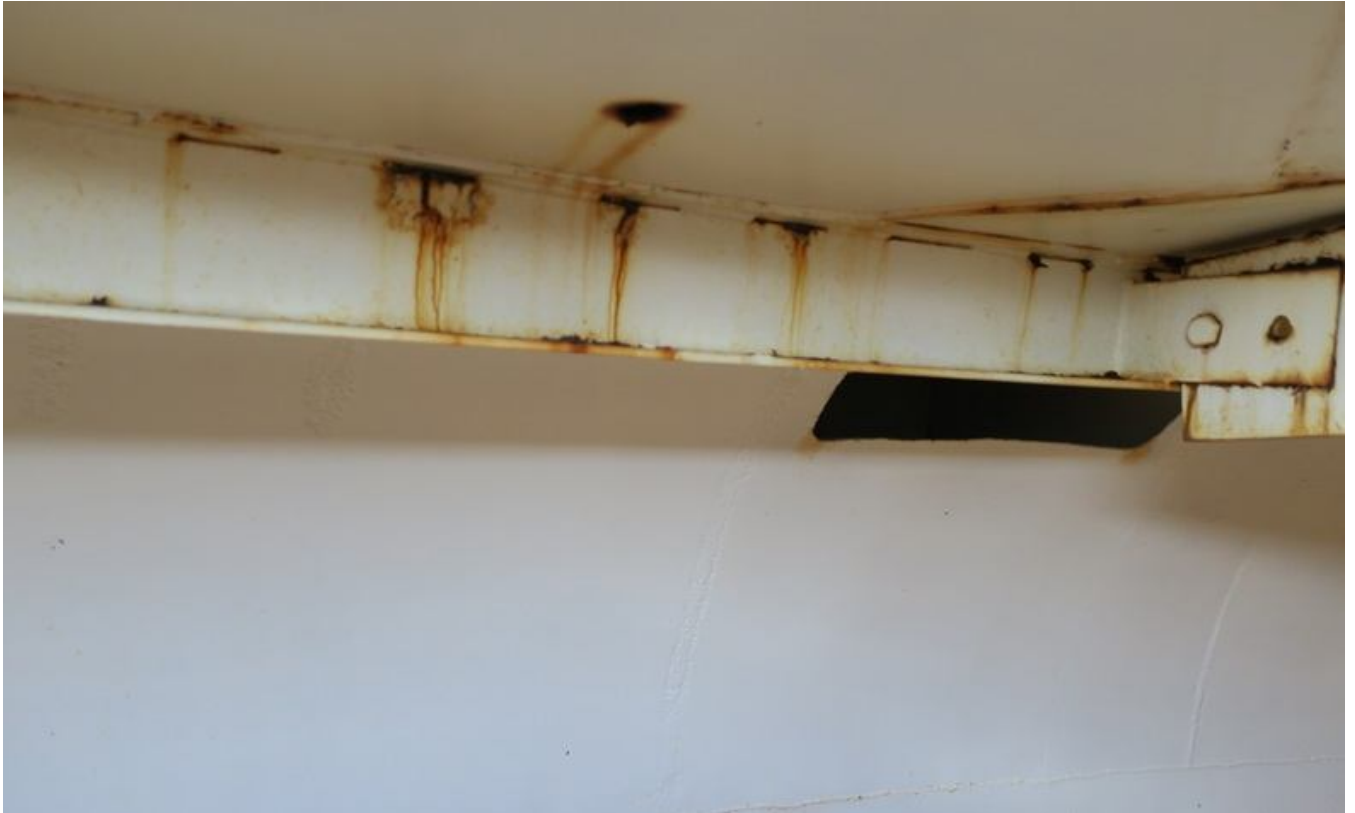
66. Support rafter and bolted connection. Note corrosion and missing bolt.

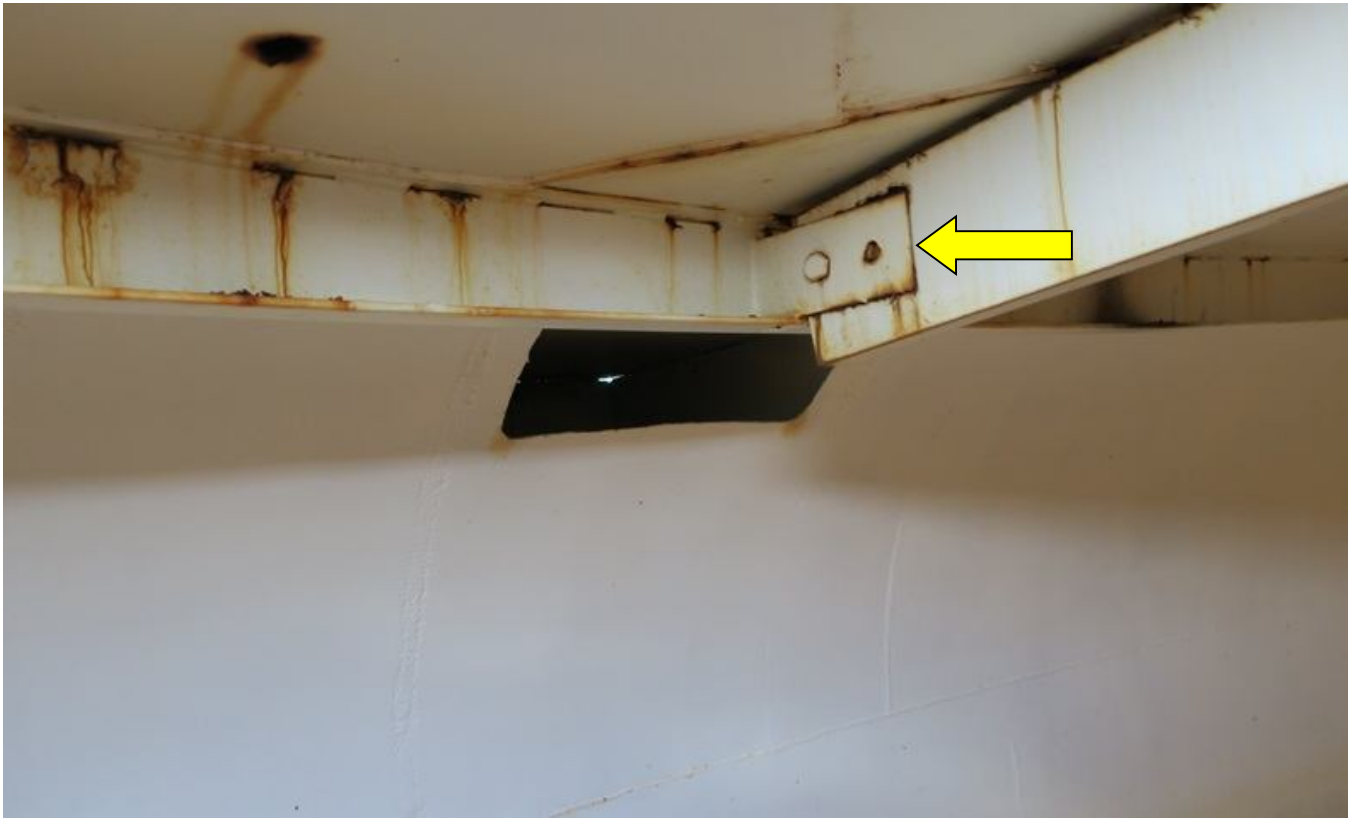
67. Rafter and bolted connection. Note corrosion, missing bolt, and overflow inlet.

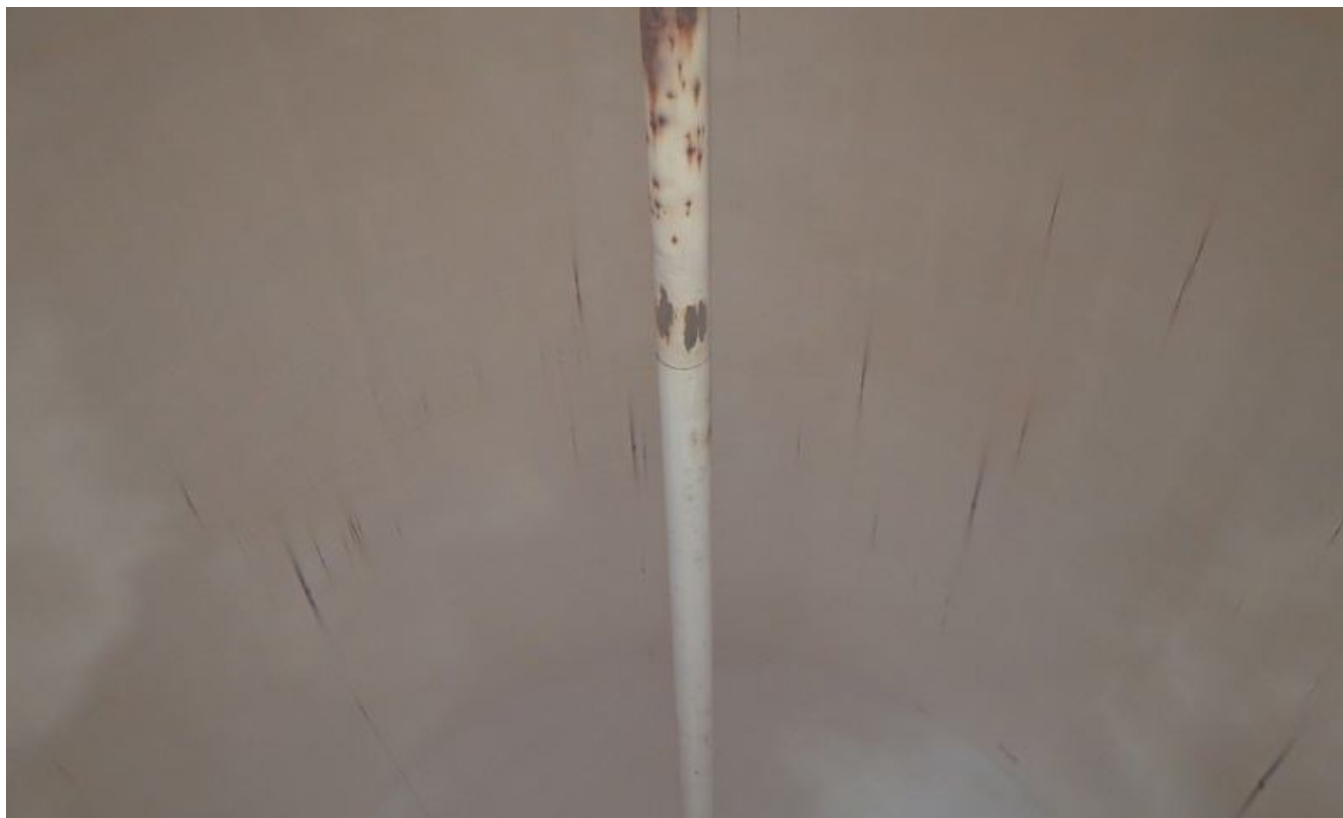
69. Tank interior and support column. Note corrosion along column.

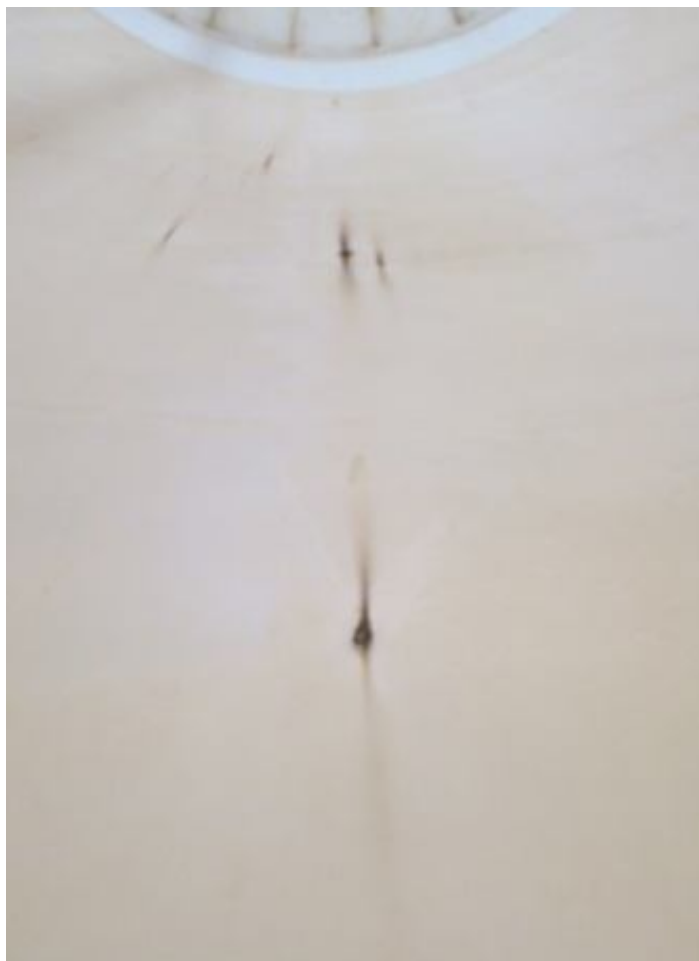
3. **Shell Condition:** The coating on the shell interior appeared to be in fair overall condition. The shell coating was discolored due to mineral staining from the water. Spots of corrosion were located throughout the shell. The coating on the lower shell had blistered, and corrosion was located in these areas. Corrosion was also located at the cathodic protection penetration. Metal loss measurements taken during this evaluation indicated a typical pit depth of 0.02 in., and the deepest pit found measured 0.04 in. deep. (See photos 55-77)

71. Tank interior. Note corrosion.

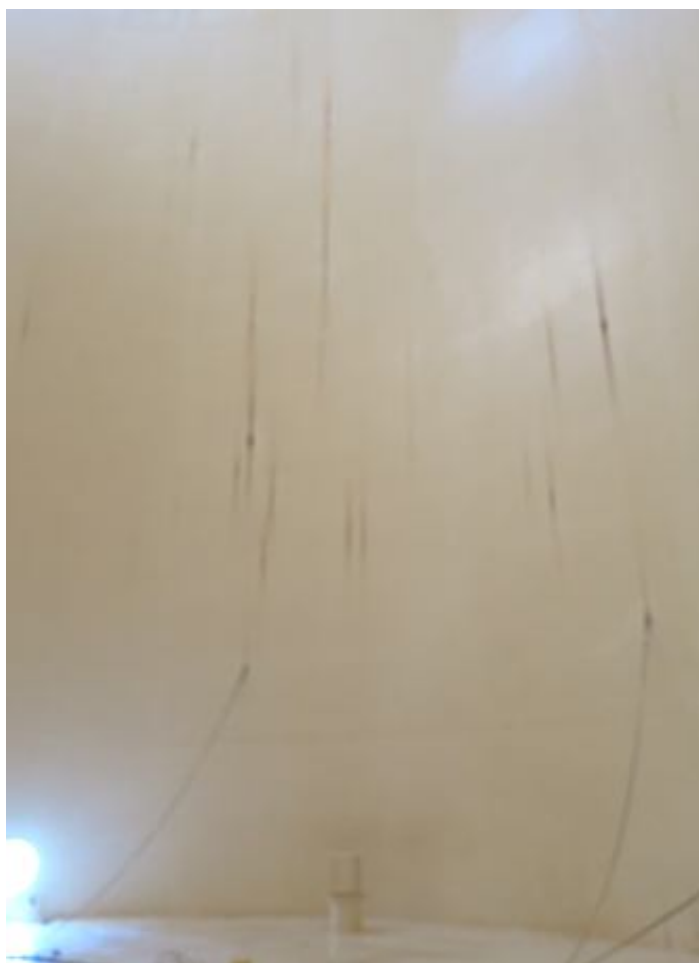
72. Tank interior. Note corrosion.

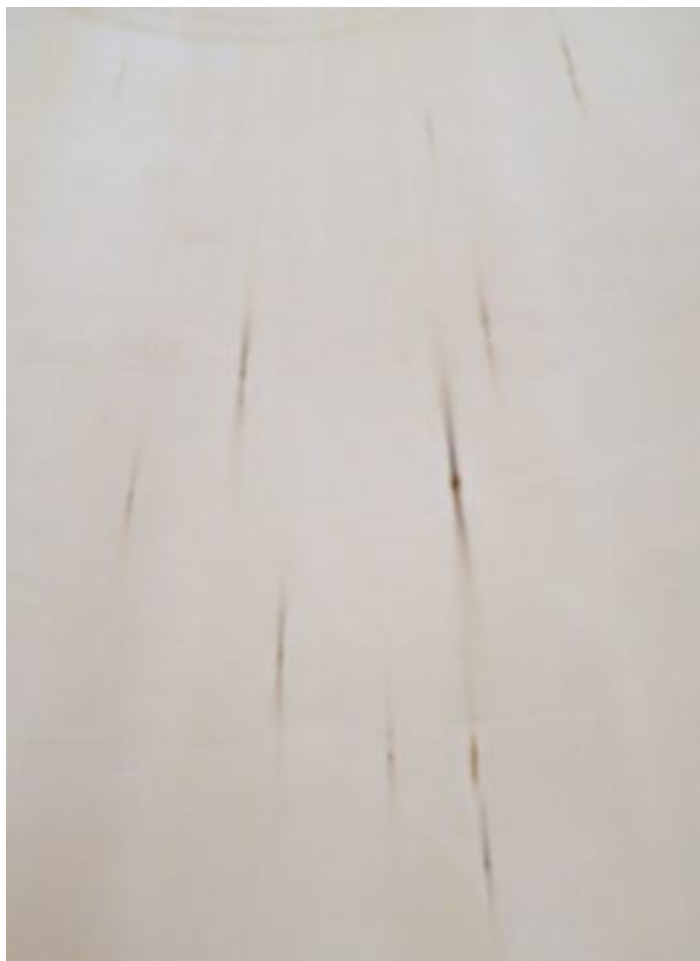
73. Tank interior. Note corrosion.

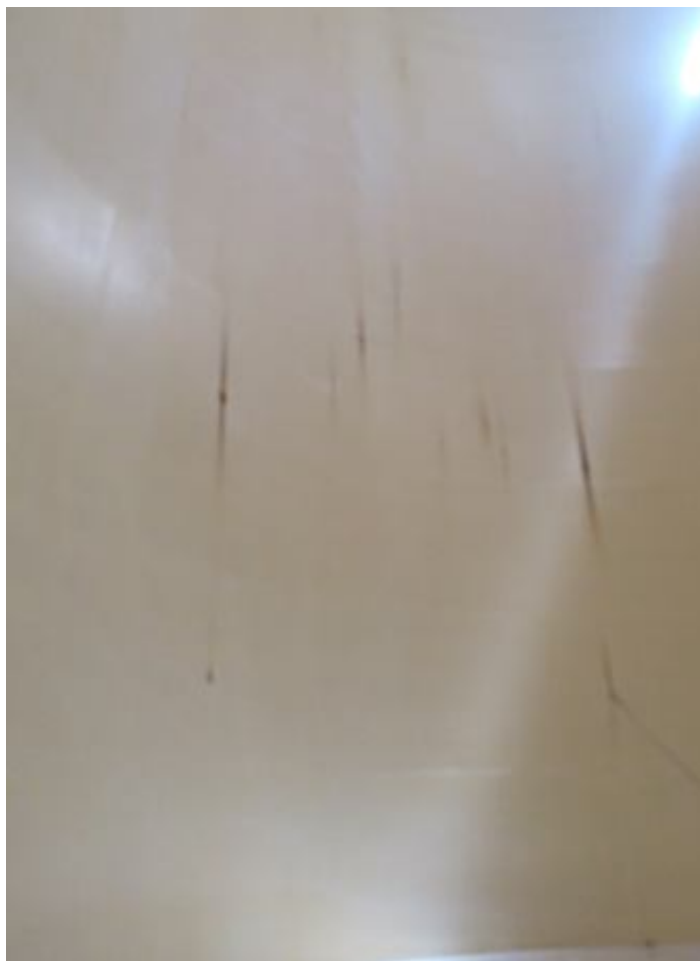
74. Tank interior. Note corrosion.

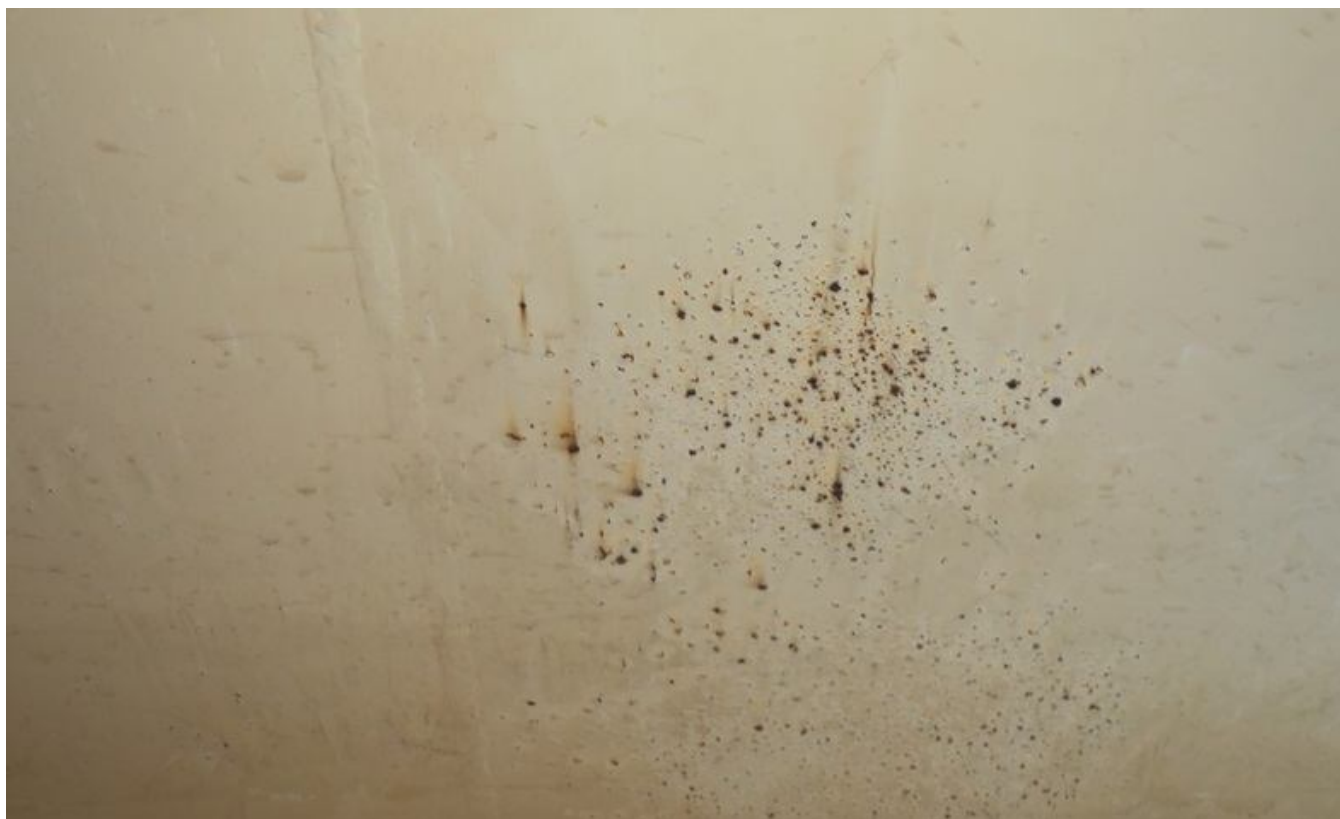
76. Blistered coating and corrosion on tank shell.

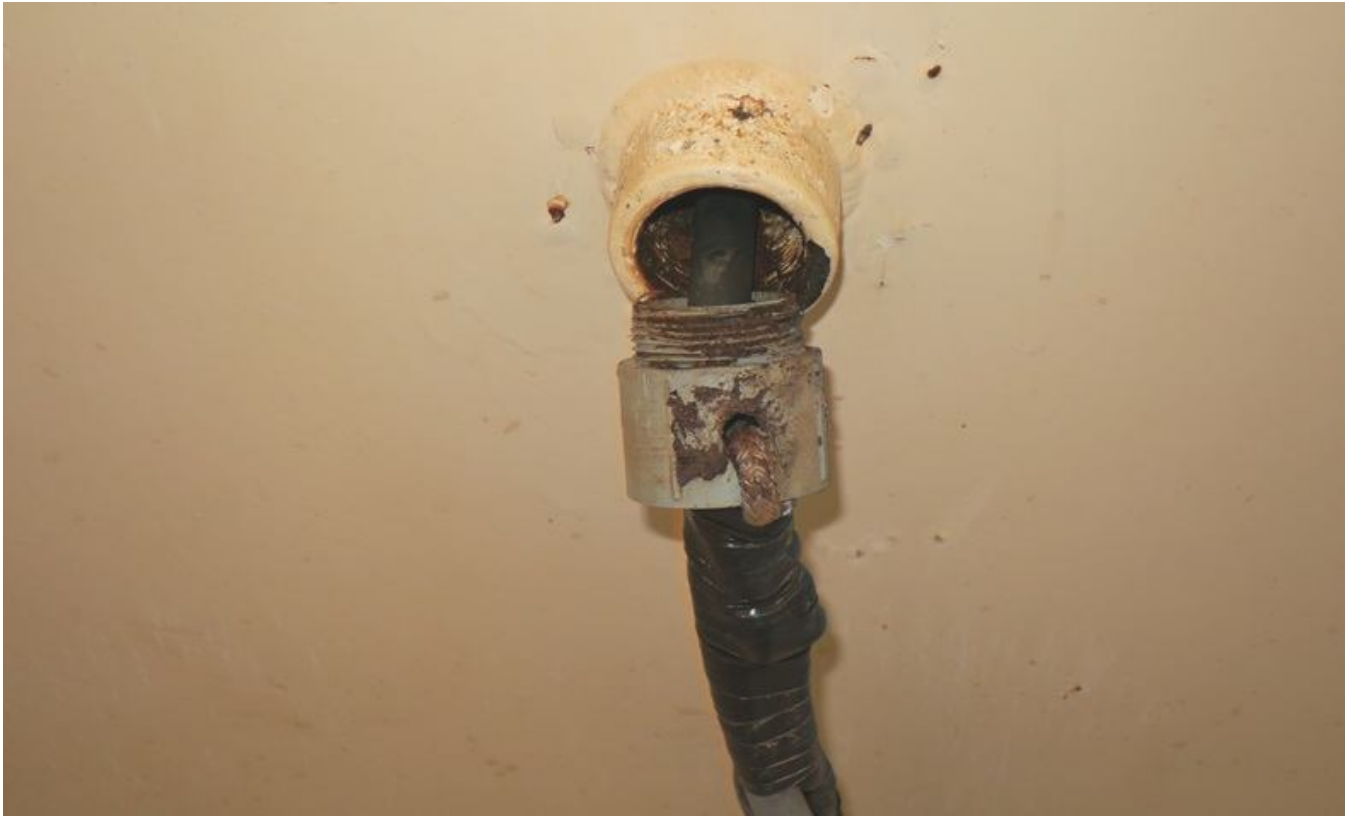
6. **Cathodic Protection:** The tank was equipped with a cathodic protection system. The system consisted of a submerged wire anode. The cathodic protection anode system was anchored from the lower portions of the shell and was equipped with floats. The wiring appeared to be intact. It did not appear that the system was operating properly as areas of corrosion were observed. Fitting at shell penetration was broken. (See photos 78-80, 86)

77. Broken cathodic protection equipment fitting.

3. **Cathodic Protection:** The tank cathodic protection system should be equipped with an automatically controlled potential rectifier. The manufacturer should then recalibrate and make necessary adjustments. The broken penetration connection should be repaired.

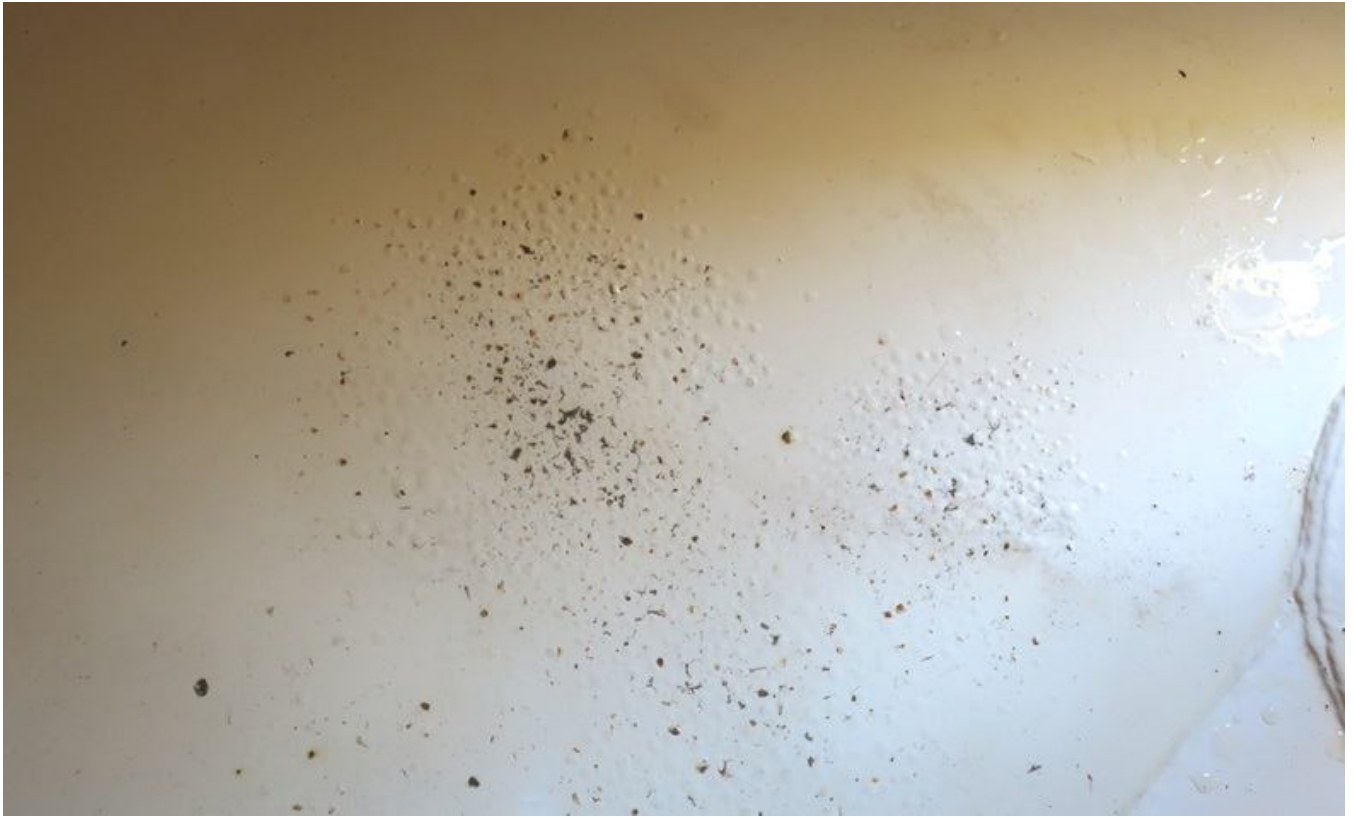
5. **Bottom Plate Condition:** The coating on the tank bottom appeared to be in poor overall condition. The coating had blistered. Corrosion was located at these areas. Metal loss had occurred on the floor and measured less than 1/32 in. deep. (See photos 78-86)

81. Blistered coating and corrosion on tank floor.

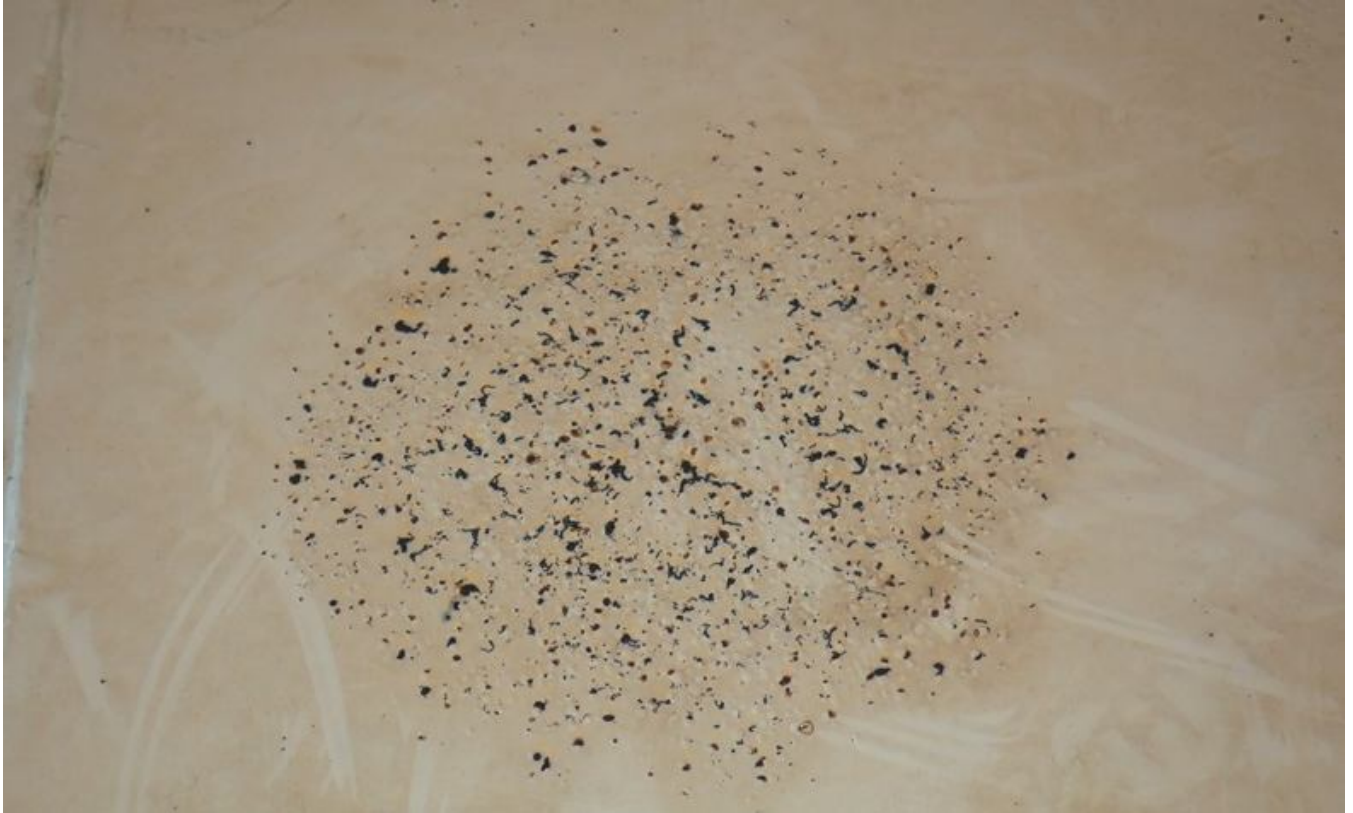
82. Blistered corrosion on coating and tank floor.

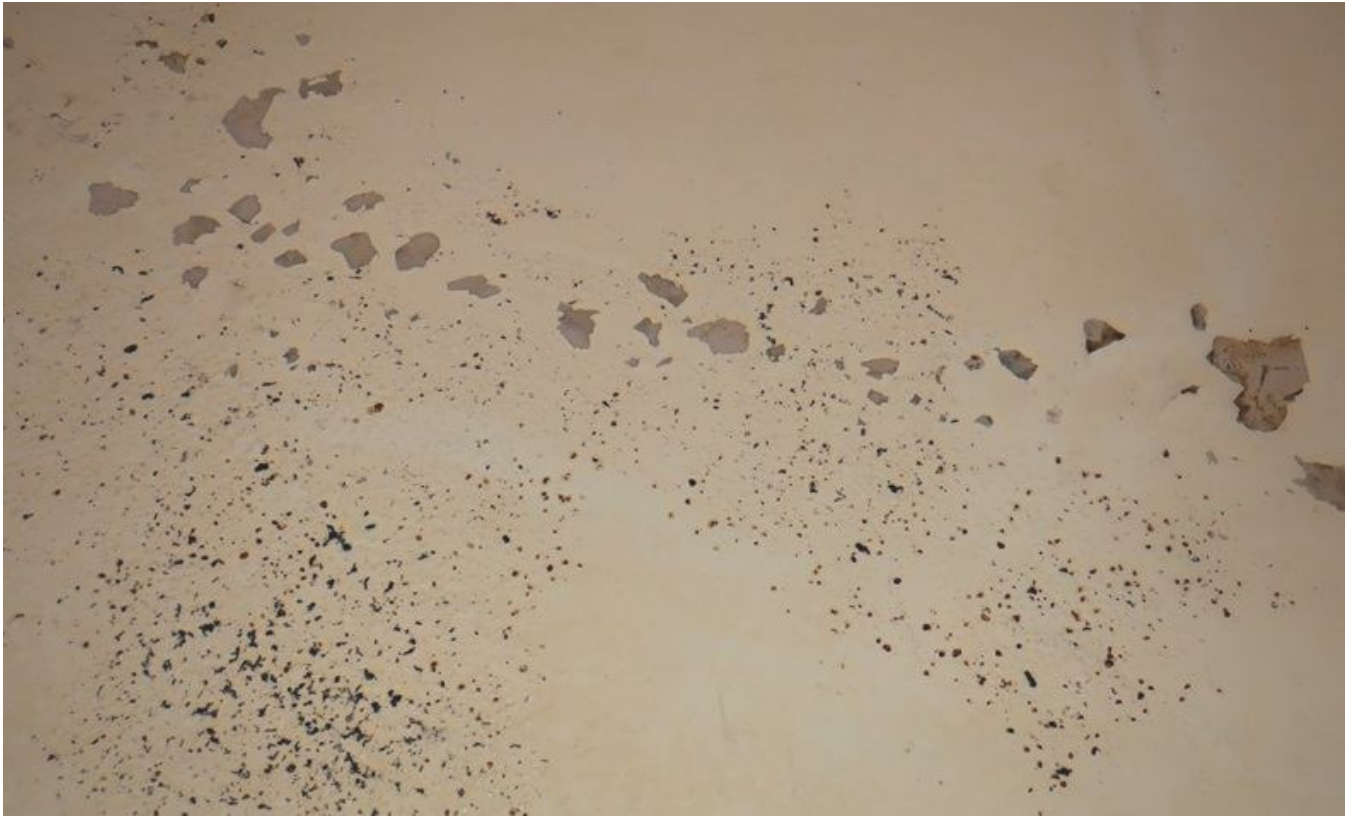
83. Blistered coating and corrosion on tank floor.
