**EVALUATION OF THE
1,730,000 GALLON STANDPIPE
NEW CARLISLE, OHIO
FOR
CITY OF NEW CARLISLE
NEW CARLISLE, OHIO**

July 14, 2017

17.096.H1664.001

The subject of this report is the field evaluation of the 1,730,000 gallon standpipe in New Carlisle, Ohio. The tank was owned by the City of New Carlisle, Ohio. The field evaluation was performed on July 14, 2017 by Gregory P. Cannon, NACE Certified Coating Inspector Level 3, Certificate No. 10339, Jamie Stewart, NACE Coating Inspector Level 1 Certified, Certificate No. 64809, and Jared Colahan, NACE Certified Inspector Level 3, Certificate No. 47251 of Tank Industry Consultants. The Owner's representative on the site at the time of the field evaluation was Jason Rose. The column and rafter supported roof tank was of welded steel construction. According to information on the tank nameplate, the tank was built in 1975 by Chicago Bridge and Iron Company under contract number 74-20814, and had a capacity of 1,730,000 gallons. The tank nameplate also stated that the tank diameter was 60 ft, and the nominal shell height was 82 ft.

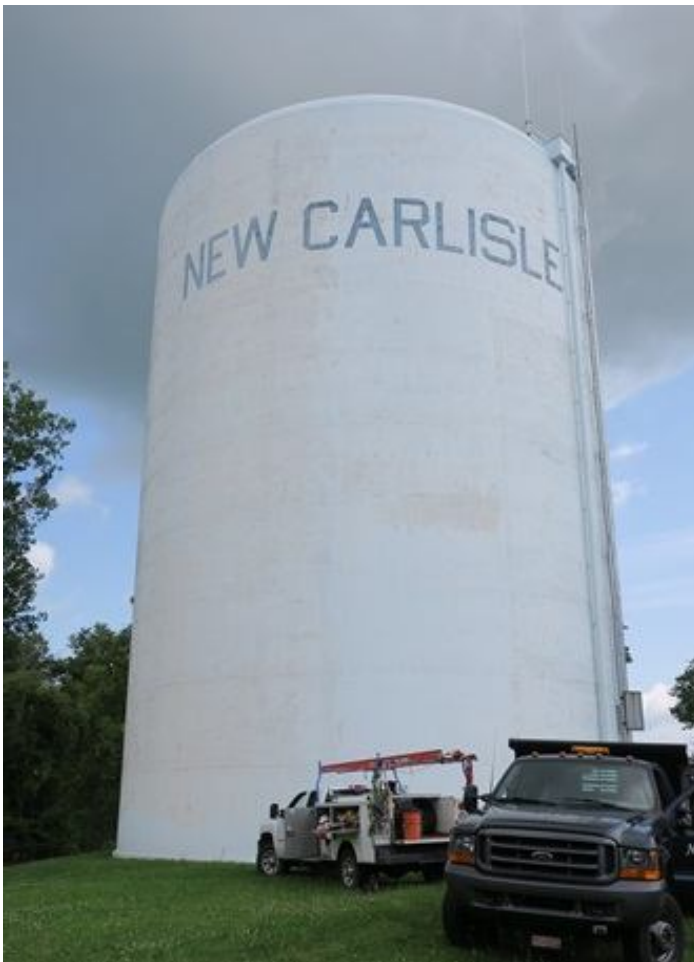
2. **Site Conditions:** **There was a safety deficiency: electrical cables were exposed at a broken conduit adjacent to the tank.** The tank site was covered with grass and was not graded to provide adequate drainage away from the foundation. The tank site was fenced. The chain link fence was topped with barbed wire and was equipped with a locked gate on the west side of the site. The fence appeared to be in fair overall condition with the exception of a damaged section of barbed wire on the northwest corner of the site. An informational sign was posted in site fence. Shed, electronic meter, and an antenna tower were located on site. (See photos 1-11)

1. Tank and site.

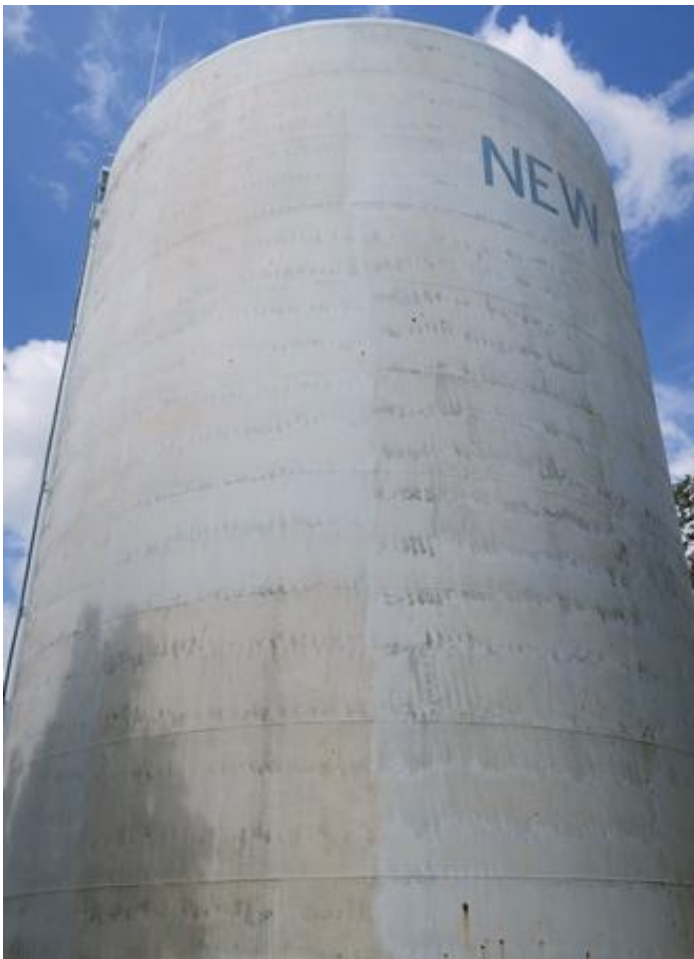
2. Tank.

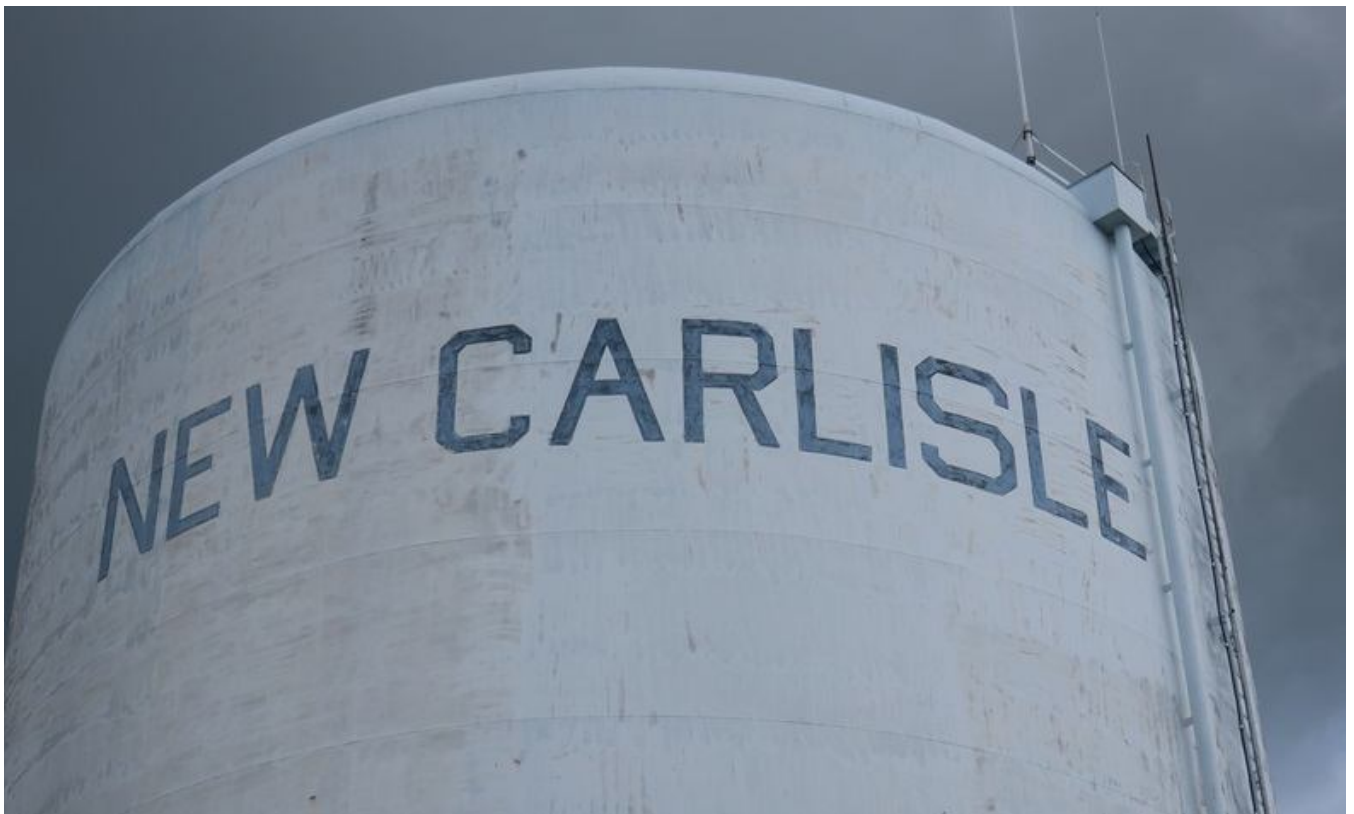
4. Tank logo.

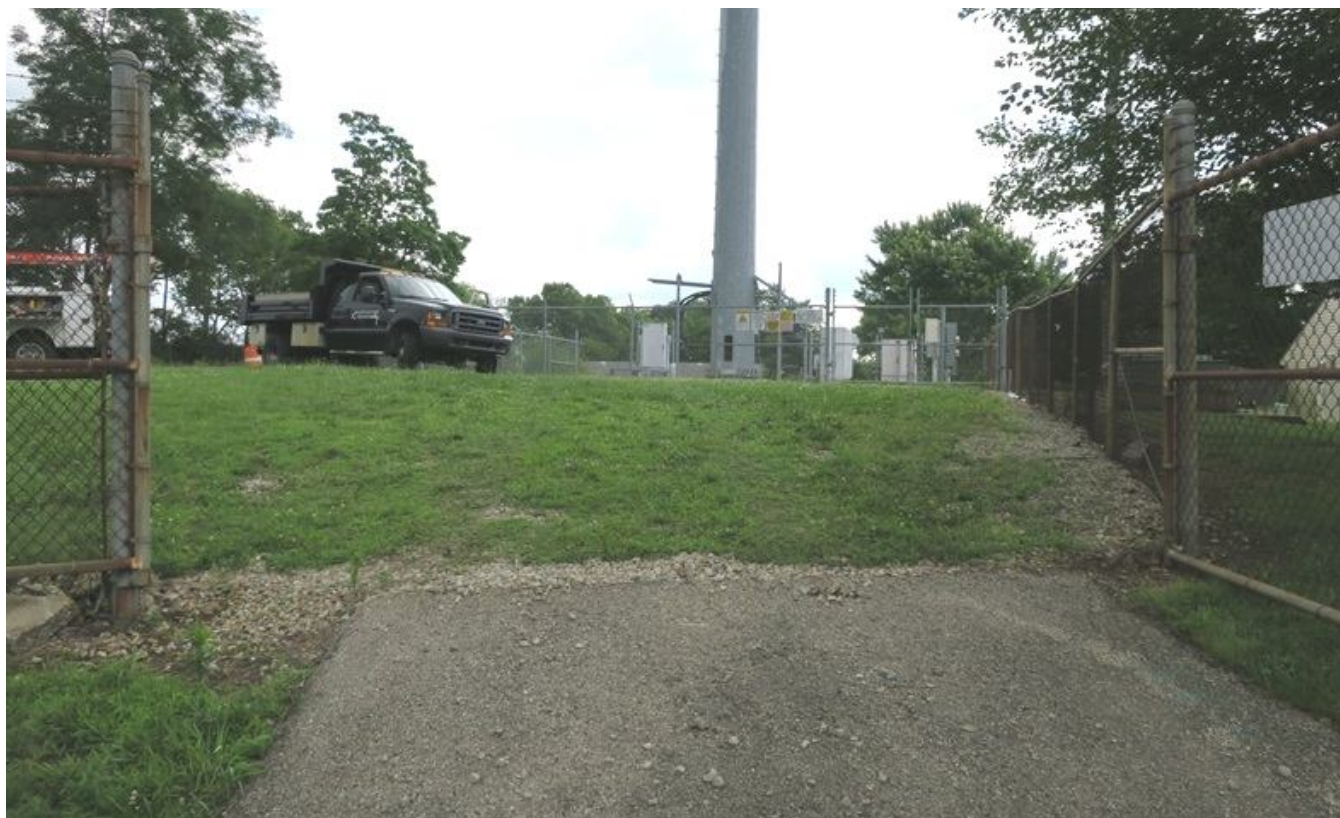
5. Road up to site entrance.

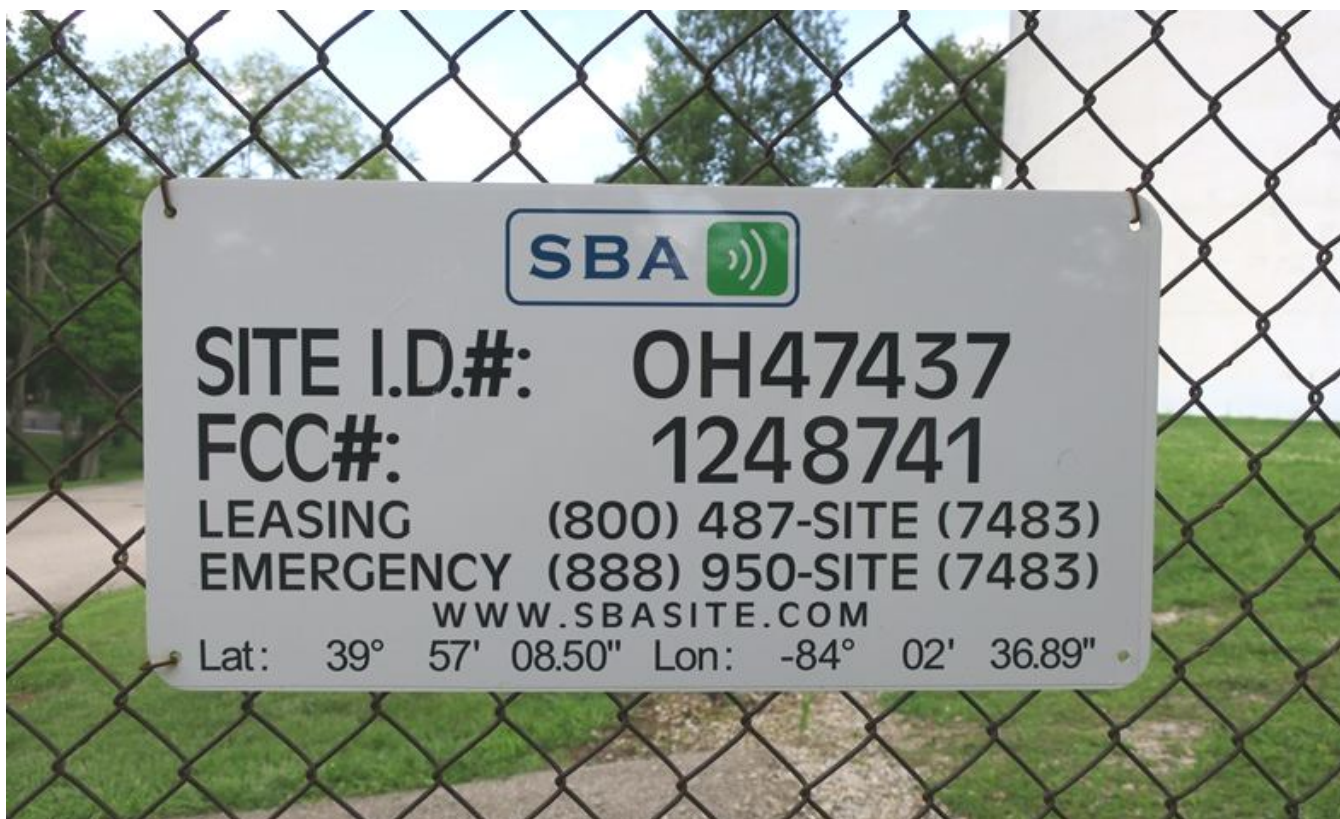
6. Site I.D. and emergency contact sign.

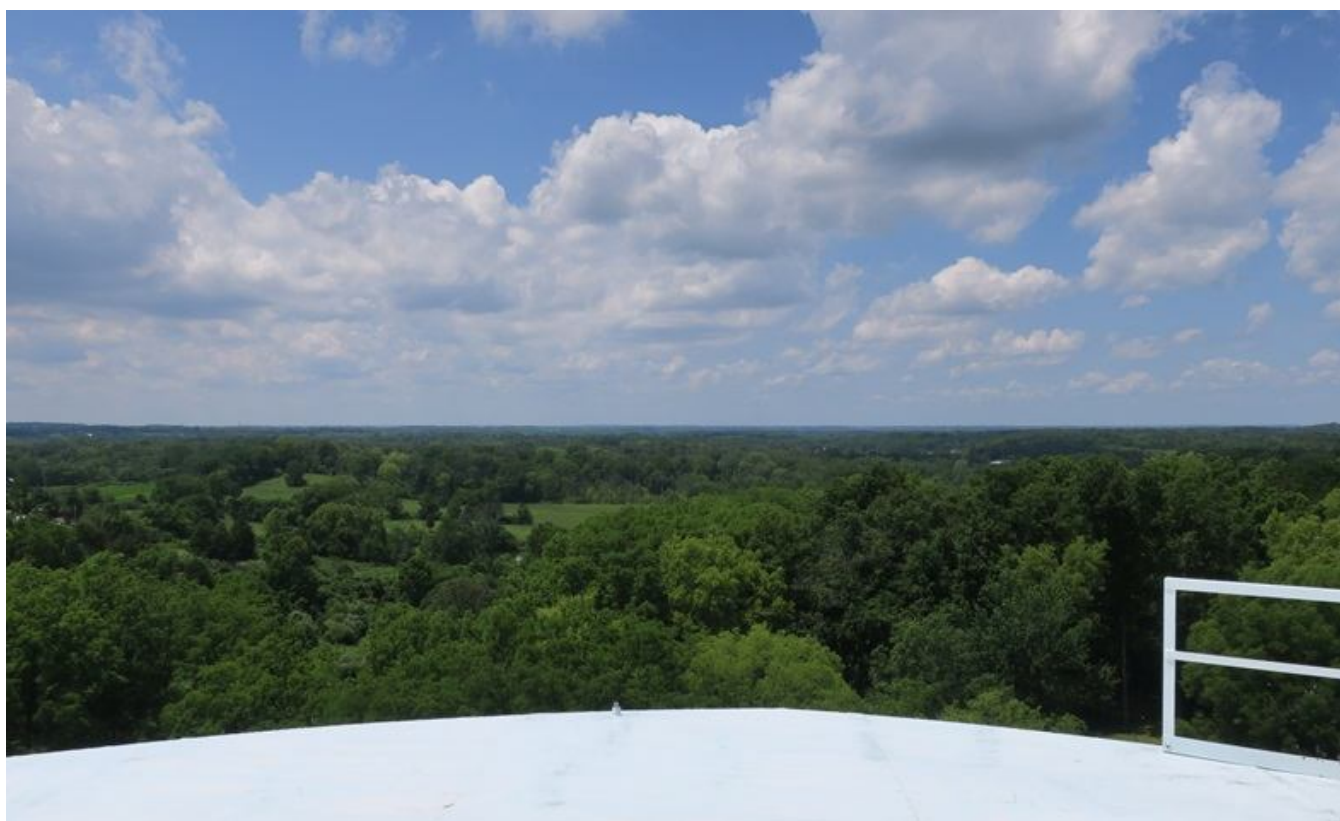
8. Surrounding area.

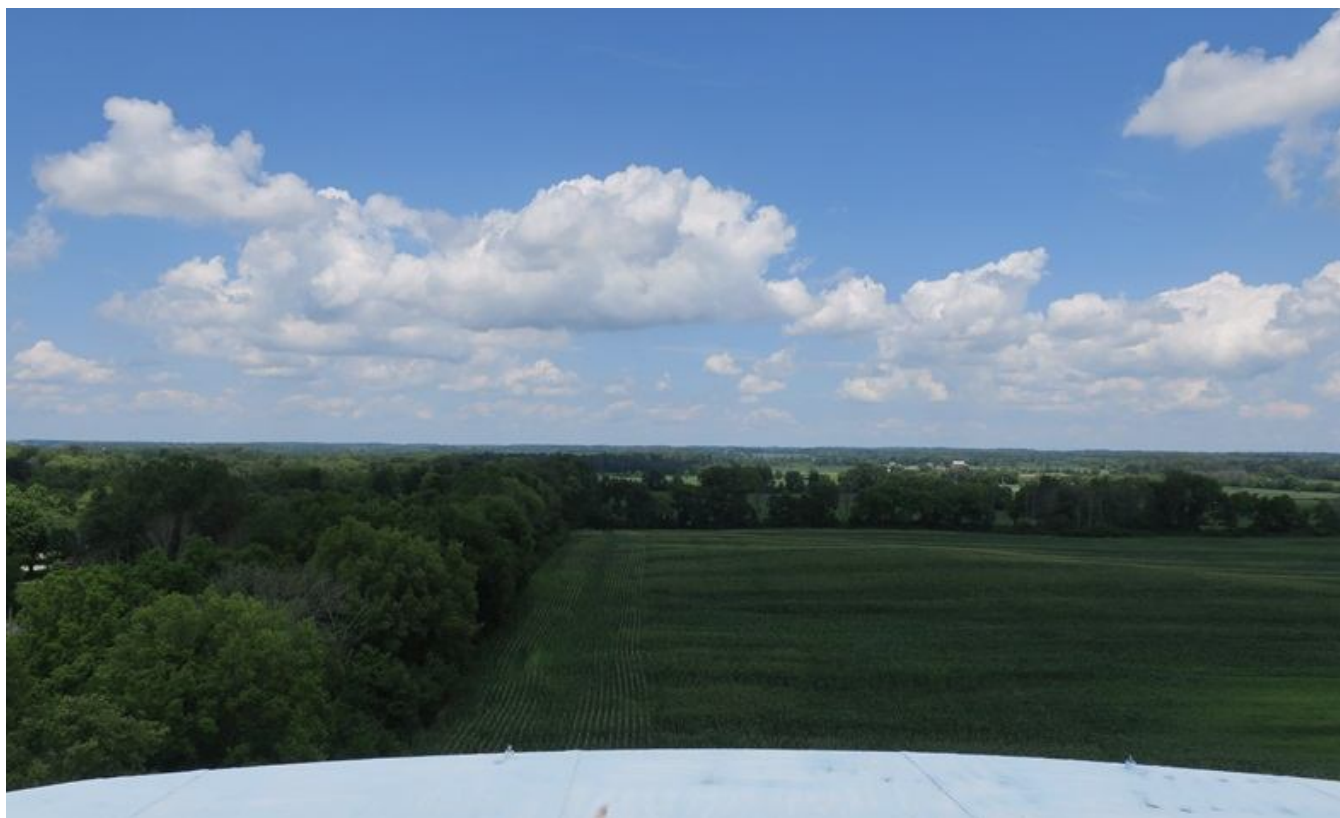
9. Surrounding area.

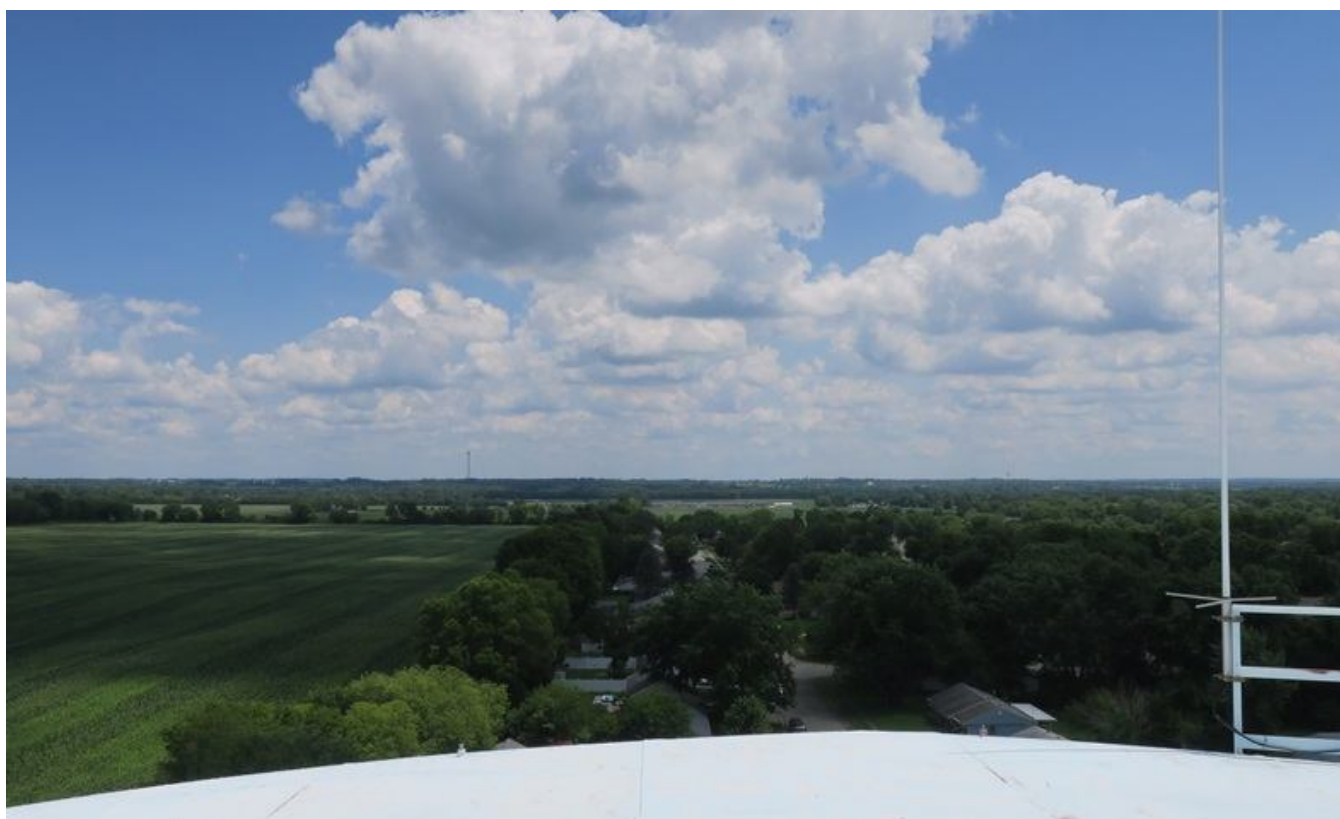
10. Surrounding area.

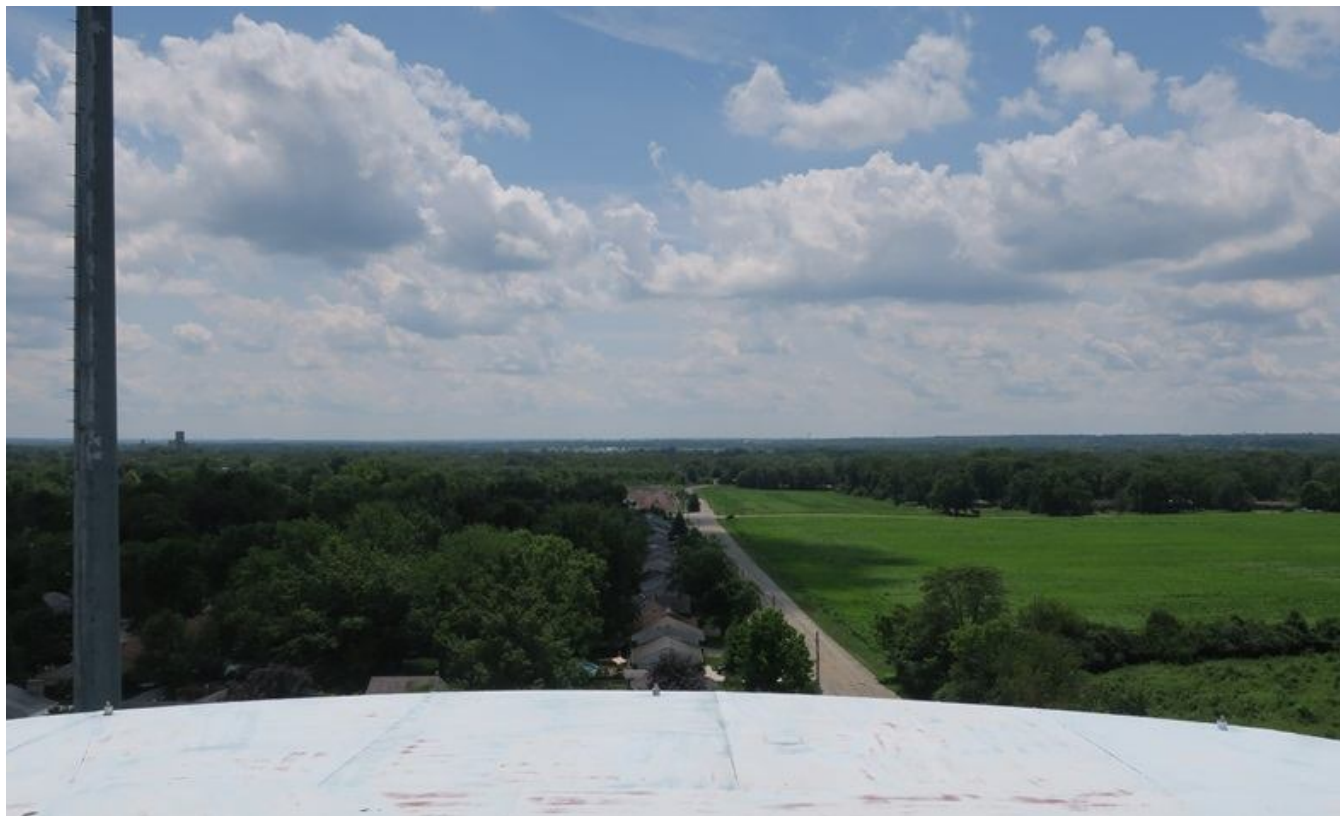
11. Surrounding area.

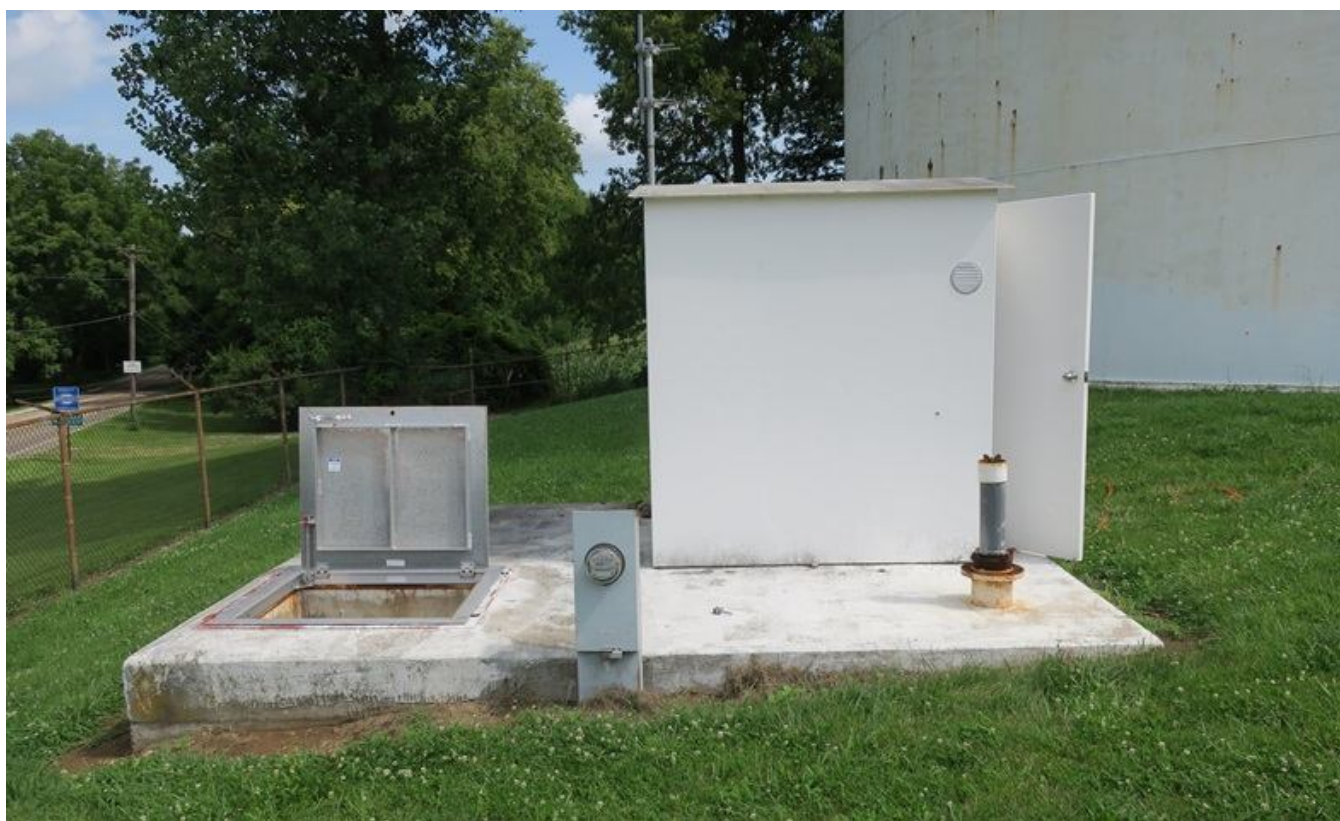
5. **Valve Vault:** There were a safety and OSHA deficiencies noted: (1) the 6 in. toe room did not meet the required 7 in. minimum, (2) the 28 in. minimum head clearance did not meet the minimum required 30 in., (3) the electrical equipment did not appear to include ground fault interrupt circuits, and (4) water was located on floor and vault contained electrical equipment. There was a valve vault located on the west side of the tank site. Access into the valve vault was locked prior to or after this field evaluation. The piping in the valve vault was in poor condition with widespread corrosion. The vault was equipped with a heater vent, and inoperable light fixtures. An electrical meter was immediately adjacent to valve exterior. Water was observed in the bottom of the vault. (See photos 12-15)

12. Valve vault access, shed, and electric meter.

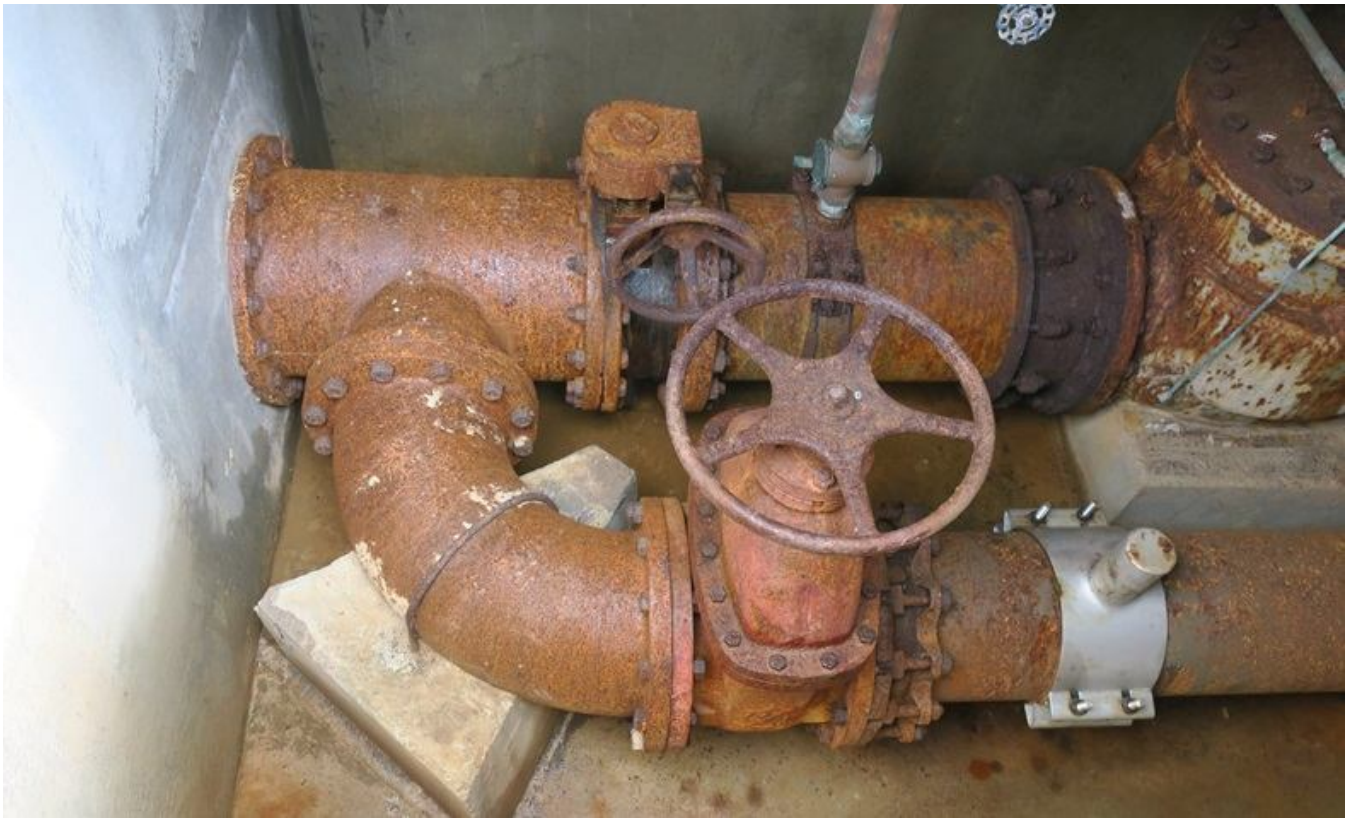
15. Piping and valves in vault.

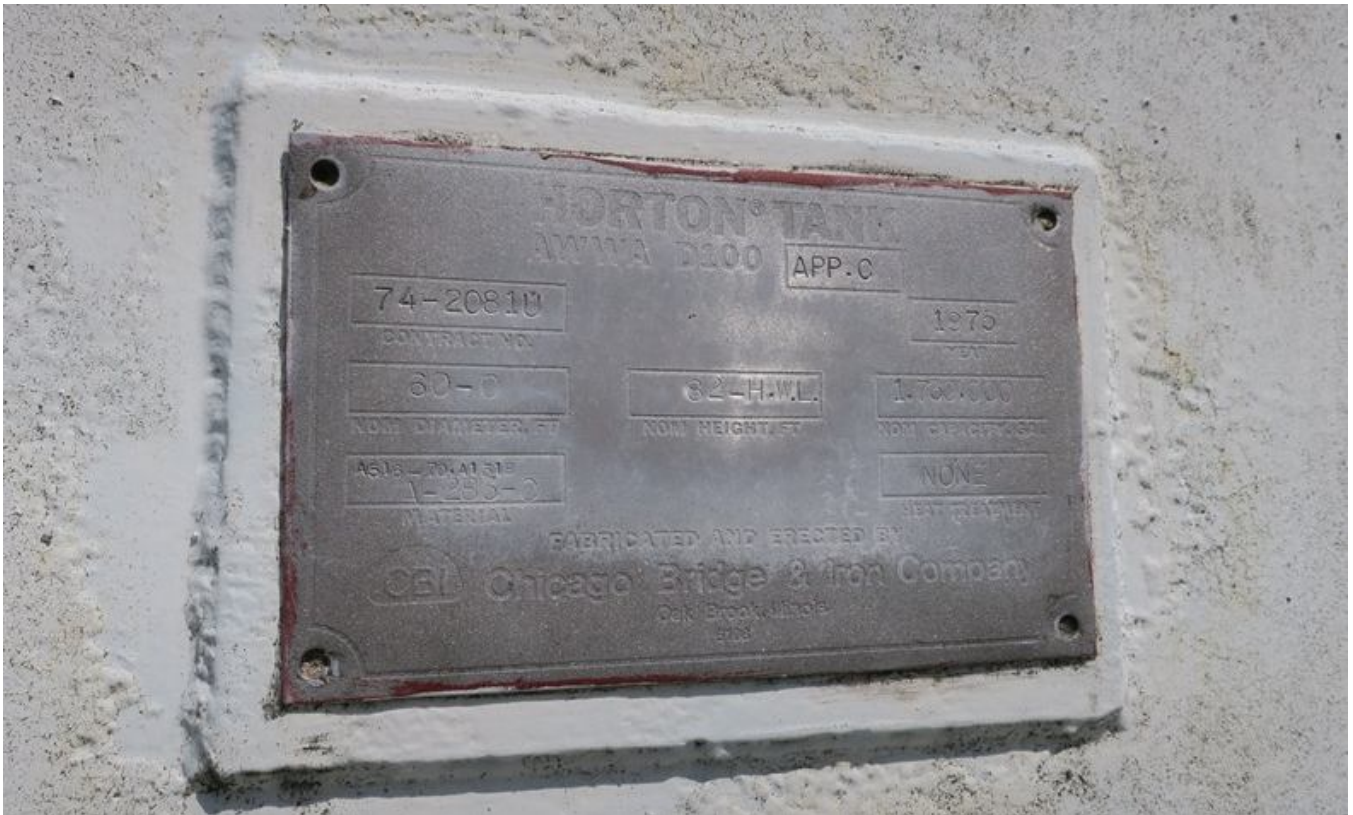
16. Tank nameplate.

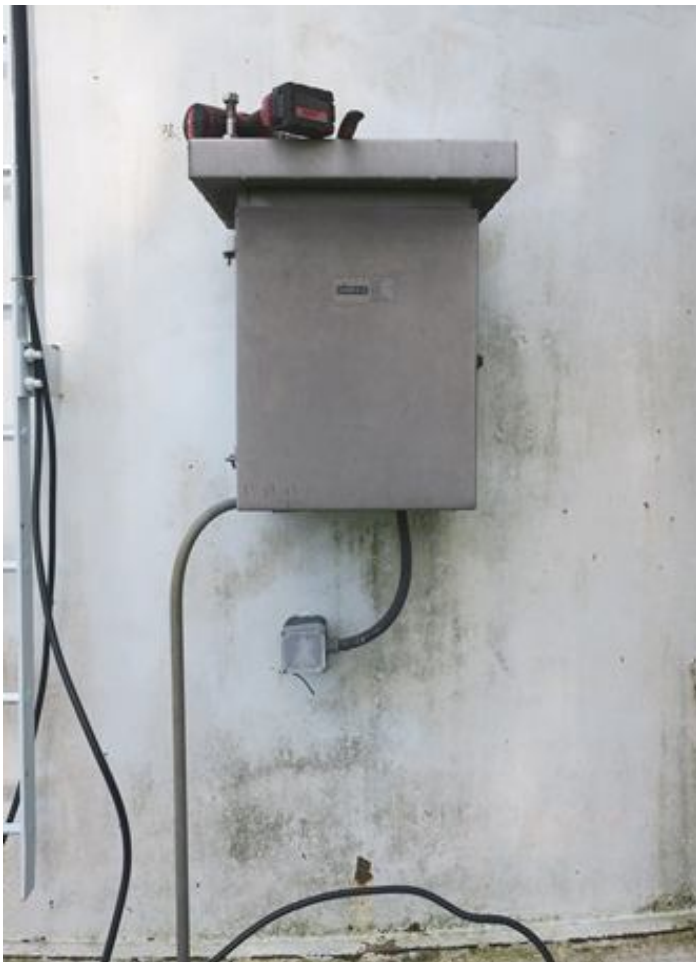
23. Cathodic protection cabinet.

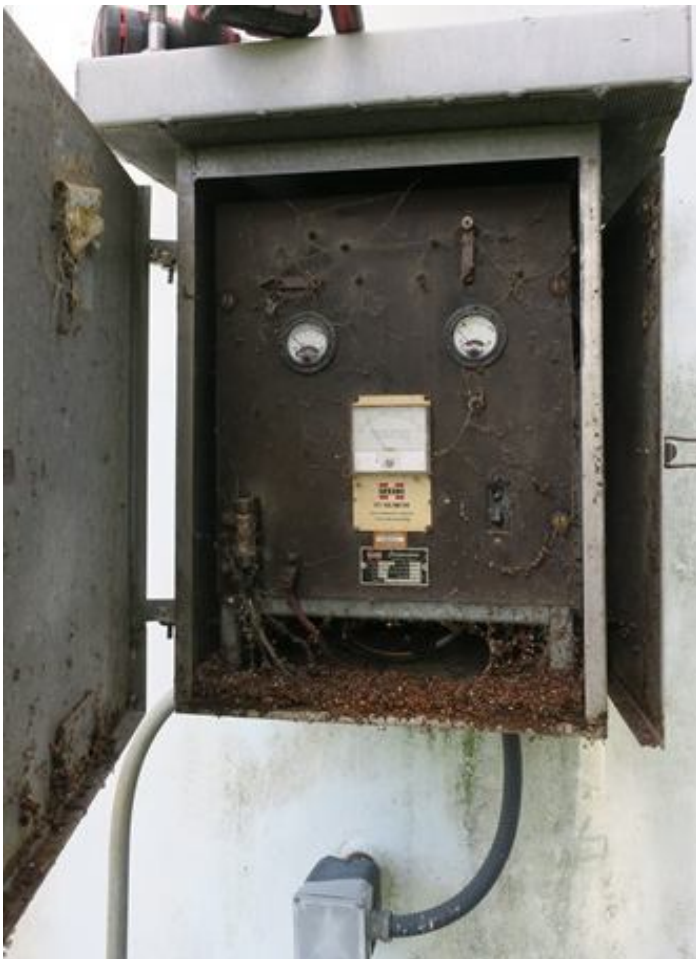
24. Cathodic protection cabinet.

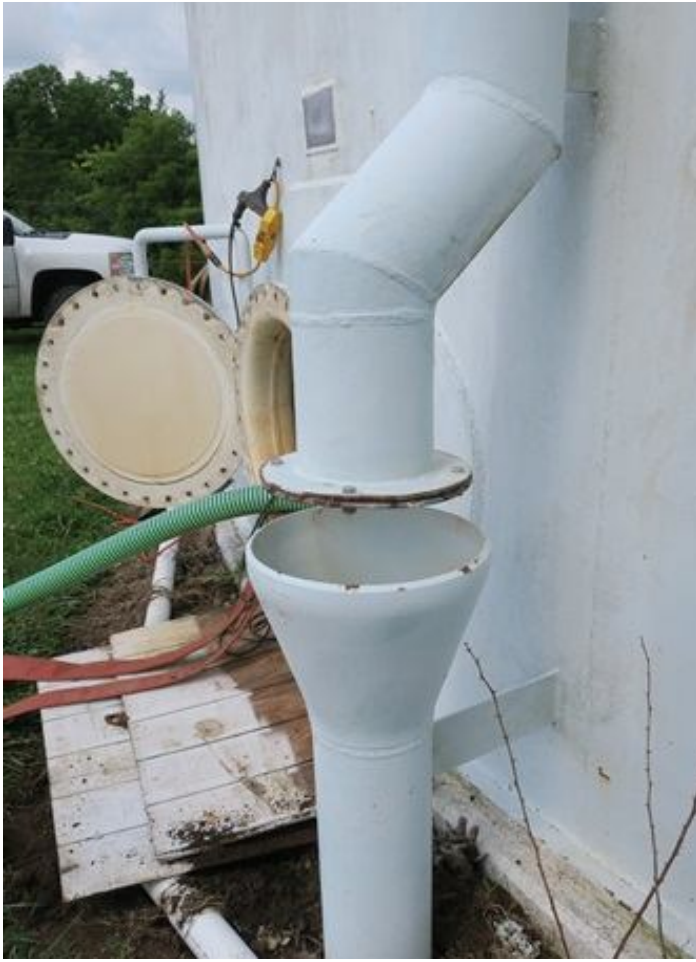
25. Overflow pipe air break and drain.

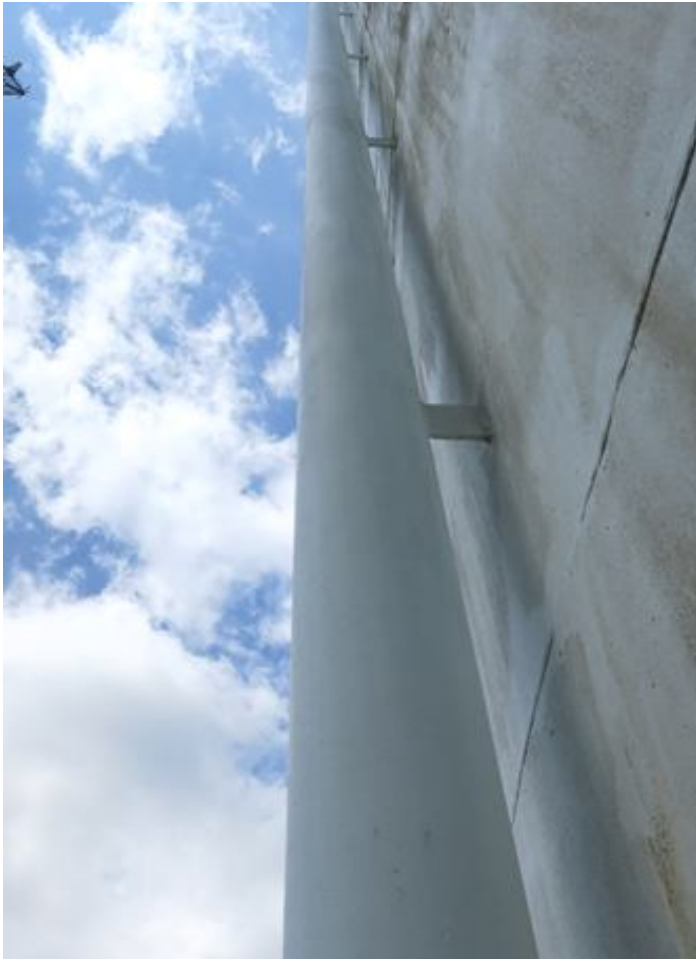
27. Overflow pipe.

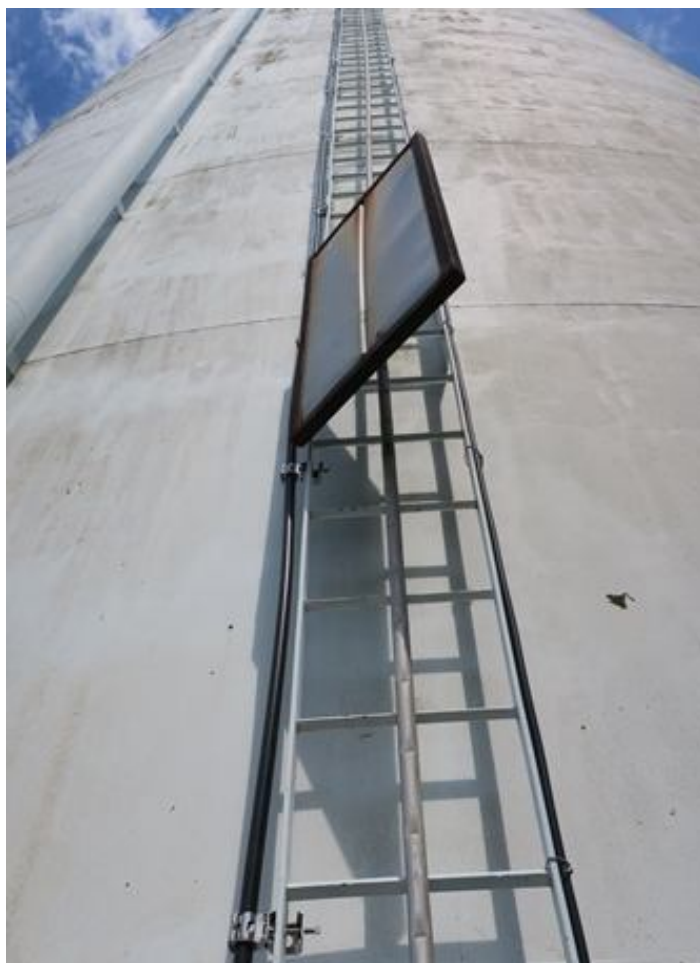
30. Exterior ladder and vandal deterrent.

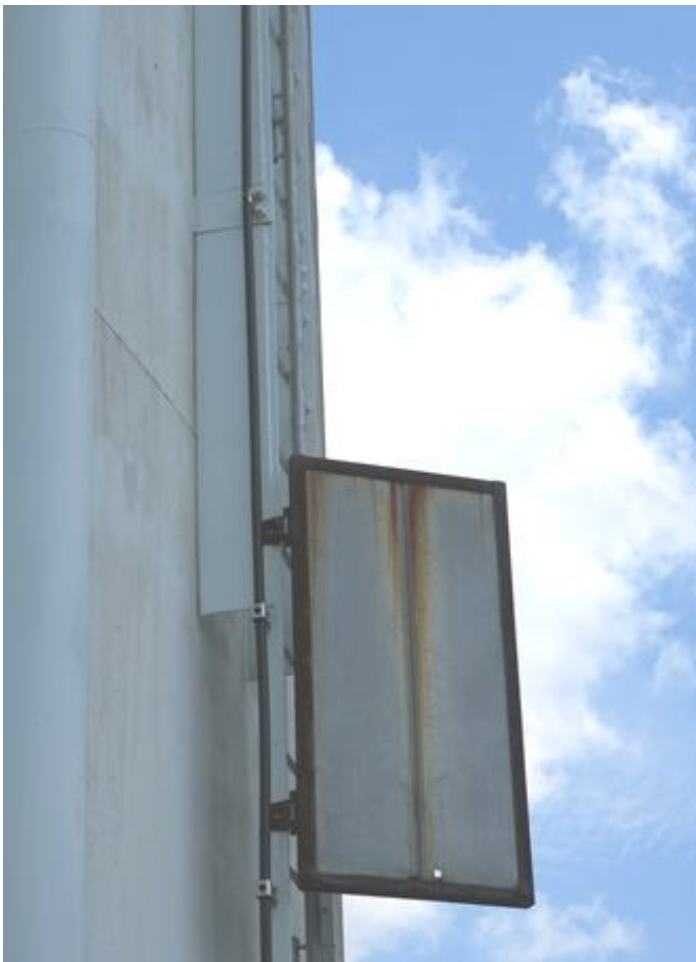
31. Exterior ladder and vandal deterrent.

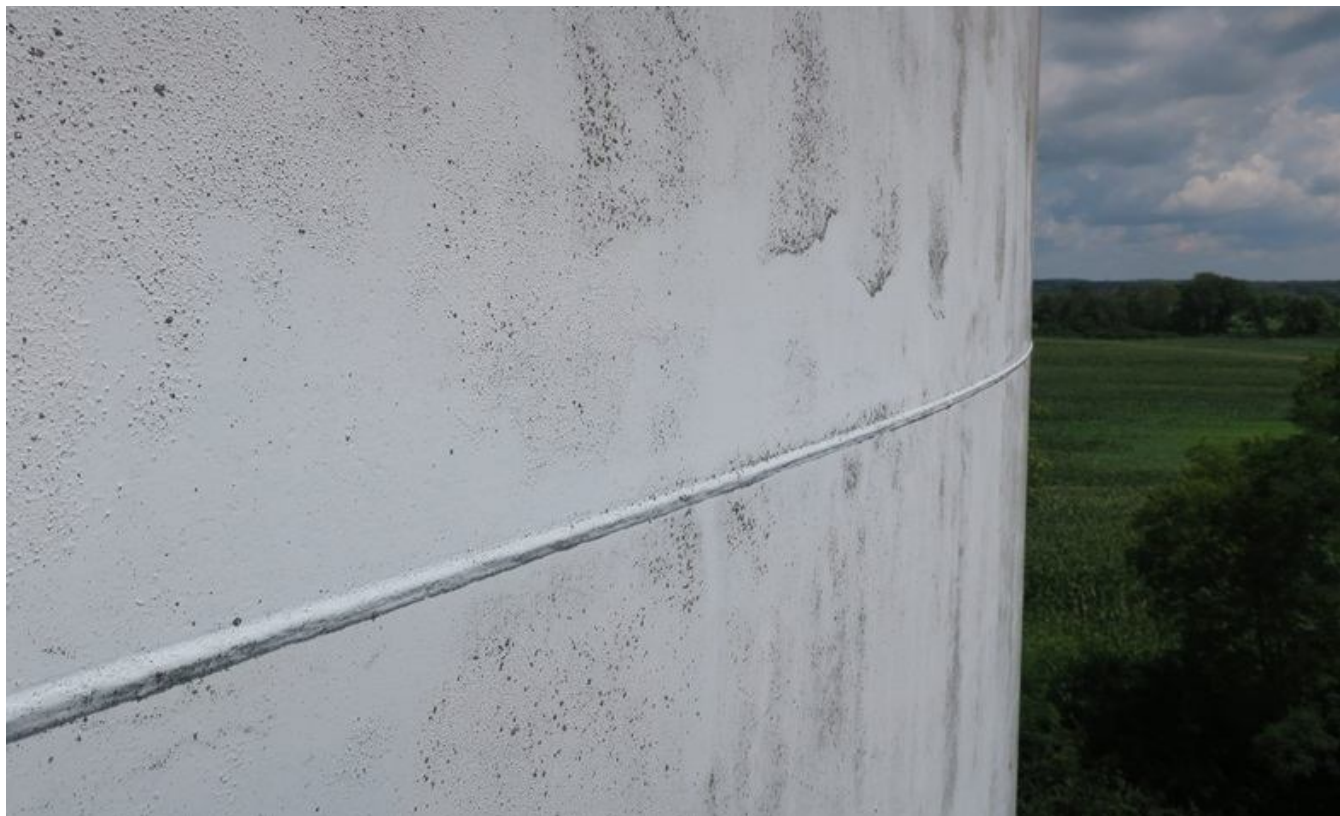
33. Shell exterior weld seam.

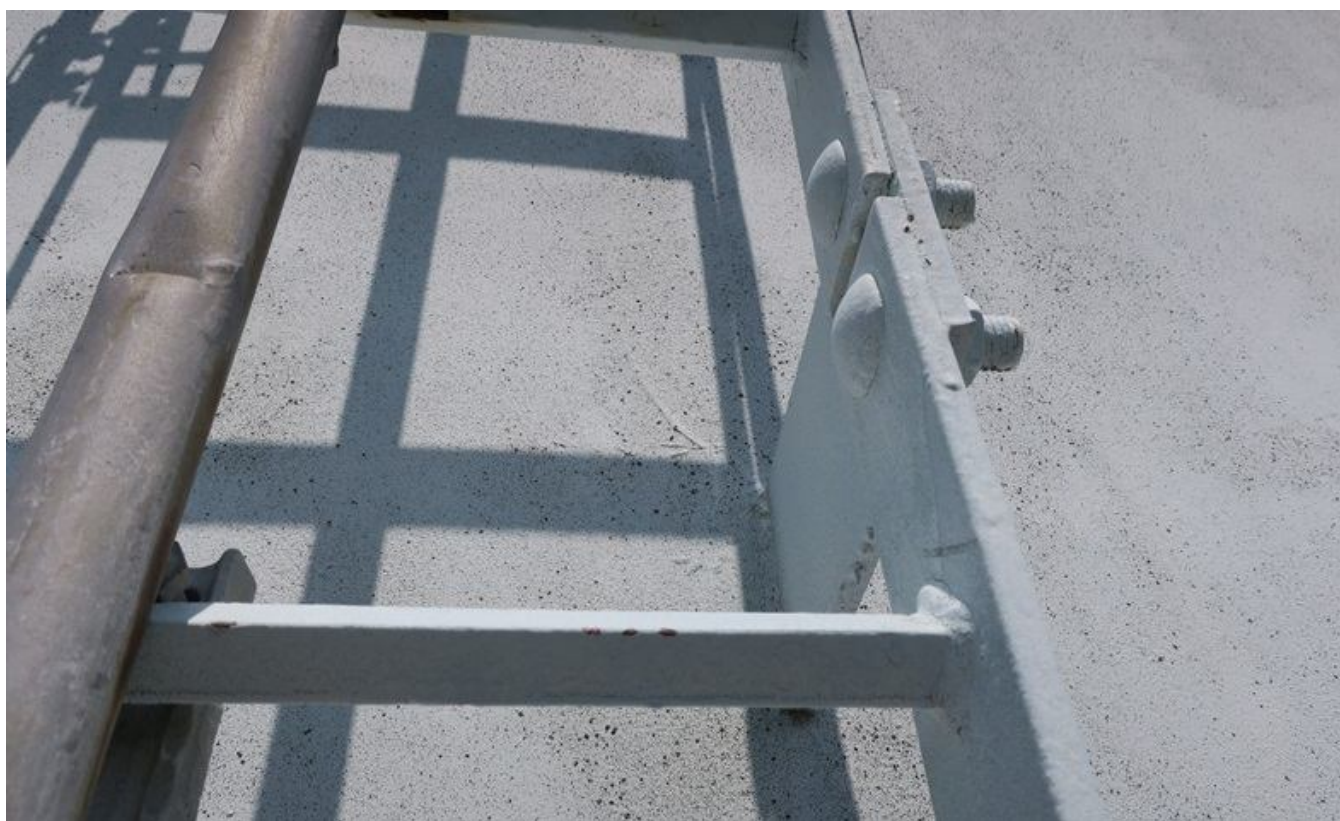
34. Exterior ladder connection.

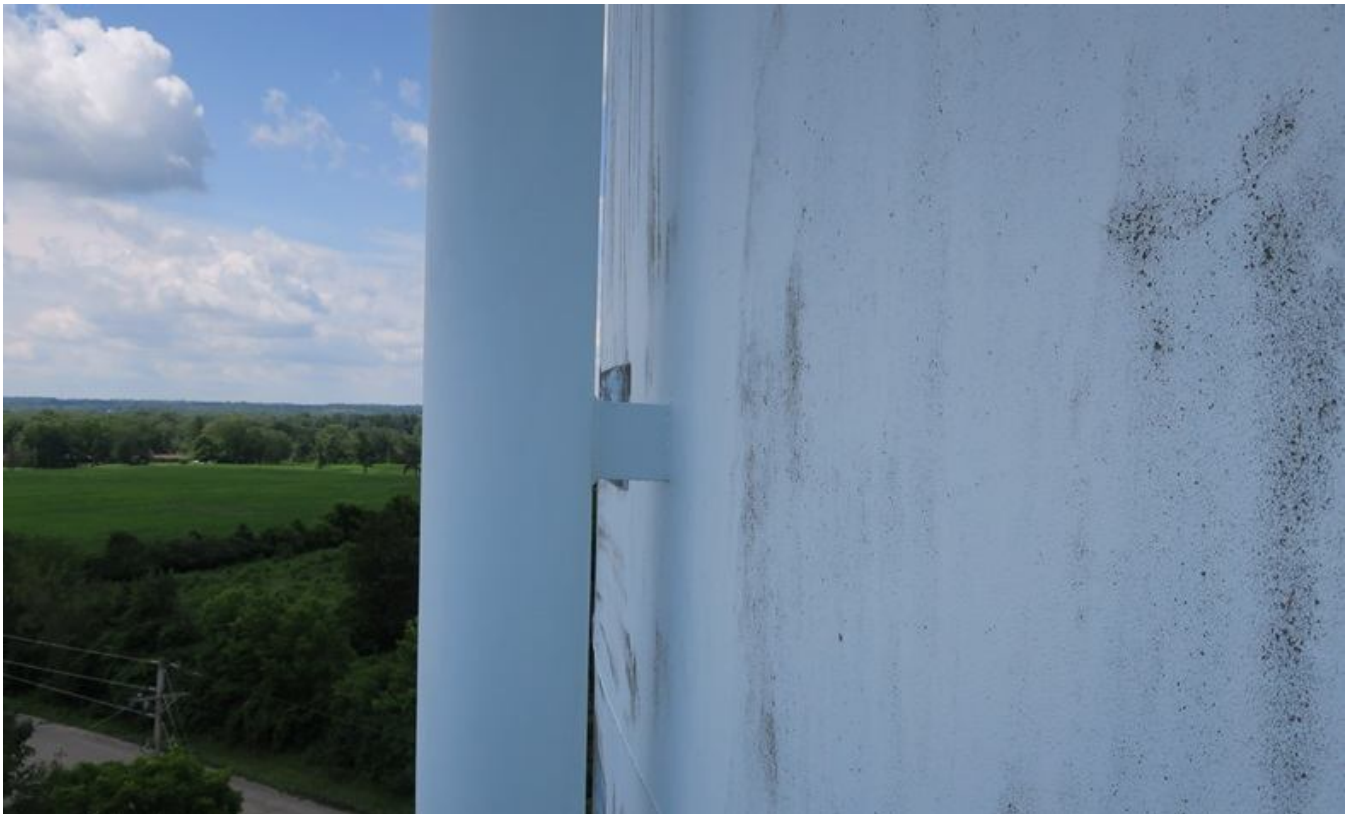
36. Overflow pipe bracket.

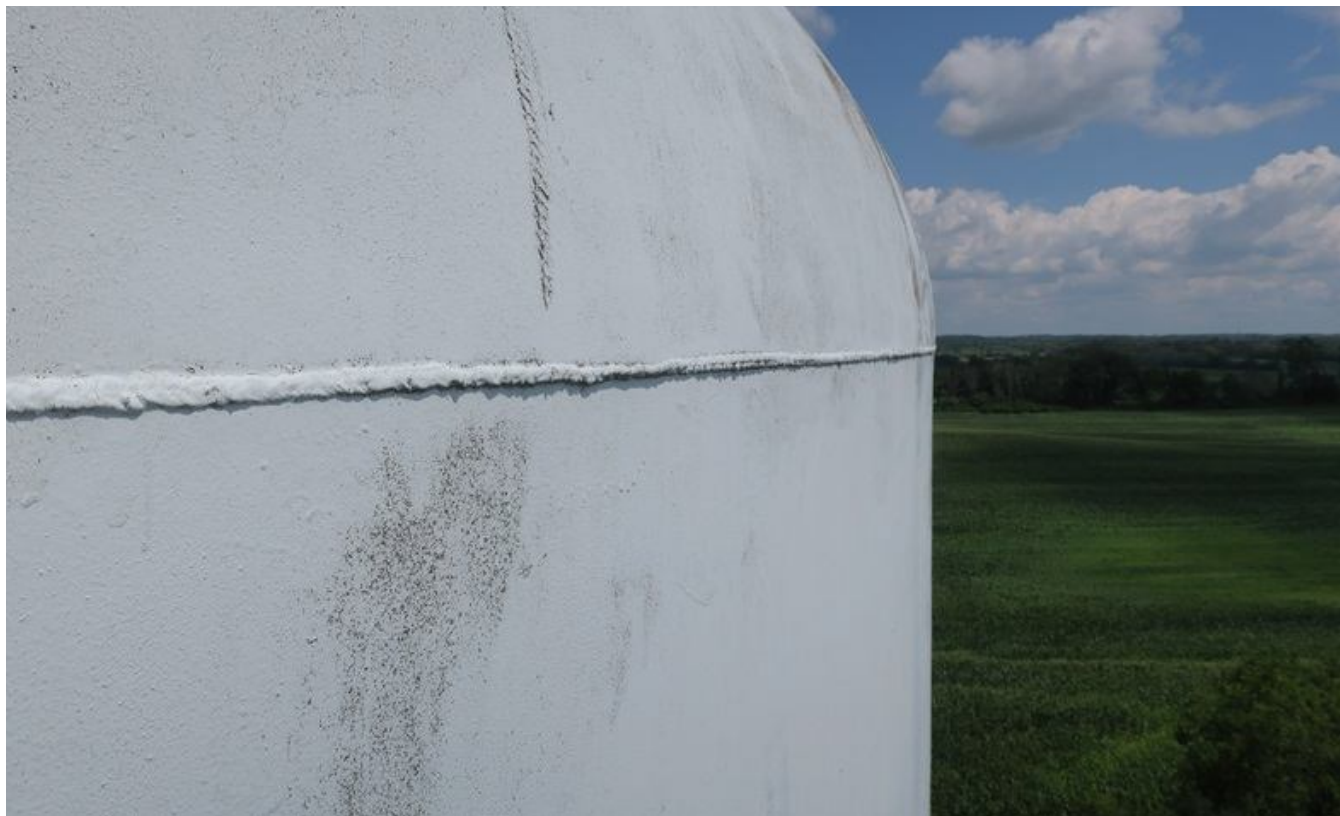
37. Shell exterior weld seam.

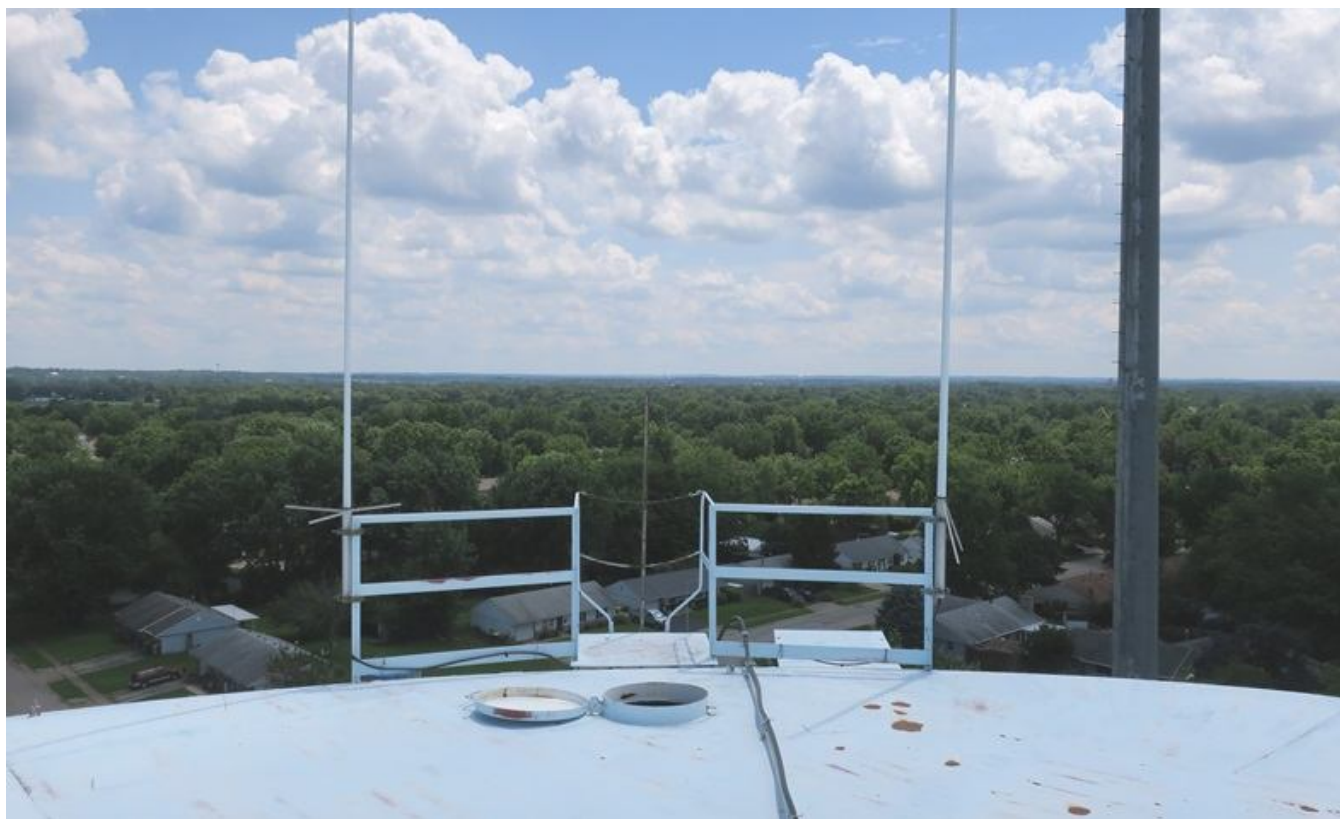
38. Roof access, platform, antennas, manhole, and safety railings.
