**EVALUATION OF THE
1,730,000 GALLON STANDPIPE
NEW CARLISLE, OHIO
FOR
CITY OF NEW CARLISLE
NEW CARLISLE, OHIO**

July 14, 2017

17.096.H1664.001

The subject of this report is the field evaluation of the 1,730,000 gallon standpipe in New Carlisle, Ohio. The tank was owned by the City of New Carlisle, Ohio. The field evaluation was performed on July 14, 2017 by Gregory P. Cannon, NACE Certified Coating Inspector Level 3, Certificate No. 10339, Jamie Stewart, NACE Coating Inspector Level 1 Certified, Certificate No. 64809, and Jared Colahan, NACE Certified Inspector Level 3, Certificate No. 47251 of Tank Industry Consultants. The Owner's representative on the site at the time of the field evaluation was Jason Rose. The column and rafter supported roof tank was of welded steel construction. According to information on the tank nameplate, the tank was built in 1975 by Chicago Bridge and Iron Company under contract number 74-20814, and had a capacity of 1,730,000 gallons. The tank nameplate also stated that the tank diameter was 60 ft, and the nominal shell height was 82 ft.

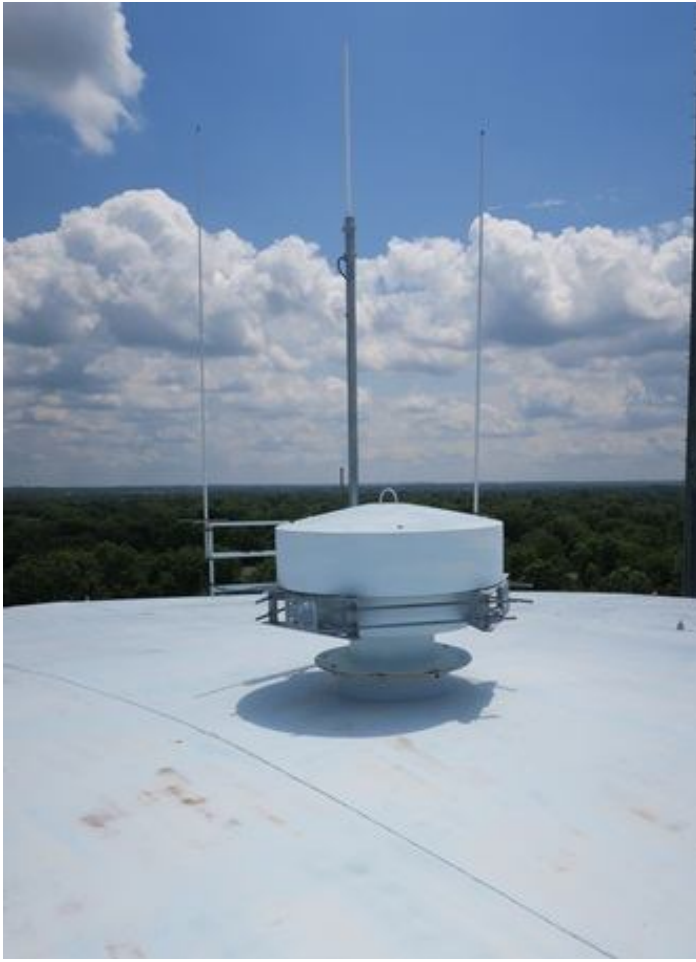
41. Roof vent and antenna.

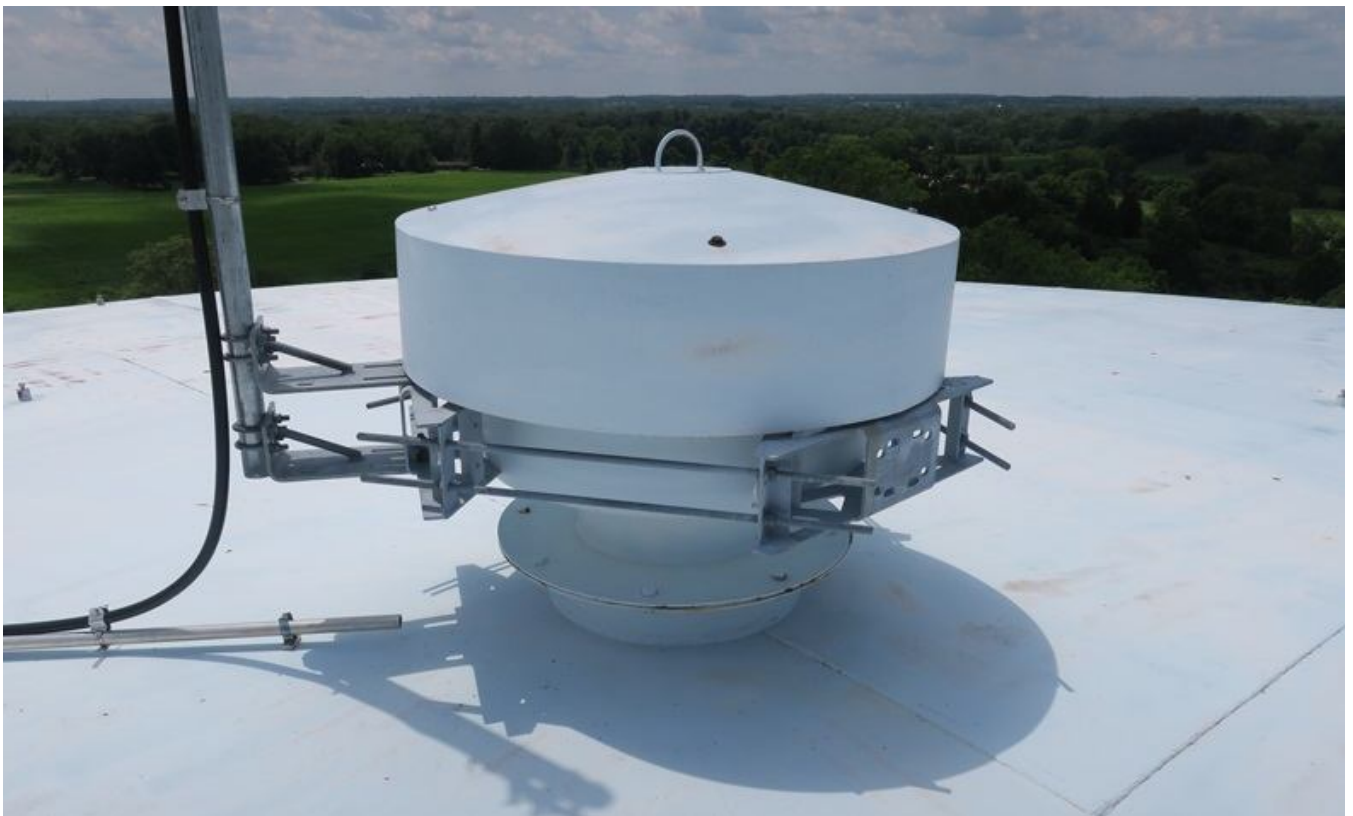
42. Roof vent and antenna. Note vent lug.

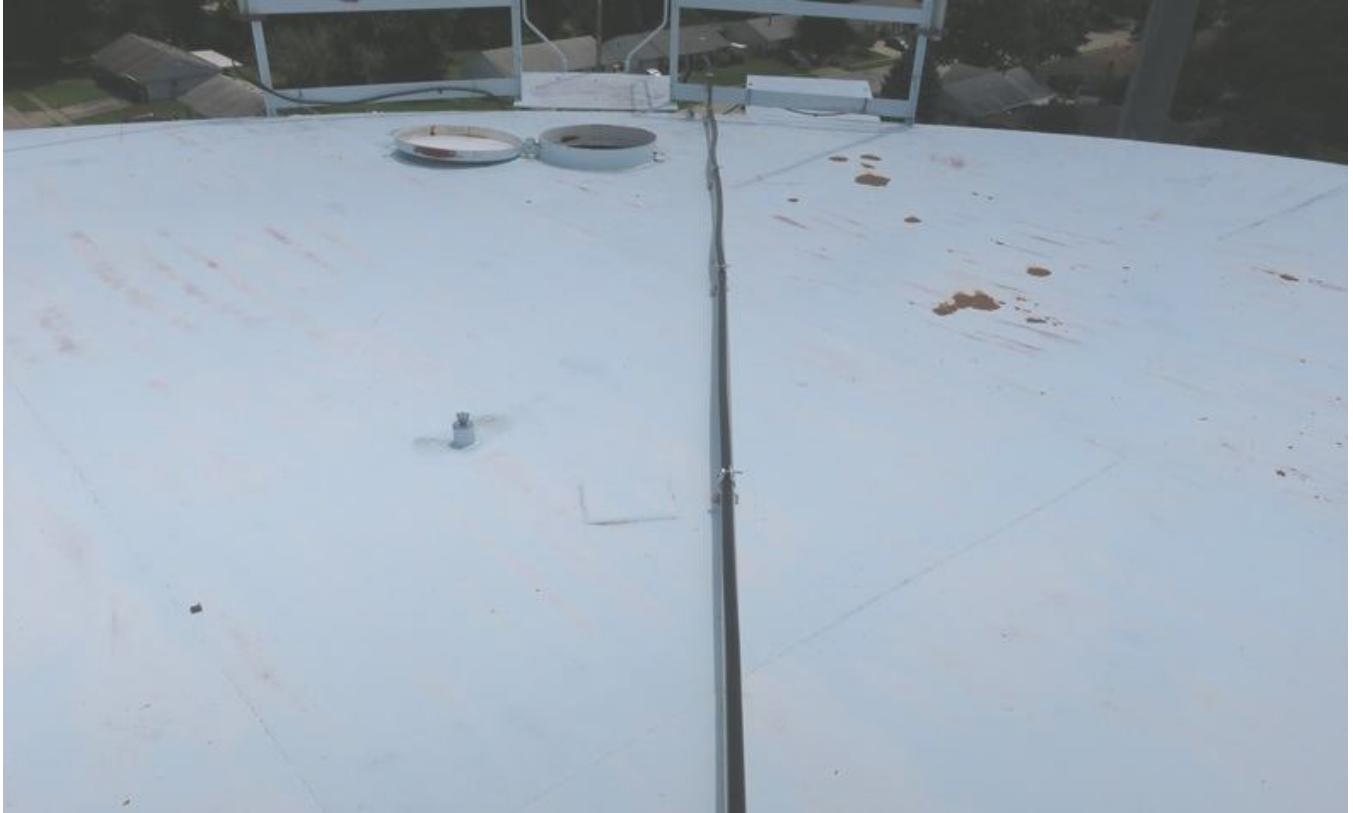
44. Roof antenna cable.

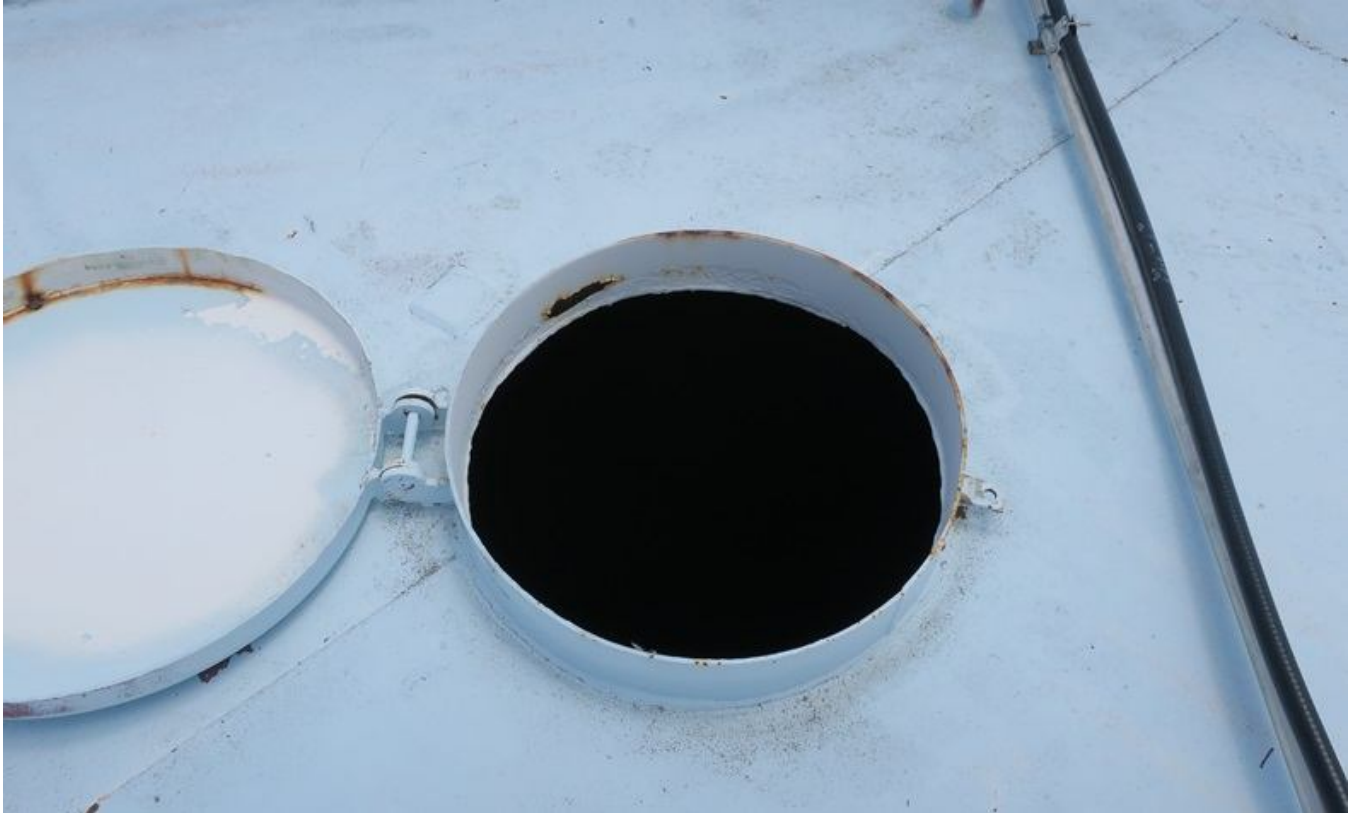
- ◆ roof manholes were not locked.

46. Roof manhole.

This deficiency should be corrected.

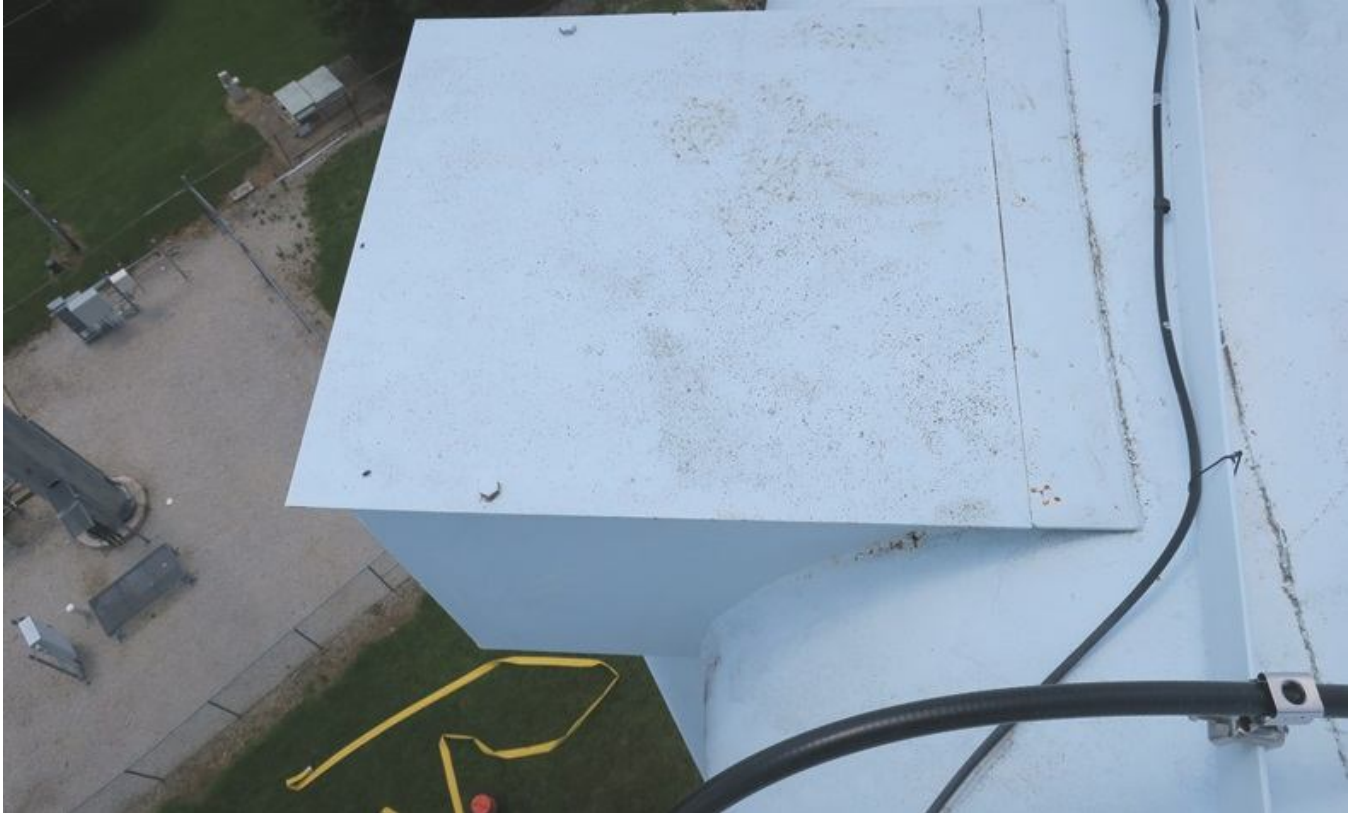
48. Exterior overflow weir box.

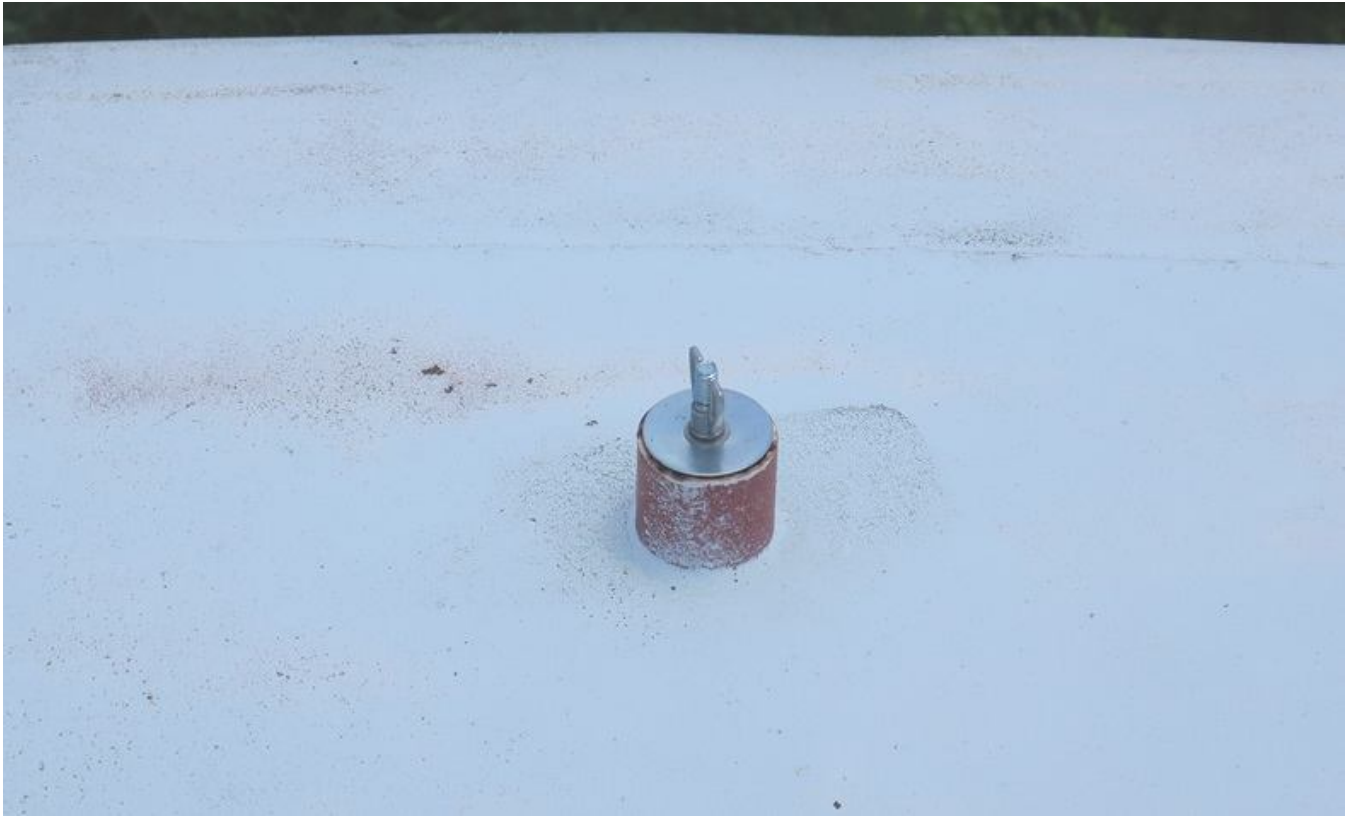
49. Roof plugged coupling.

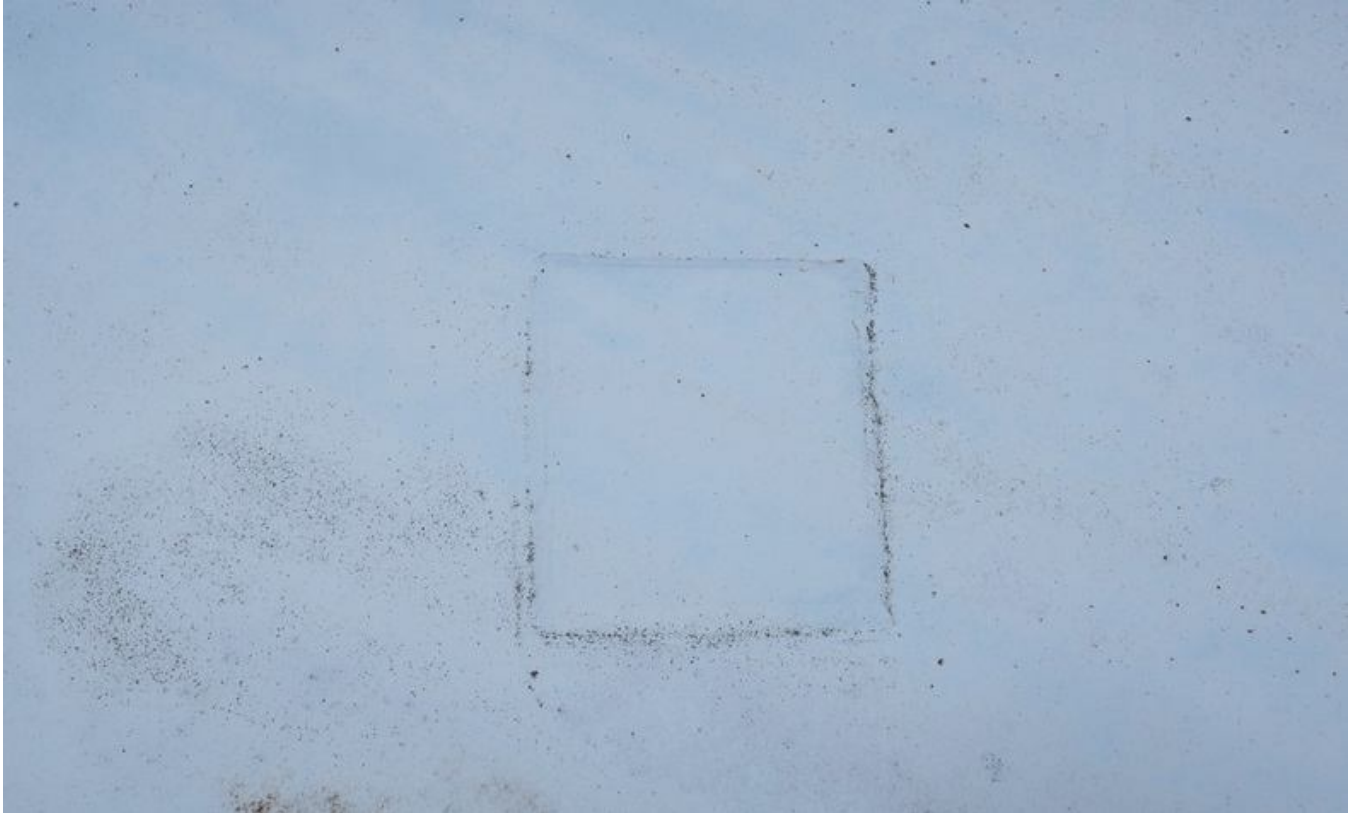
50. Patch plate weld.

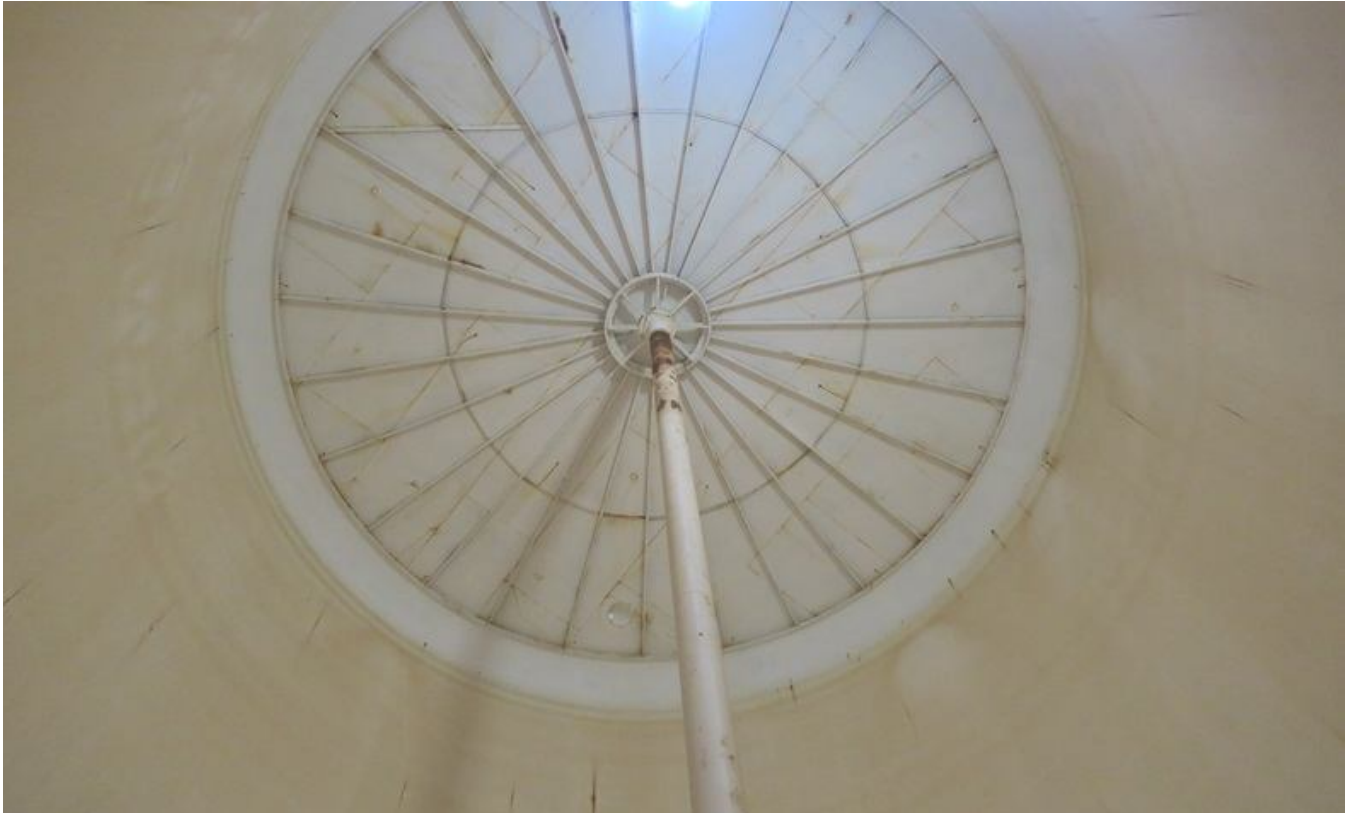
54. View of roof interior.

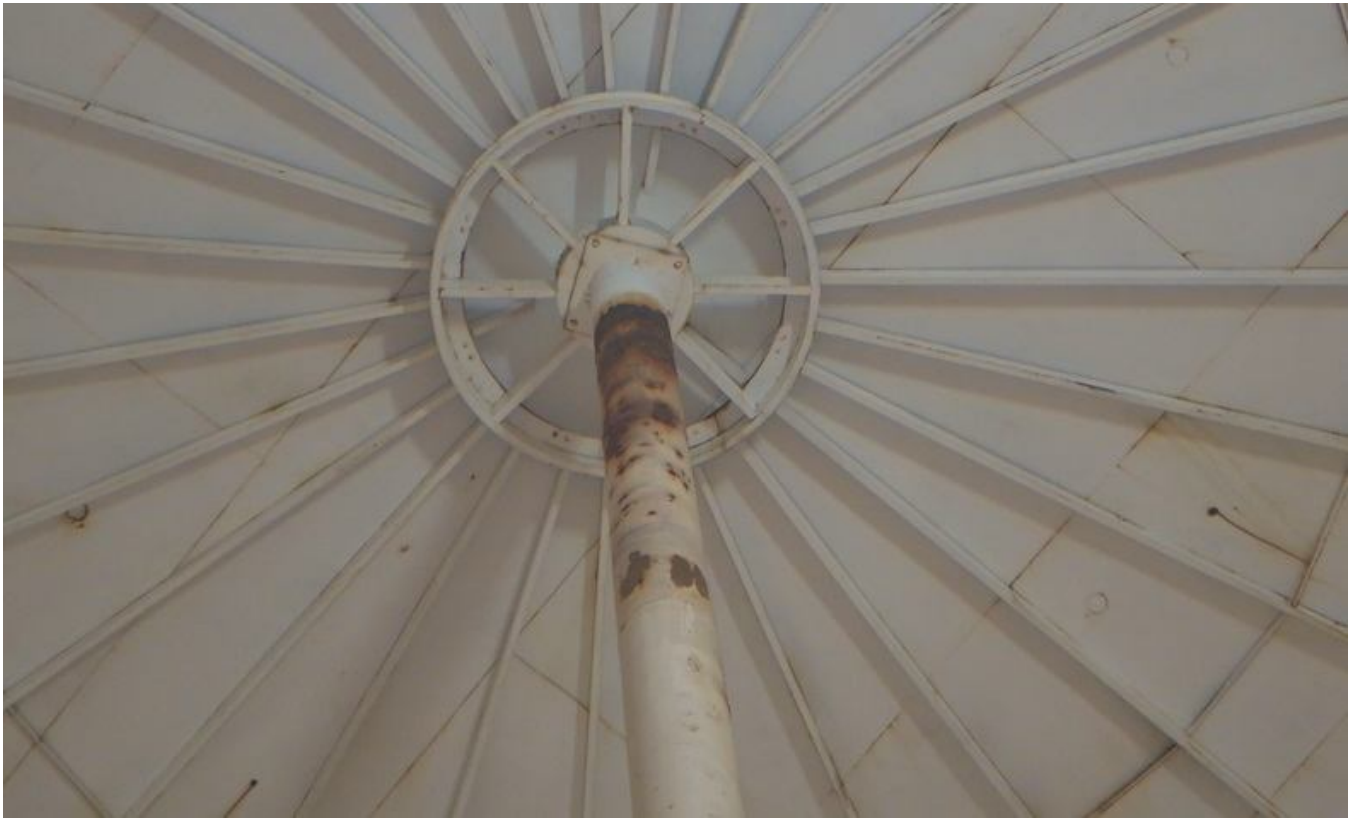
55. View of roof interior.

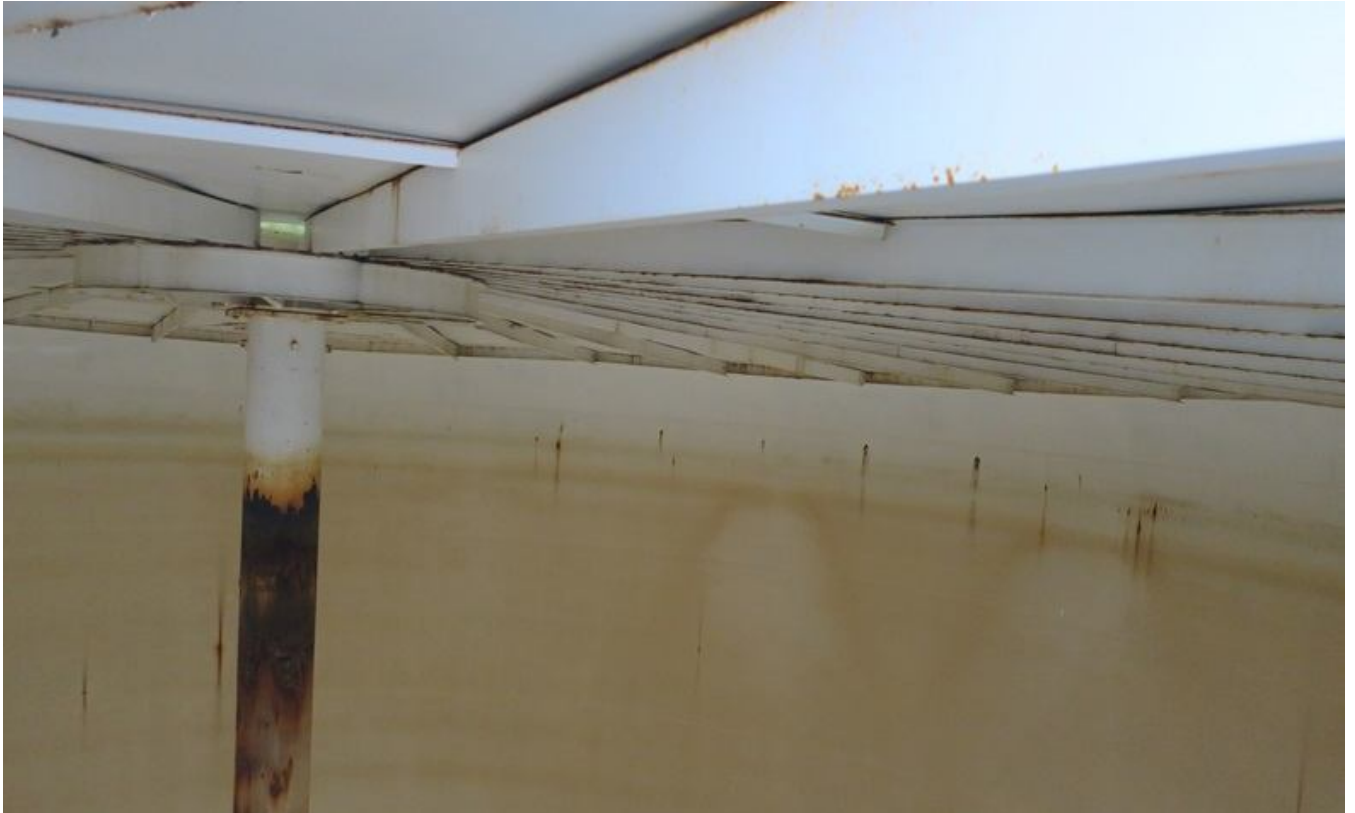
56. Interior roof, support column, and rafters.

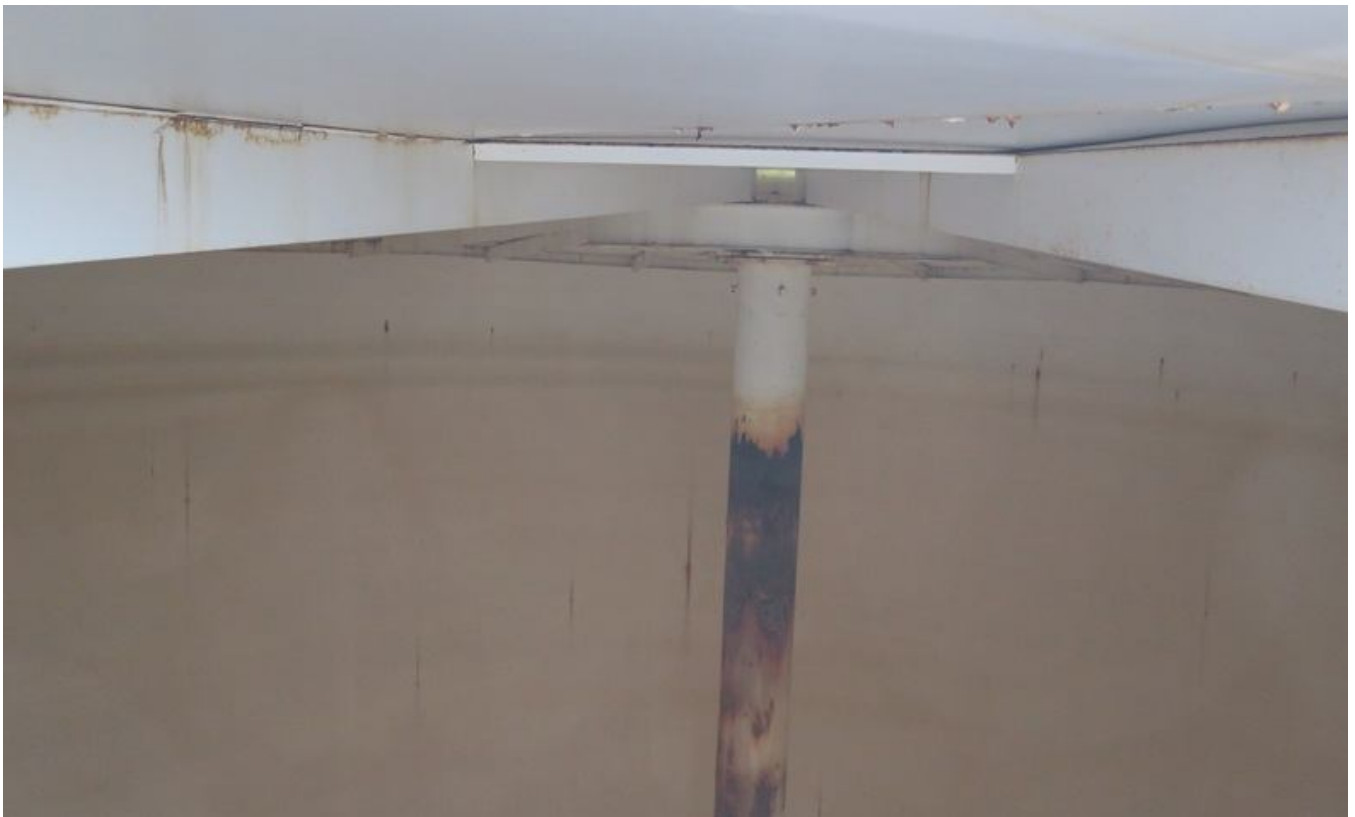
58. Interior roof, support column, and rafters.

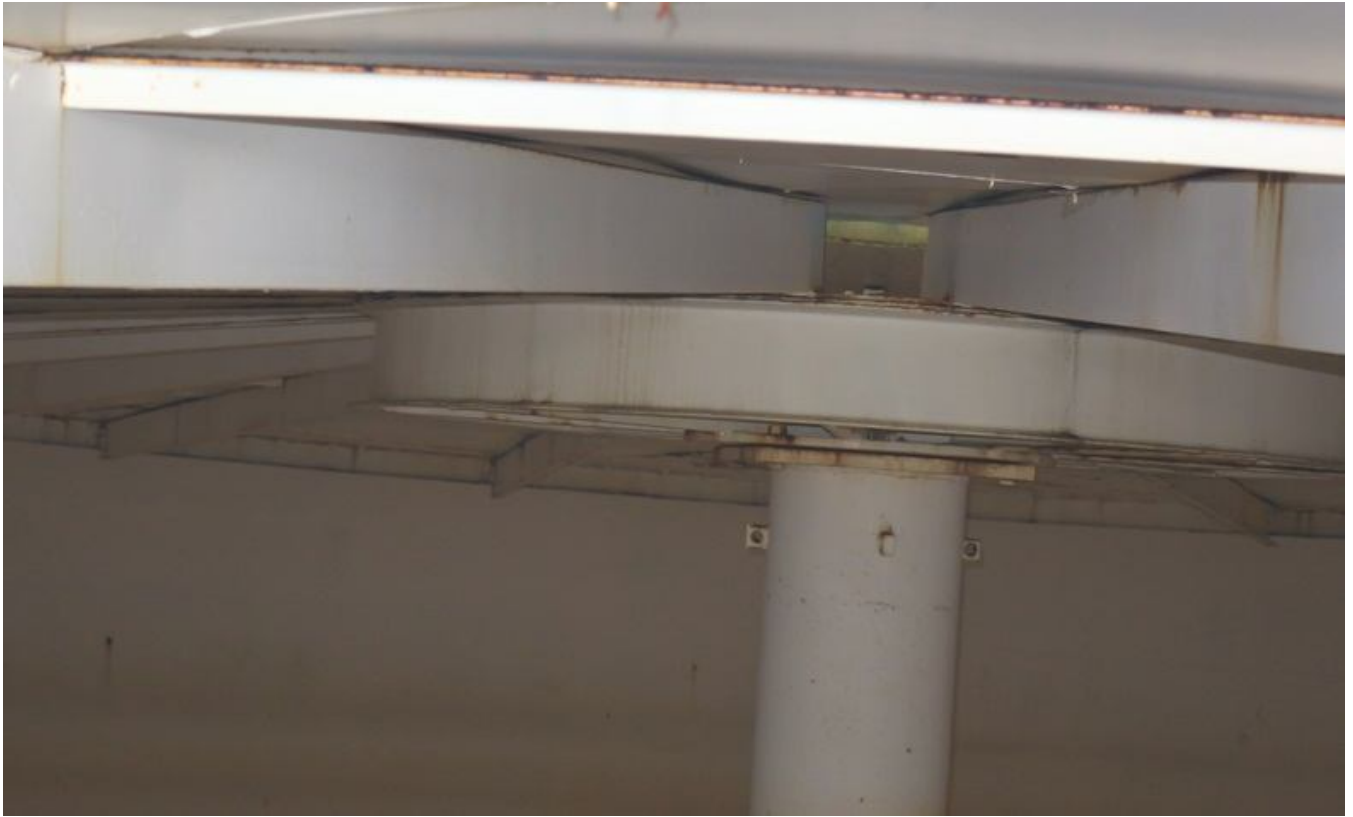
59. Interior roof, support column, and rafters.

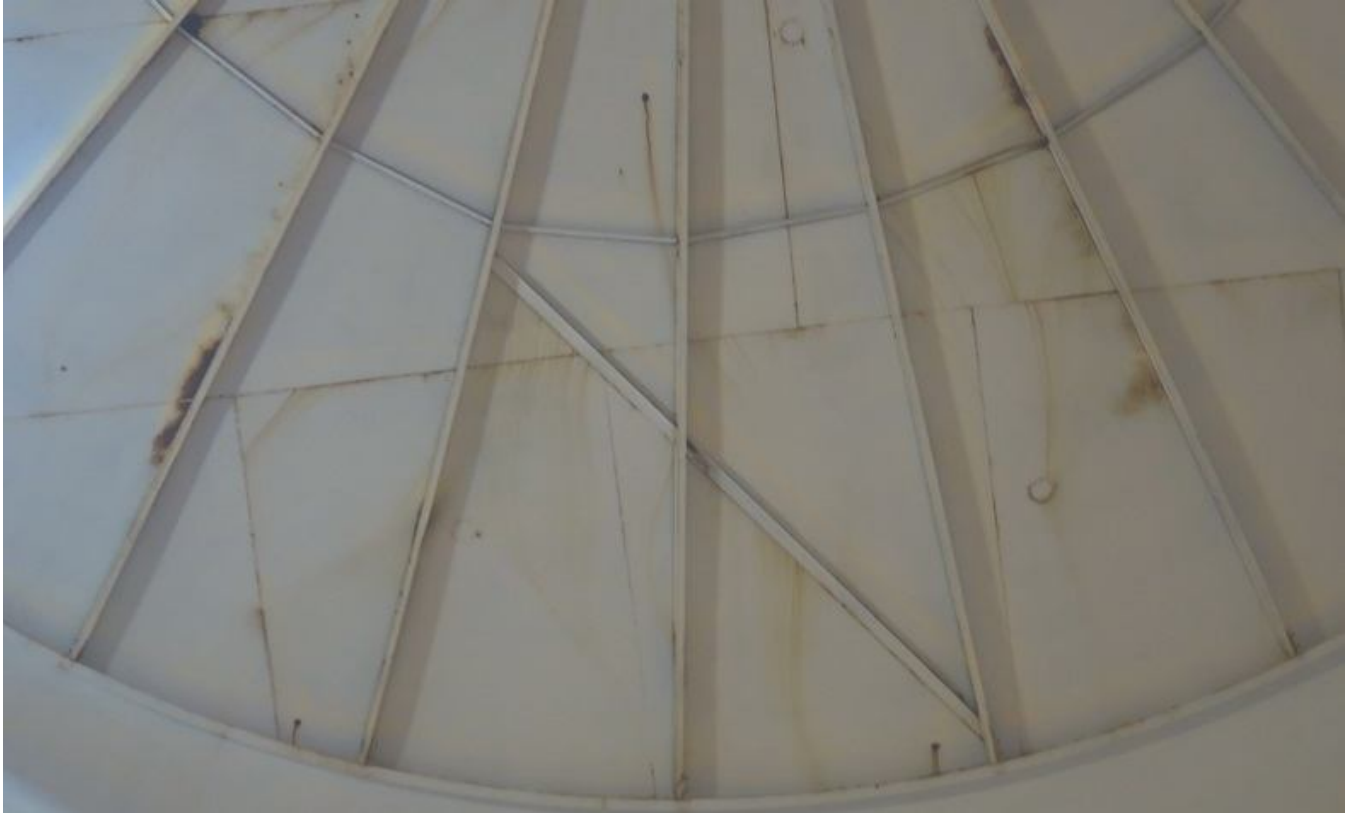
60. View of roof interior support rafters.

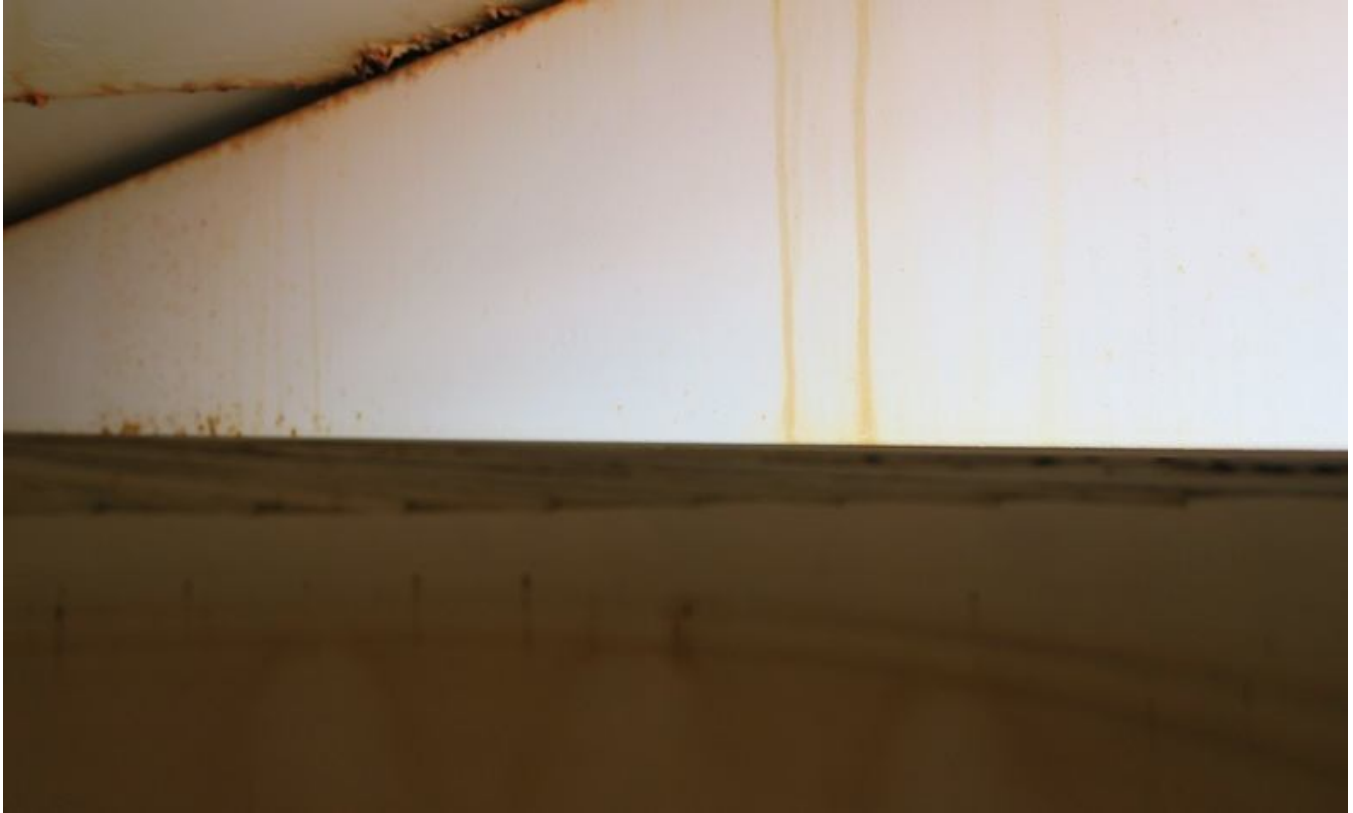
62. Support rafter.

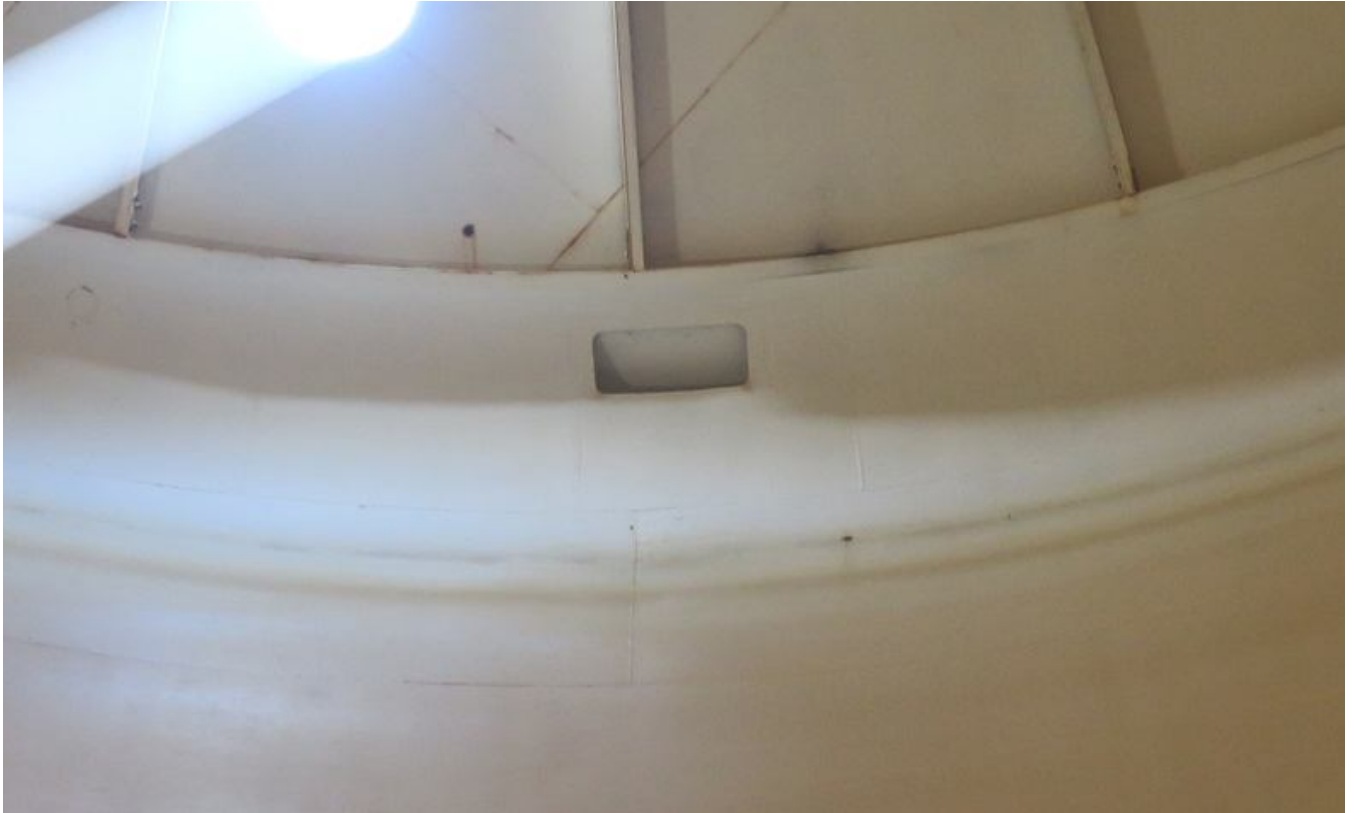
68. Overflow inlet and roof manhole opening.

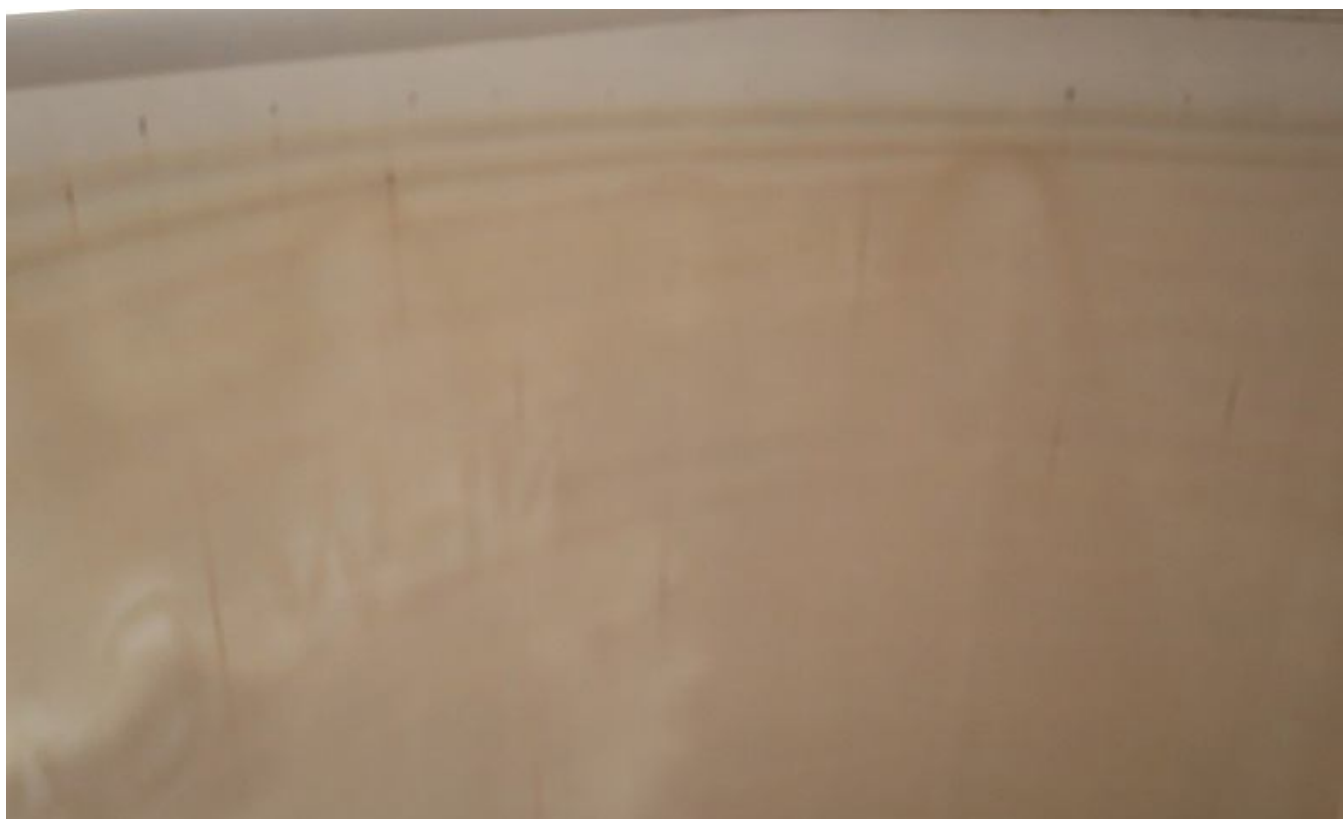
70. Tank interior.

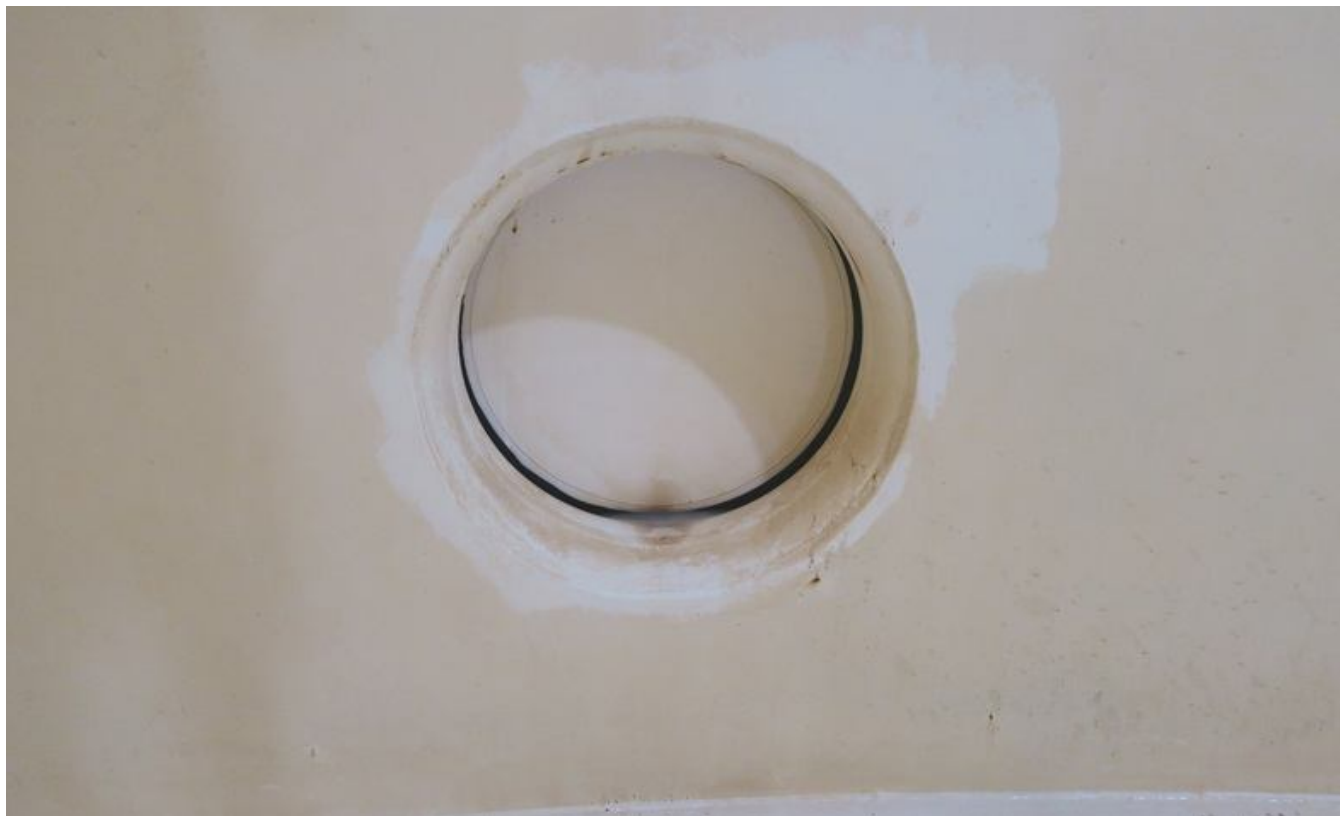
75. Shell manhole interior

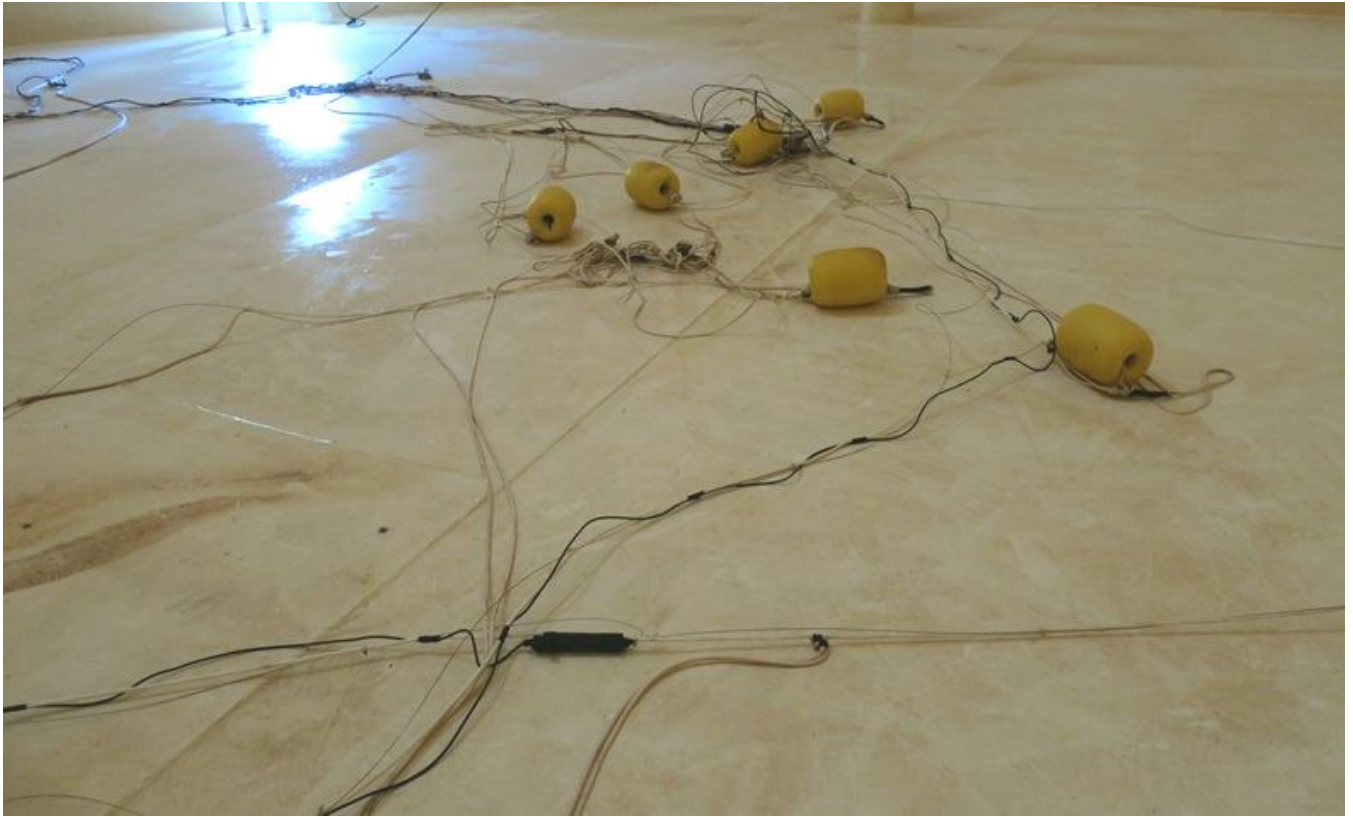
79. Cathodic protection equipment on floor.

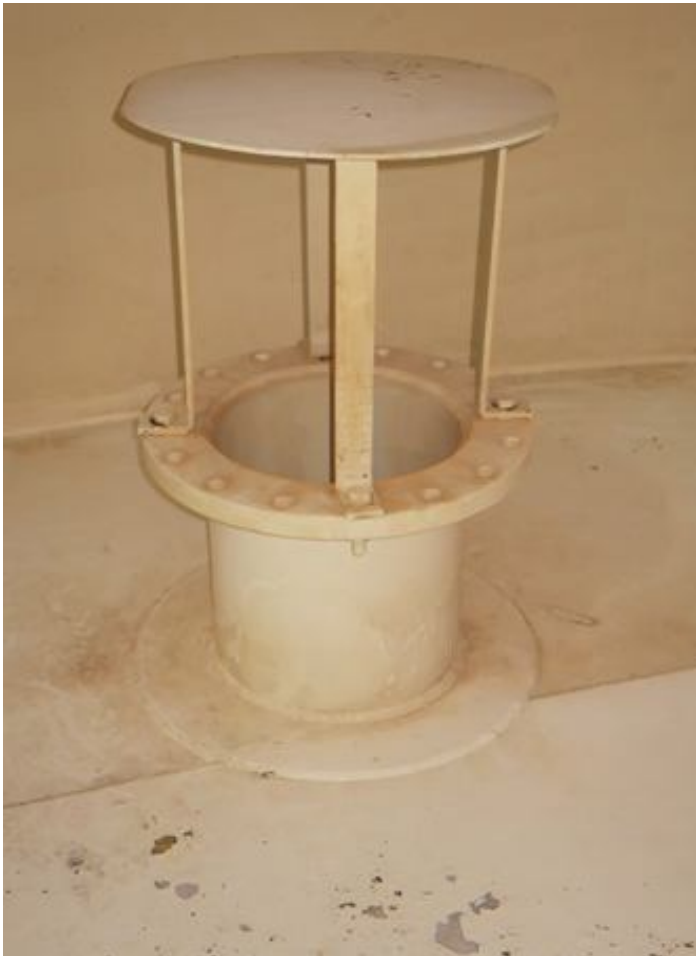
84. Inlet/outlet pipe and removeable cover.

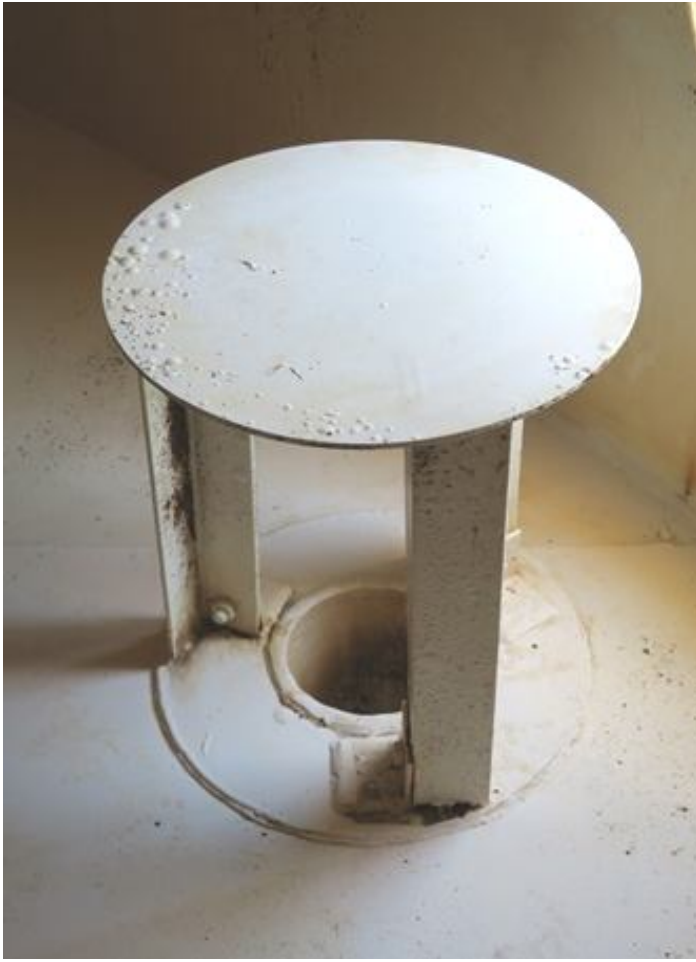
85. Drain pipe and removable cover.
